Ecora File No.: 230018-02

Regional District of Okanagan-Similkameen
101 Martin Street,
Penticton, BC
V2A 5J9

Reference: Emergency Geotechnical Assessment for 3169 10th Avenue, Keremeos, BC

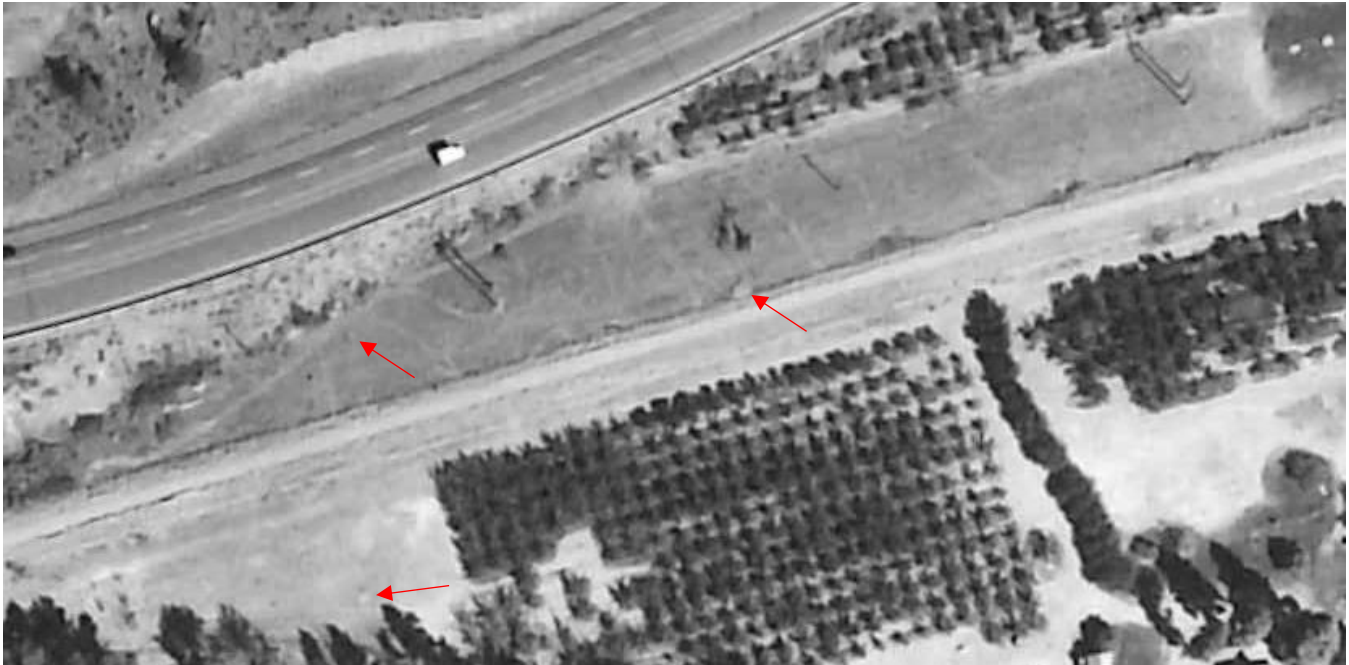
A key observation from the aerial imagery review included what appears to be several large boulders located on the 3169 10th Avenue property and the one situated immediately to the south, 3155 10th Avenue in aerial photograph BC87099 from 1987, indicating that the property had historically been subjected to rock fall prior to development of the Eagle Campground & RV Park. Figure 2.2 below shows an excerpt of the aerial photograph with the boulders (rock fall debris) indicated by red arrows.

Figure 2.2: View of 3169 10th Avenue and 3155 10th Avenue from aerial photography taken in 1987.

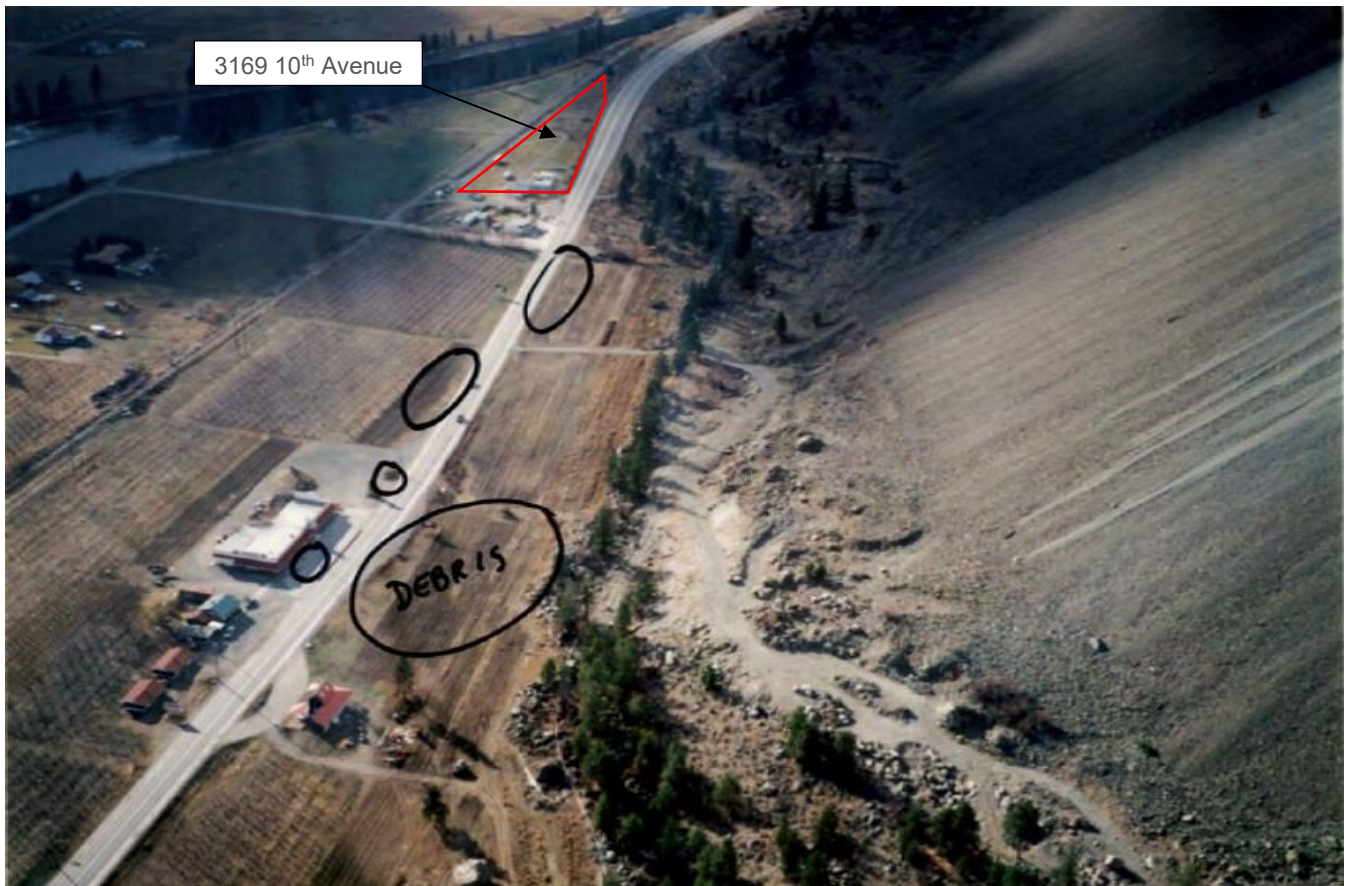
Photo 2.3a Photo of talus fan and rock fall debris locations from February 9th, 1998 rock fall event looking west.

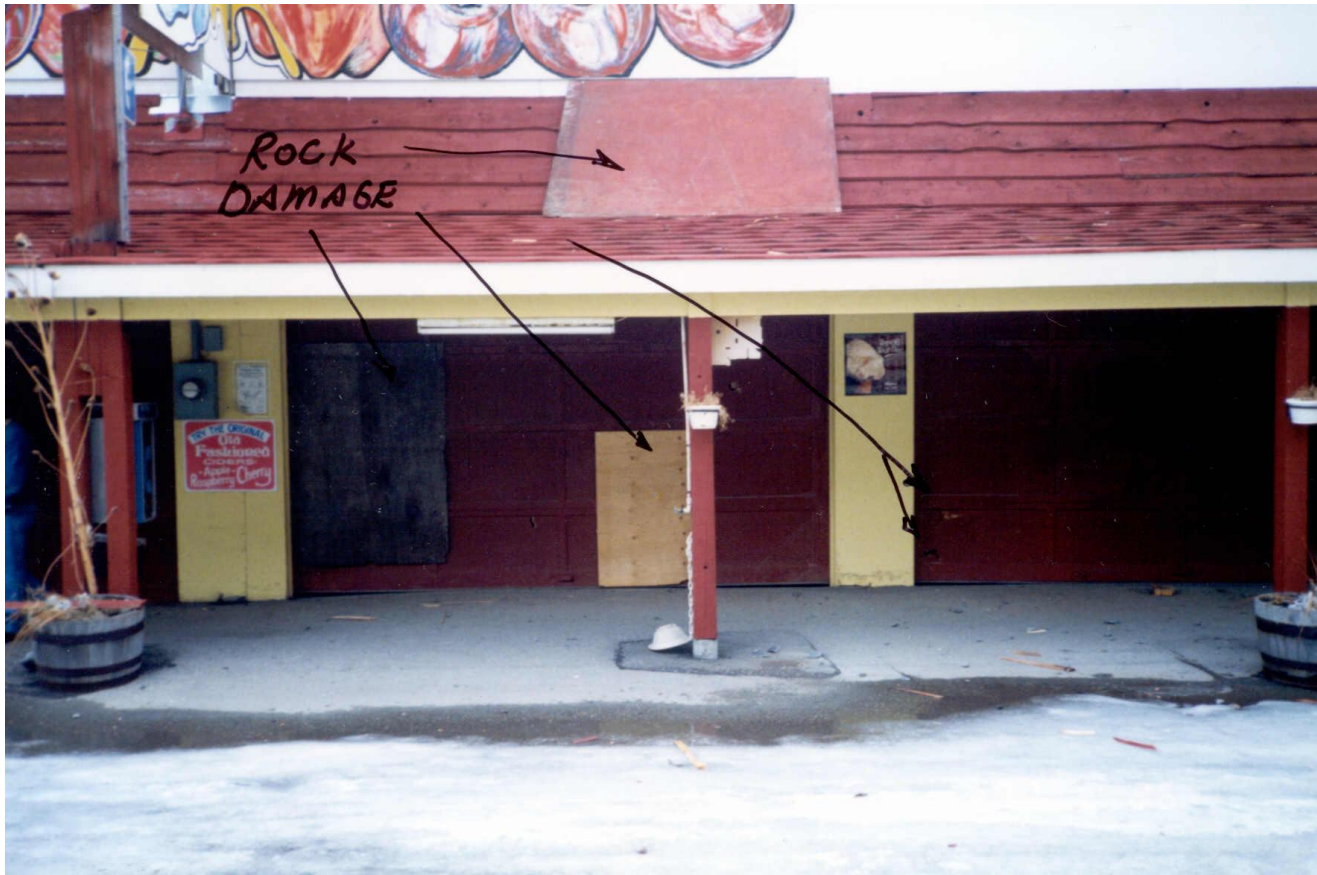
Photo 2.3b View of damage locations on the Mariposa fruit stand building from the February 9th, 1998 rock fall event.

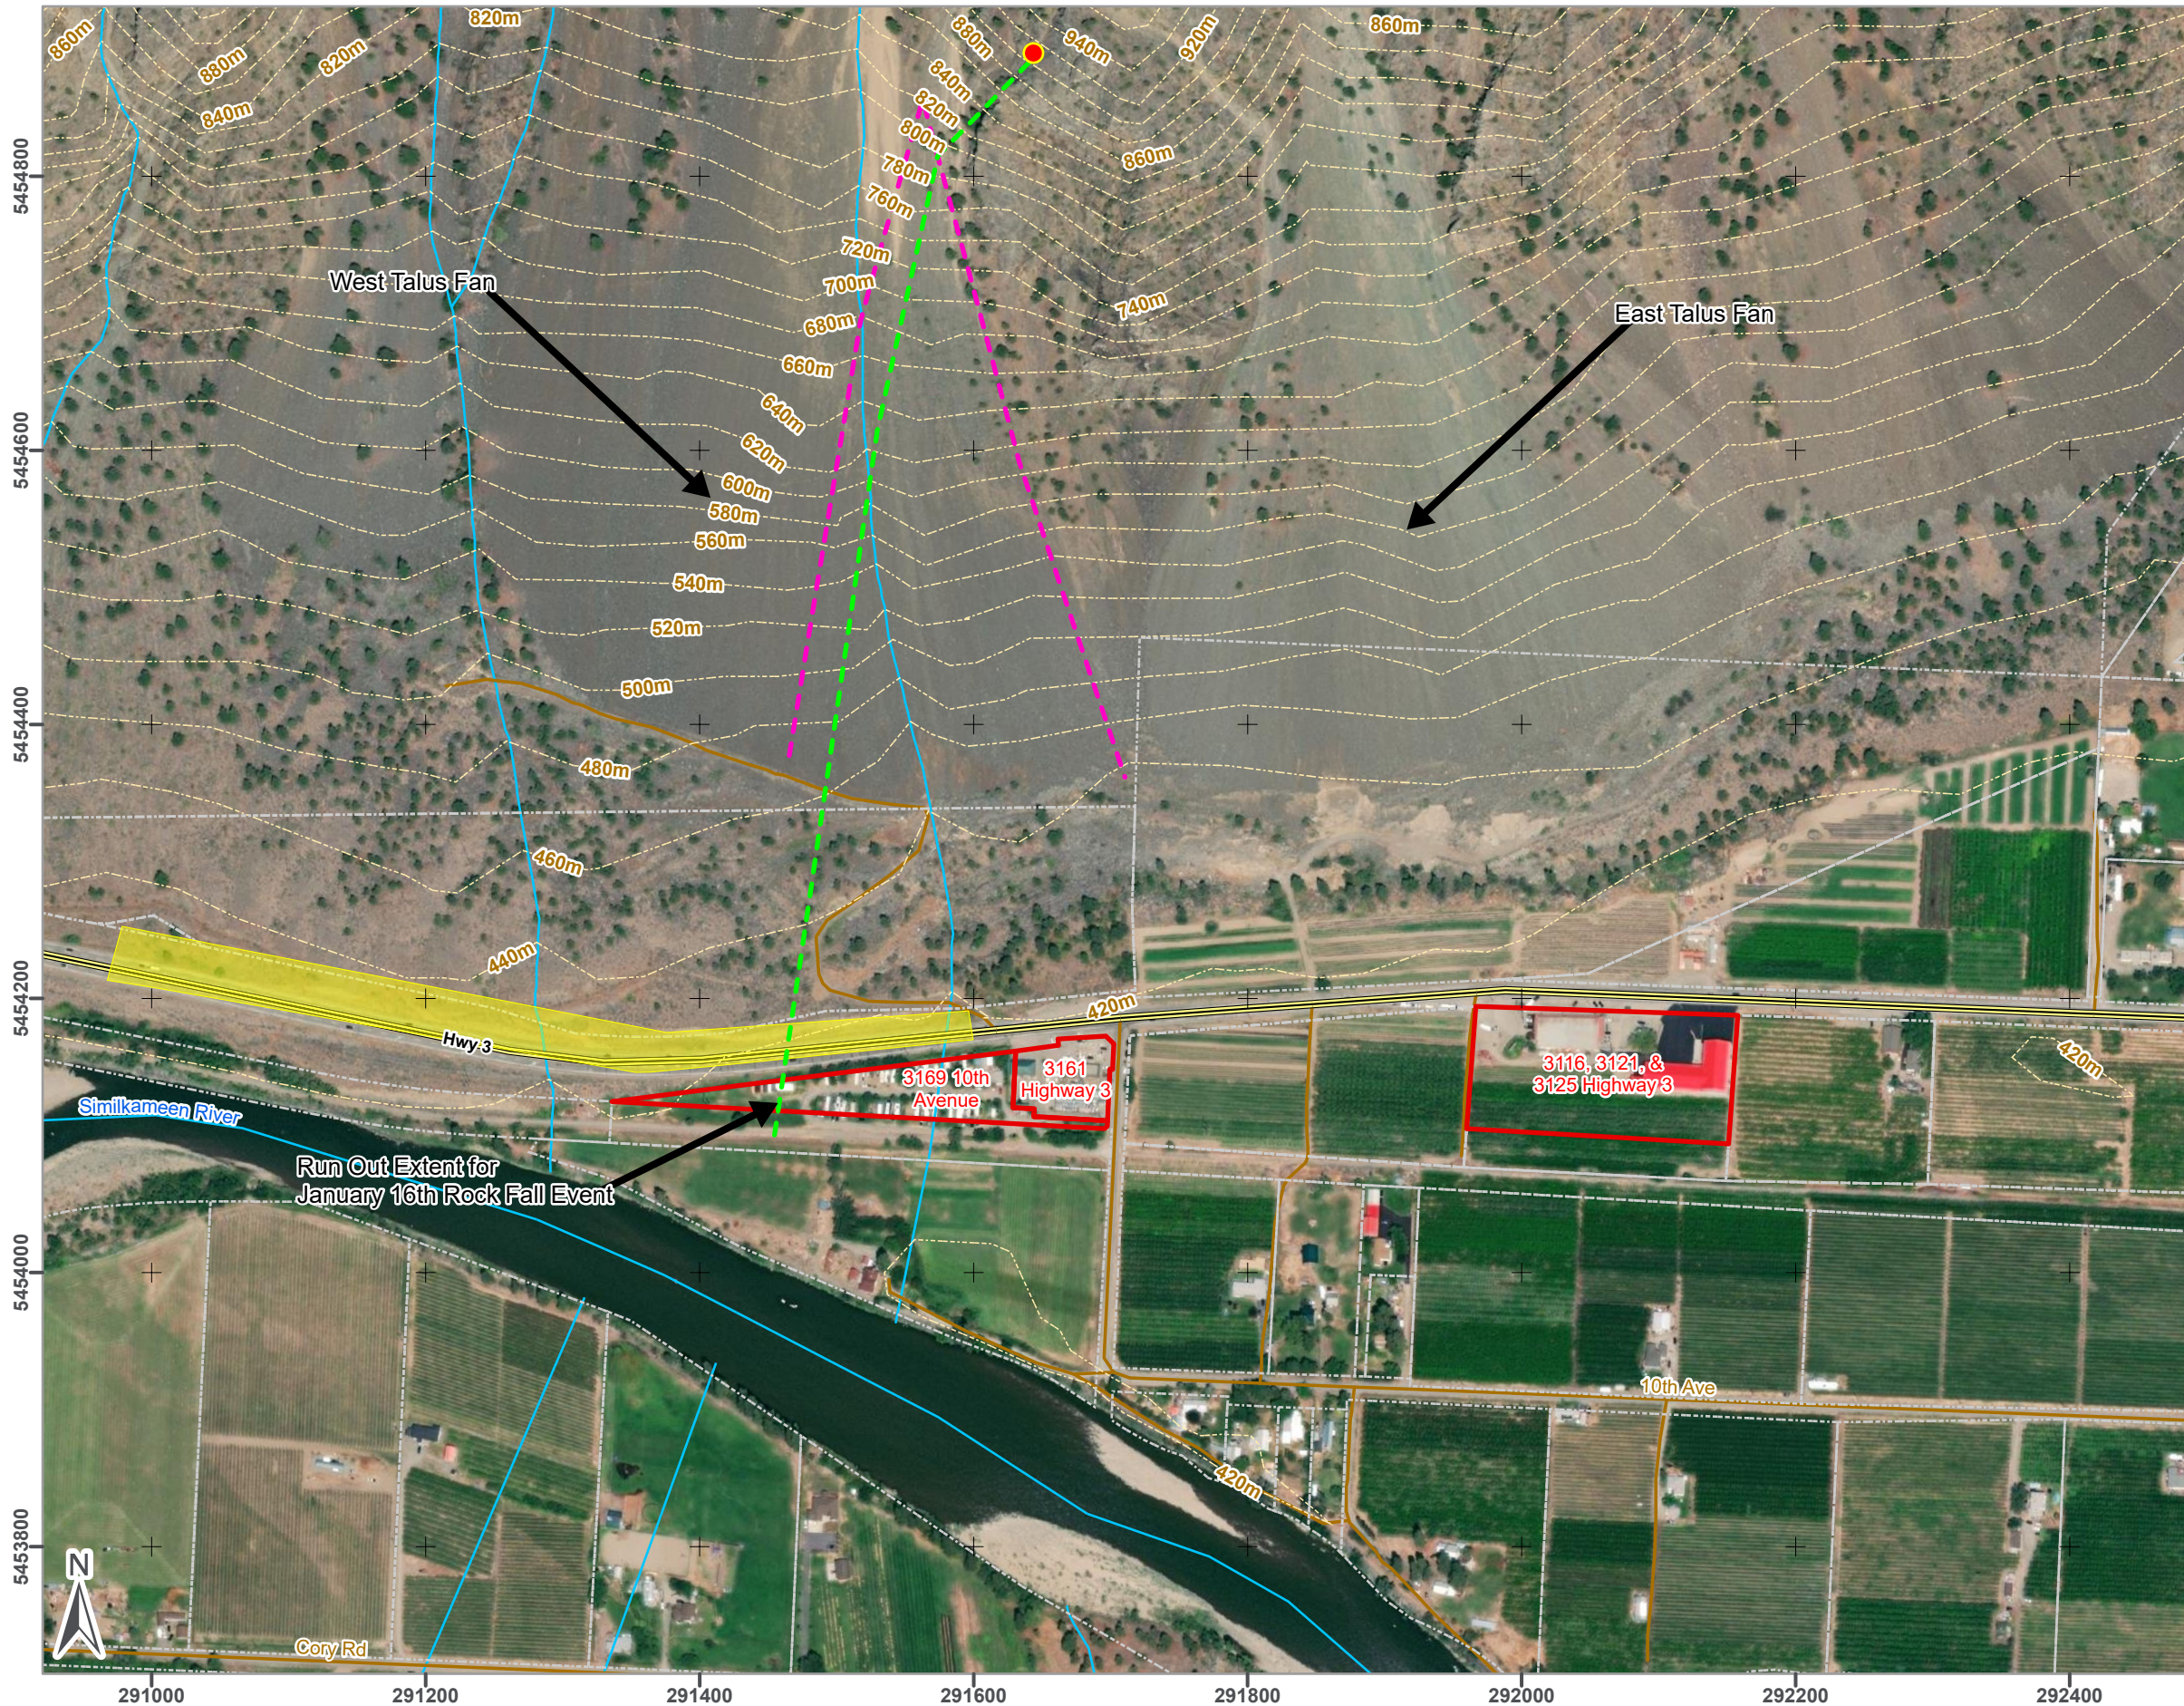
Figure 1.0

- The rock fall source from the event that occurred January 16th appeared to be located between the talus slopes above the subject property as shown on Figure 1.0. The rock fall source consists of a kinematically unstable (toppling) block along the west side of the bedrock outcrop (Photos 16 to 18). Four distinct joint sets were identified in the rock mass between the talus fans, including two subvertical, perpendicular sets (red and orange in the photos).

A preliminary analysis was undertaken to estimate the run-out extent of the rock fall hazard originating from the January 16th rock fall source. The estimated run-out extent was determined by projecting an imaginary line, 27.5 degrees from horizontal, from the apex of the talus slope below the observed rock fall source, which is based on review of historical rock fall observations as shown in Figure 4.1. The estimated rock fall run-out zone for the rock fall source from the January 16th event extends approximately to the trail located along the southern aspect of the subject property as shown on the attached Figure 1.0.

Based on the information gathered from the site reconnaissance, the base angle for the rock fall boulders from the January 16th event is estimated to be 27 degrees. This angle plots near the estimated run-out extent for the January 16th rock source location.

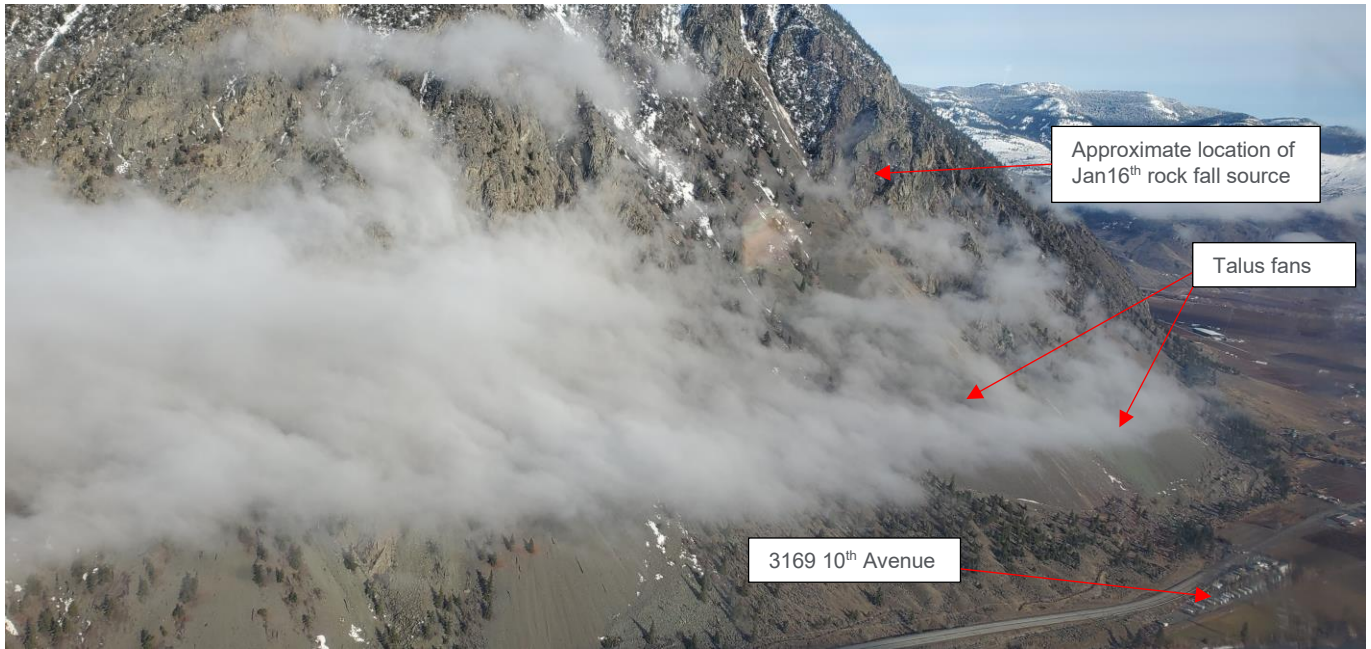
- The subject site is located between Highway 3 and the Similkameen River. A gently sloping bench (~10° to 15°), approximately 150 m wide, separates the highway from the toe of the talus fans north of the subject site. The talus slopes measured approximately 30° to 35° and 500m to 600 m in height. Rock fall source zones in the form of fractured, weathered bedrock were located above and beside the talus fans (Photo 1).

Photo 1 Aerial view of mountain and talus fans above Hwy 3 and 3169 10th Avenue.

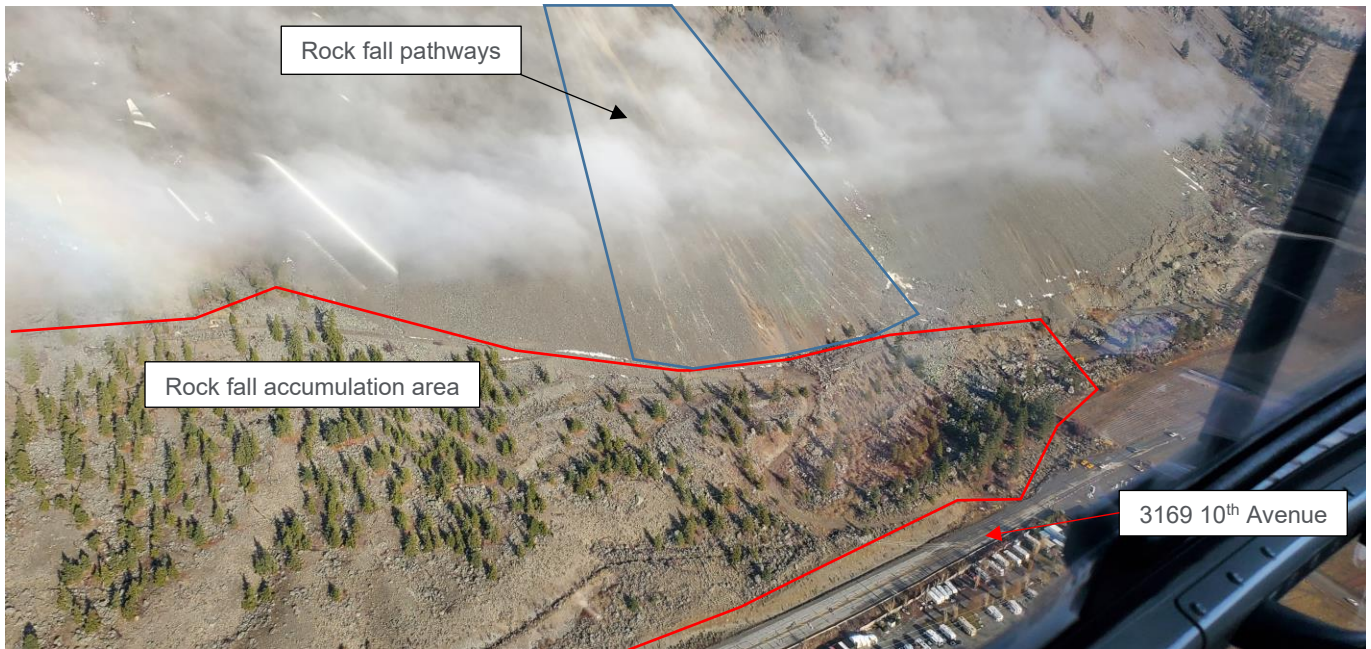
- Numerous rock fall debris (boulders) were observed on the bench between the talus slopes and highway (Photos 2 to 4). Boulders from the January 16th rock fall event were observed on both talus fans (Photos 4 and 5). Multiple linear impact features were observed on the talus slopes indicating the rock fall pathways (Photos 4 and 10) from January 16th.

Photo 2 Aerial view of Hwy 3 and 3169 10th Avenue and talus fans above.

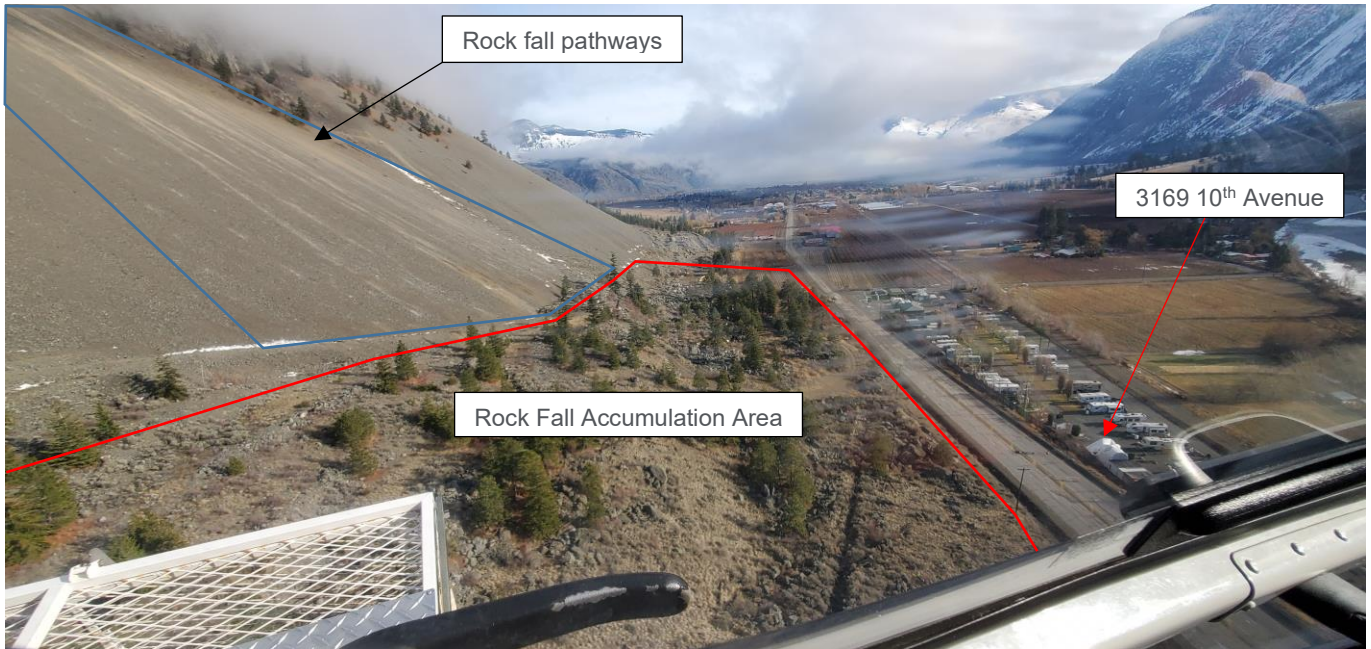
Photo 3 Aerial view of Hwy 3 and 3169 10th Avenue and talus fans above.

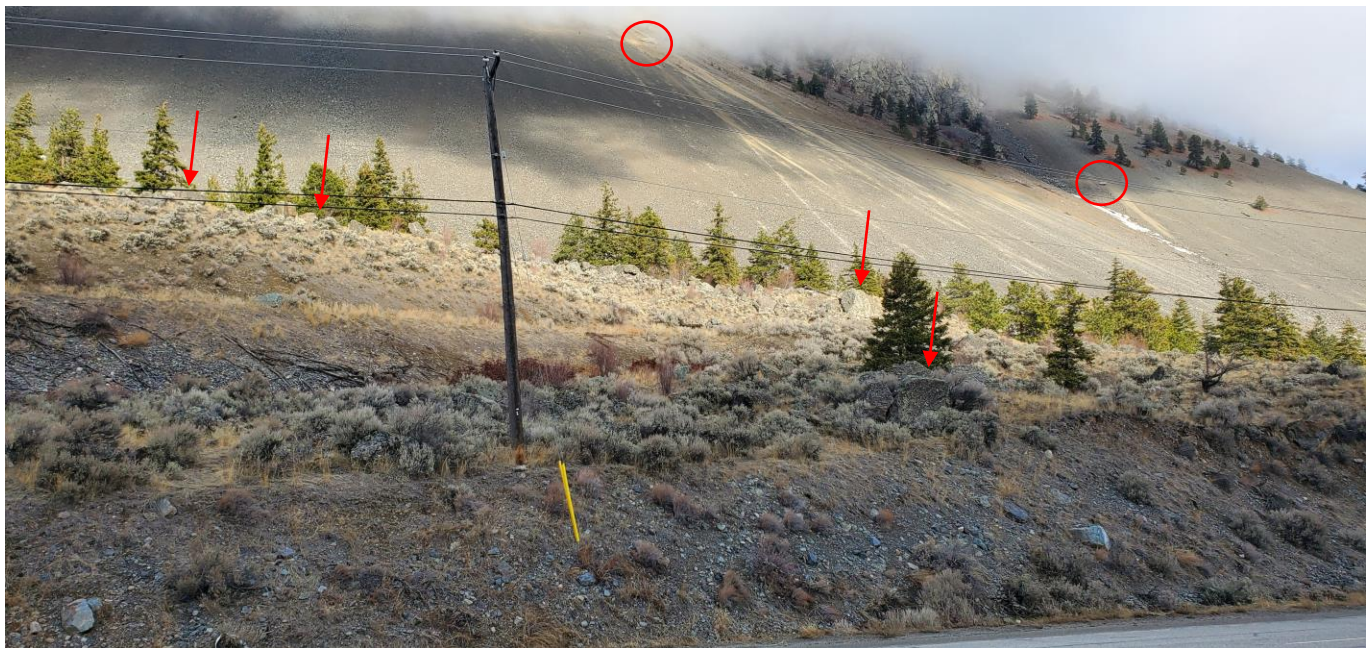
Photo 4 View of highway cut slope and talus fans above 3169 10th Avenue. Rock fall greater than 1 m diameter indicated by red arrows. A portion of January 16th rock fall boulders indicated by red circles.

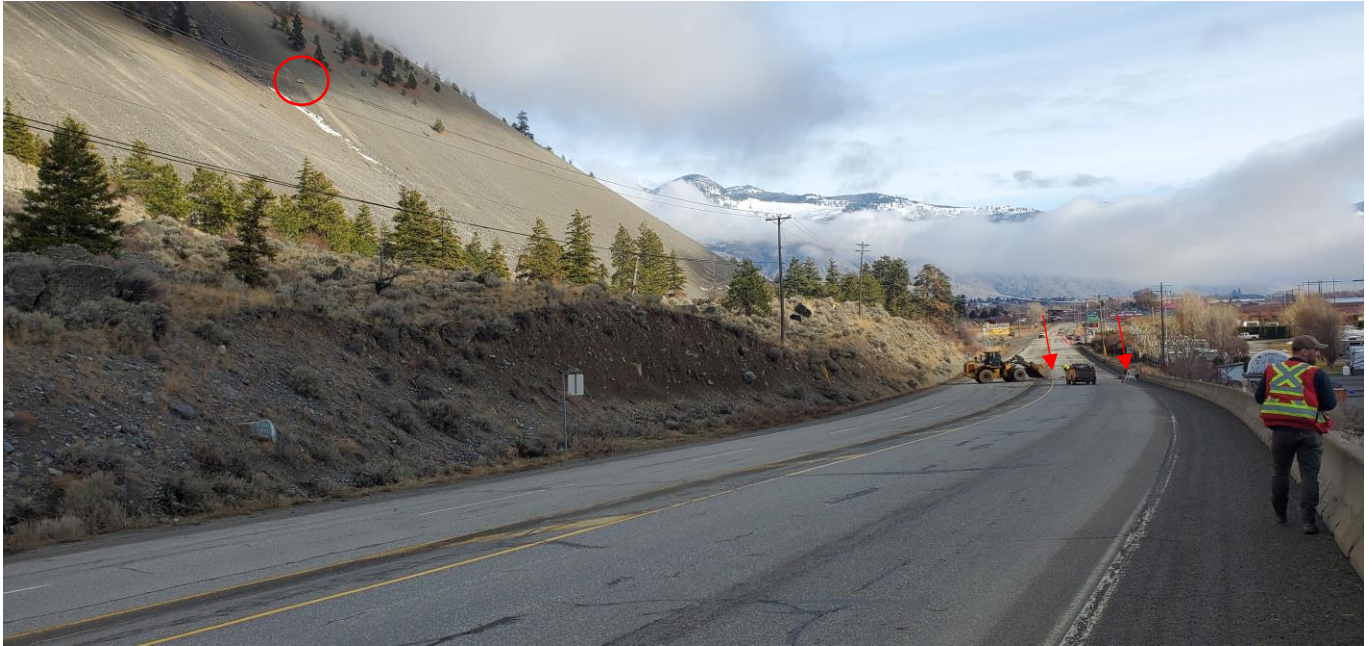
- The highway was closed from 10th Avenue to Ashnola Road. The maintenance contractor for BC MoTI was cleaning off rock fall debris from the roadway, repairing the road structure and replacing the impacted concrete roadside barriers (CRB) located along the southern side of the

road (Photos 5 to 7). The damage and debris on the highway were located directly above the damaged structures located at 3169 10th Avenue. A soil cut slope located on the north side of the highway was observed. It extends from the east end of 3169 10th Avenue, westward well beyond the subject property as shown in Photos 4 and 5 and Figure 1.0. This feature is considered a launching feature for rock fall originating upslope.

Photo 5 View of Highway 3 and associated soil cut slope above 3169 10th Avenue. Rock fall impacts located at service equipment. Recent rock fall boulder indicated by red circle.

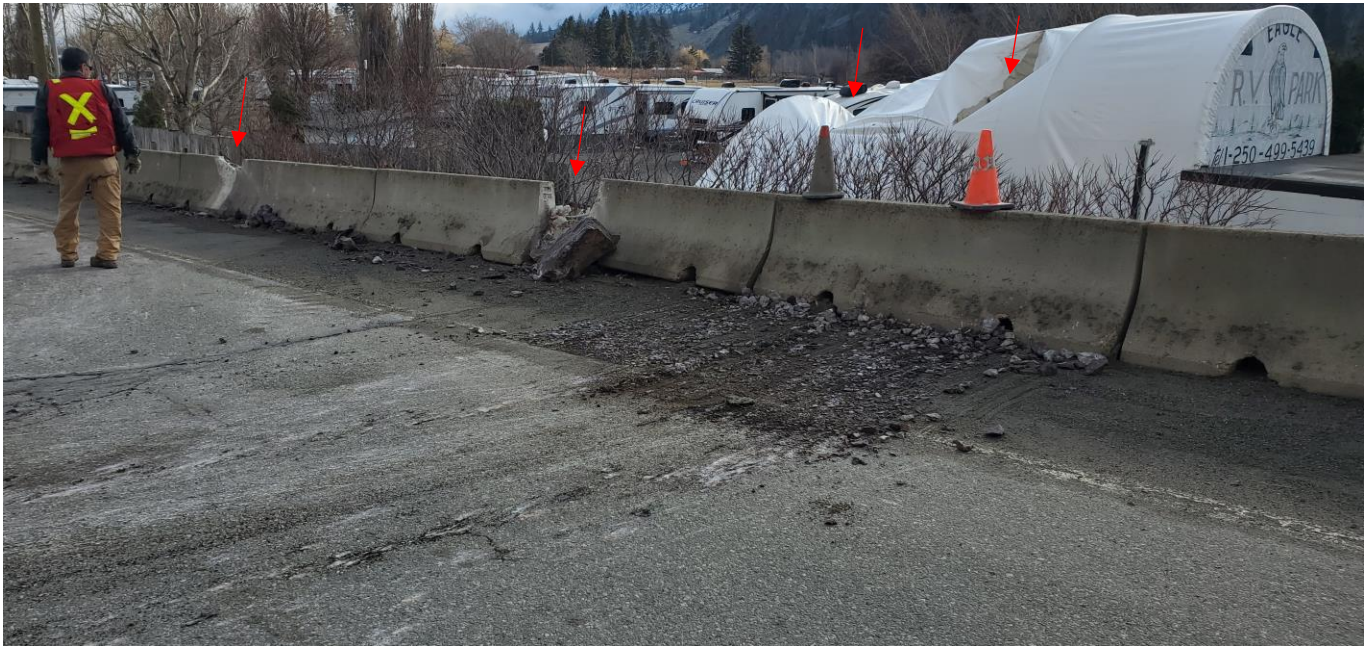
- Three boulders were observed to have impacted the subject site (Rock Fall #1 to #3). All three rock fall debris boulders appeared to have impacted the storage area directly below the highway damage. Rock Fall #1 and #2 impacted a white storage canopy and Rock Fall #3 impacted a wooden storage shed beside the canopy (Photos 6 and 7).

Photo 6 View of rock fall impact locations on concrete barrier and storage structure downslope.

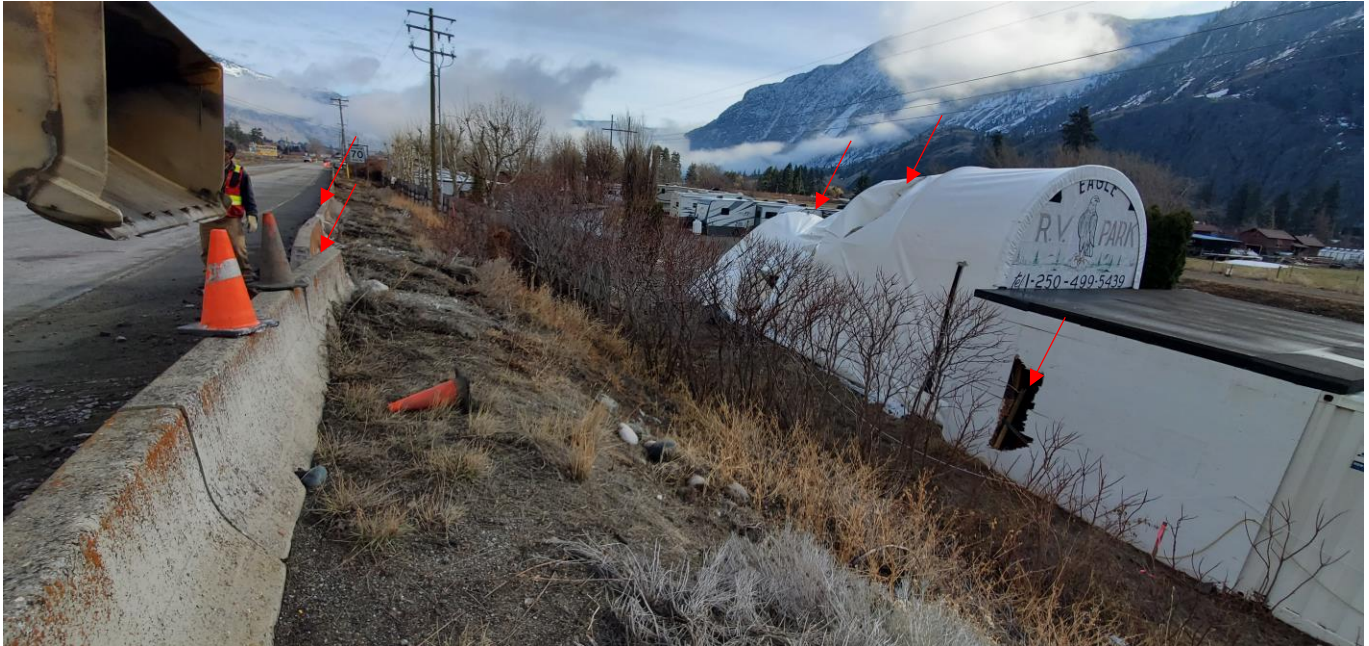
Photo 7 View of rock fall impact locations on concrete barrier and storage structures downslope.

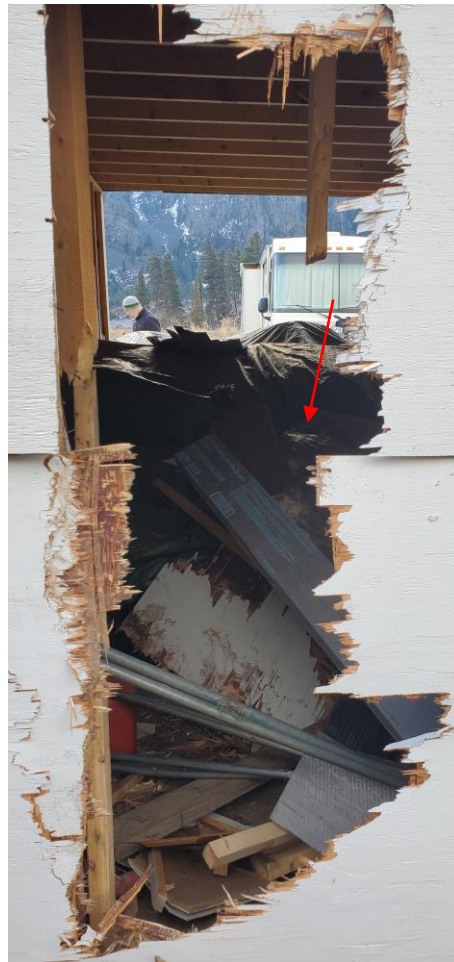
- Rock Fall #3 was observed in the wooden storage shed (Photo 8). The size of the boulder could not be determined due to being covered by debris, however the hole in the shed measured approximately 1.5 m long and 0.5 m wide.

Photo 8 View of rock fall impact on wooden storage structure. Rock was located inside structure.

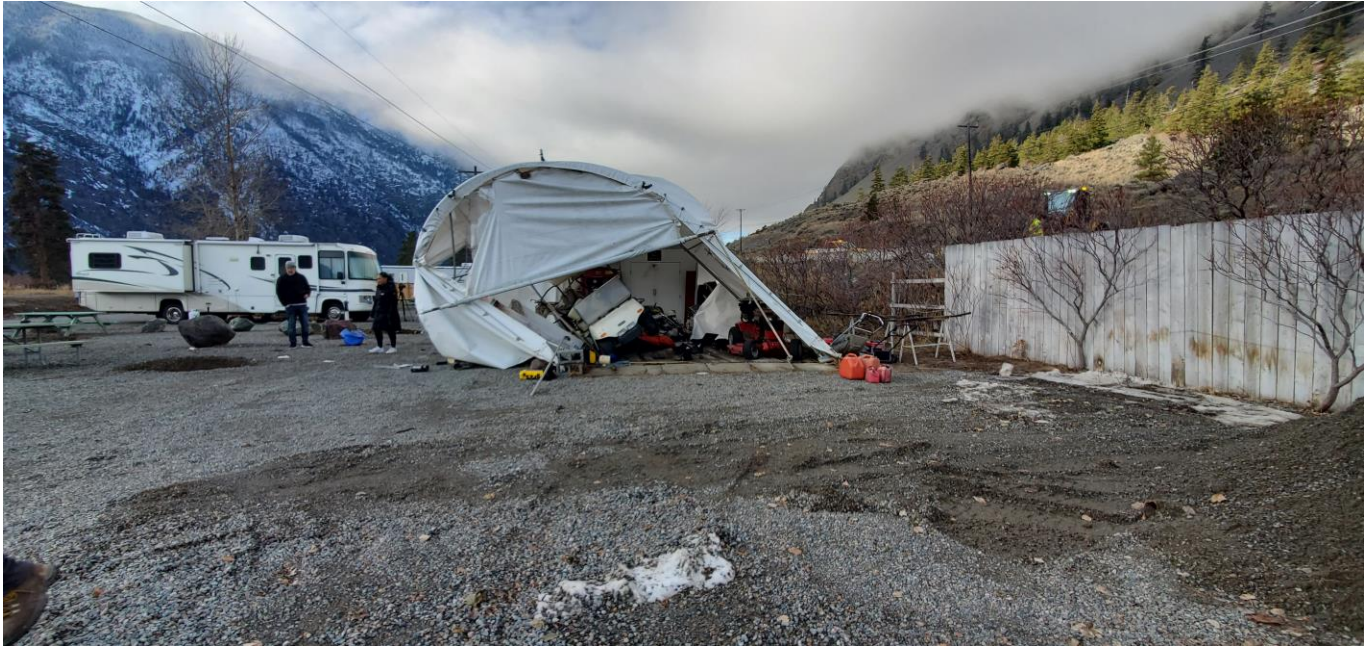
- It appeared that Rock Fall #1 and #2 traveled through the white canopy and came to rest on the west side of two separate recreational vehicles (RV's) (Photos 9 and 10). Rock Fall #2 was located approximately 300 mm from RV #2 and Rock Fall #1 impacted the west side of RV #1.

Photo 9 View of impacted storage structure, looking west.

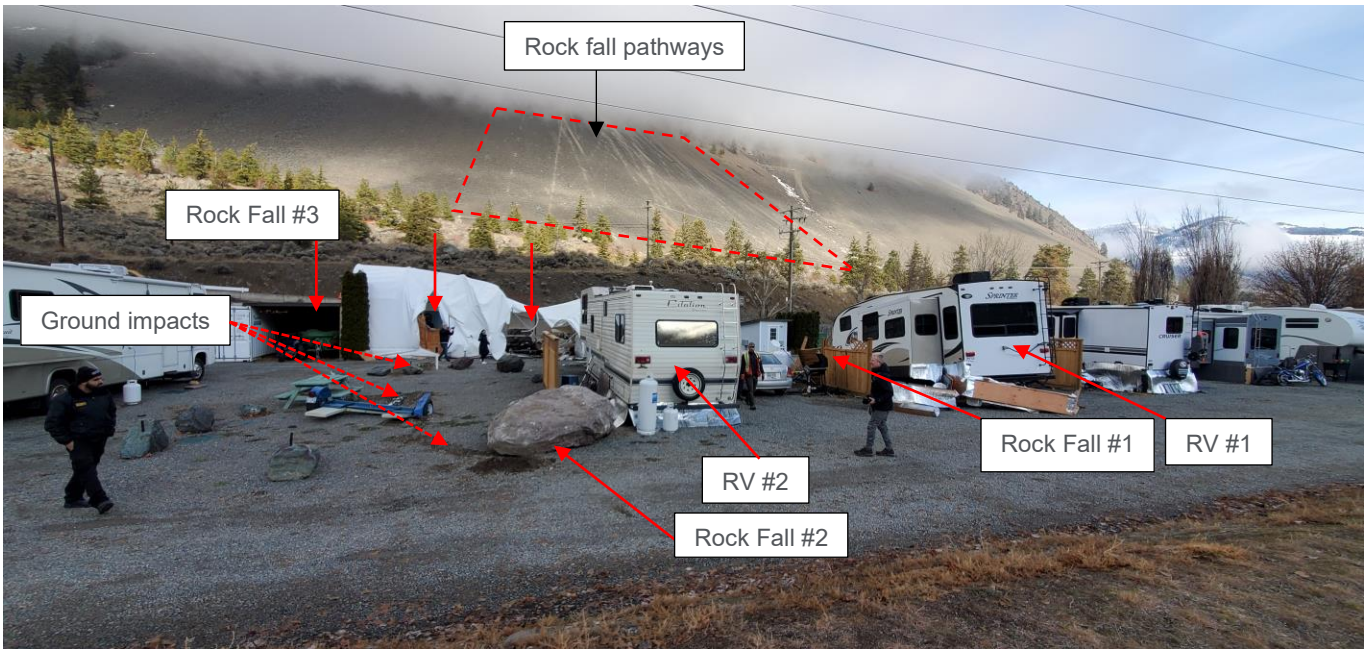
Photo 10 View of rock fall material and impacted structures, looking north.

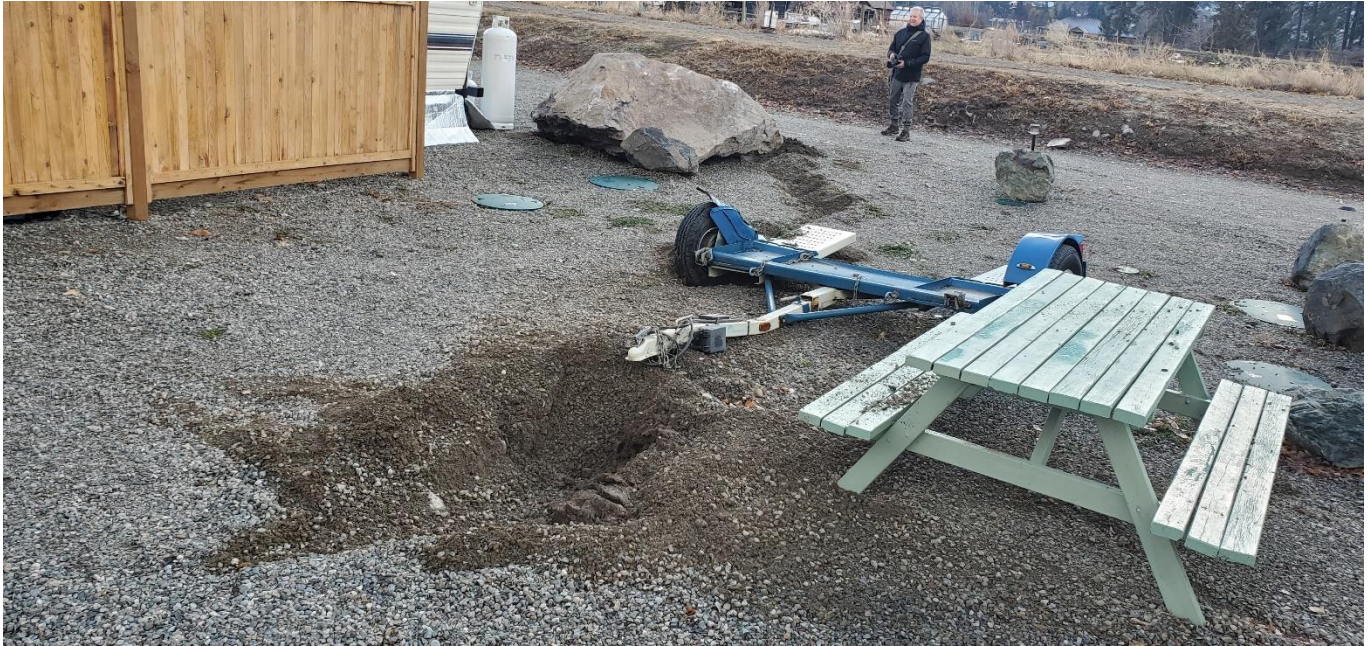
- Ground impacts from Rock Fall #2 were observed in an empty RV lot (Photo 11). The impact locations were elongated, had steep side slope angles (V-shaped) and measured approximately 100 mm to 300 mm in depth. The Rock Fall #2 boulder measured approximately 2.5 m in length, 2.0 m in width and 1.0 m in height (Photo 12). The bottom appeared relatively flat, while the top formed a convex surface and the sides contained jagged edges.

Photo 11 View of ground impact from Rock Fall #2, looking south.

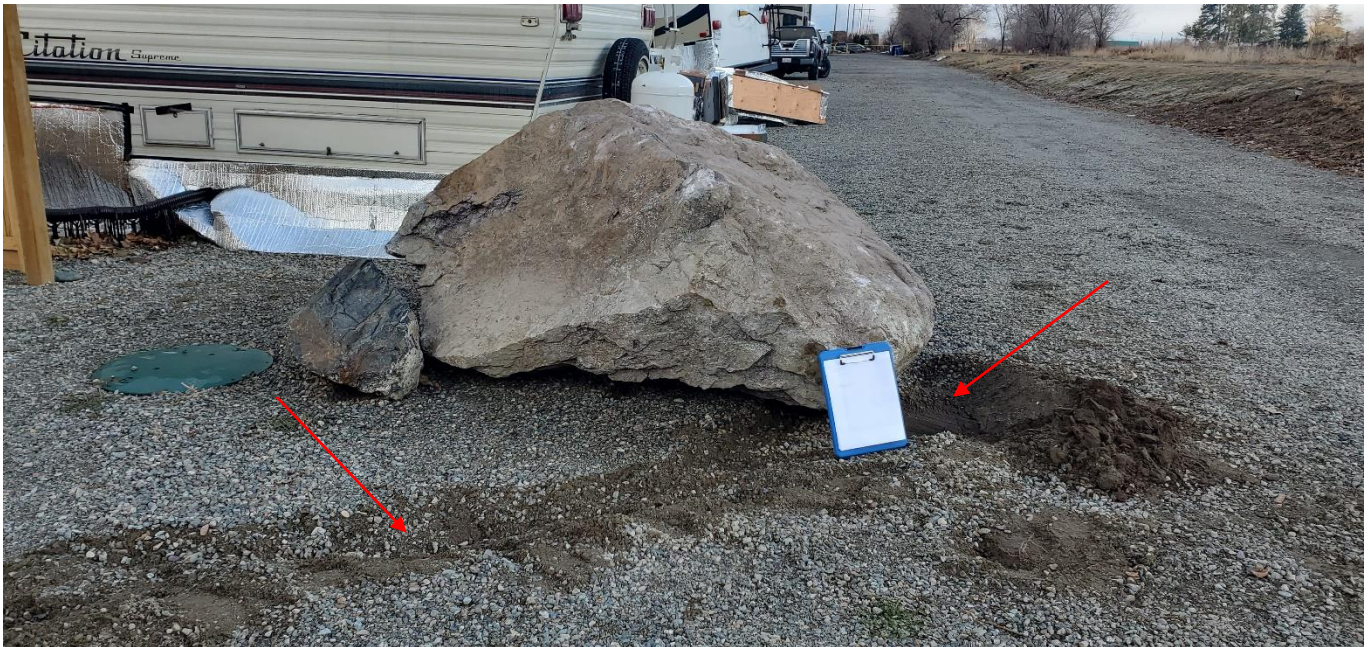
Photo 12 View of Rock Fall #2 and ground impacts, looking east.

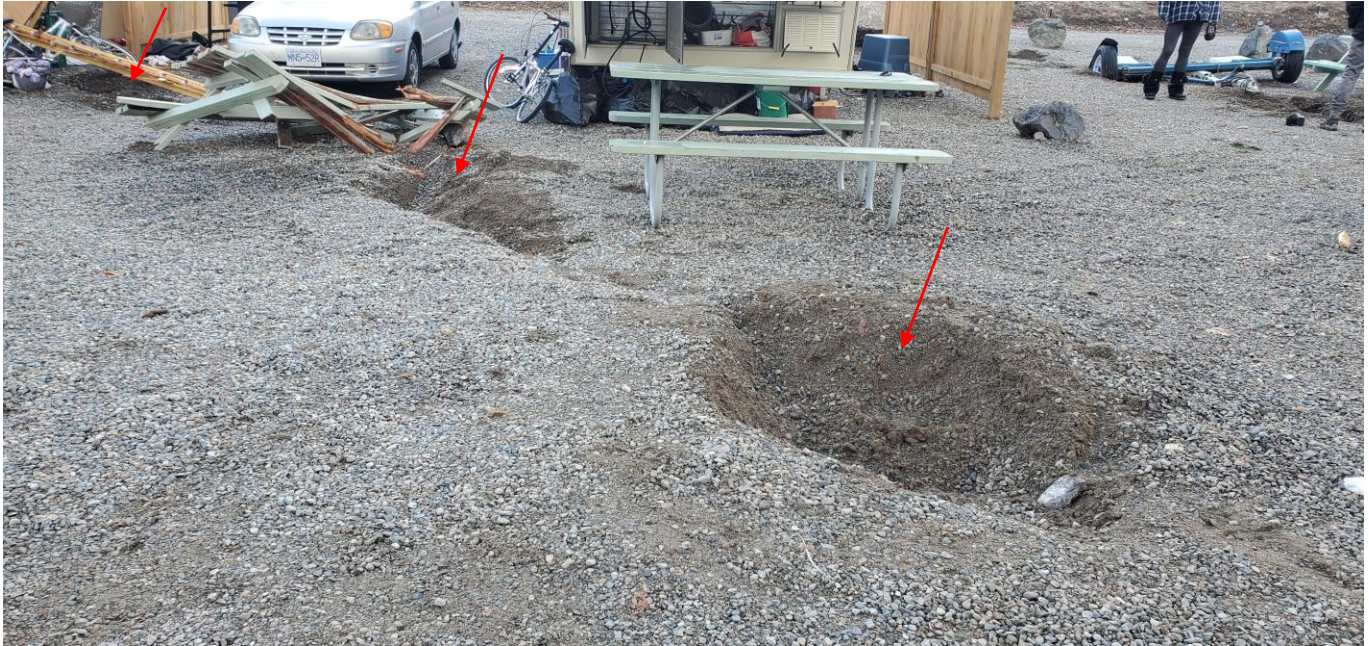
- Ground impacts from Rock Fall #3 were observed in front of RV #2 (Photo 13). The impact locations were elongated, had steep side slope angles (V-shaped) and measured approximately 200 mm to 300 mm in depth. The Rock Fall #3 boulder was rectangular in shape and measured approximately 2.5 m in length, 2.0 m in width and 1.4 m in height (Photos 14 and 15).

Photo 13 View of ground impact from Rock Fall #1.

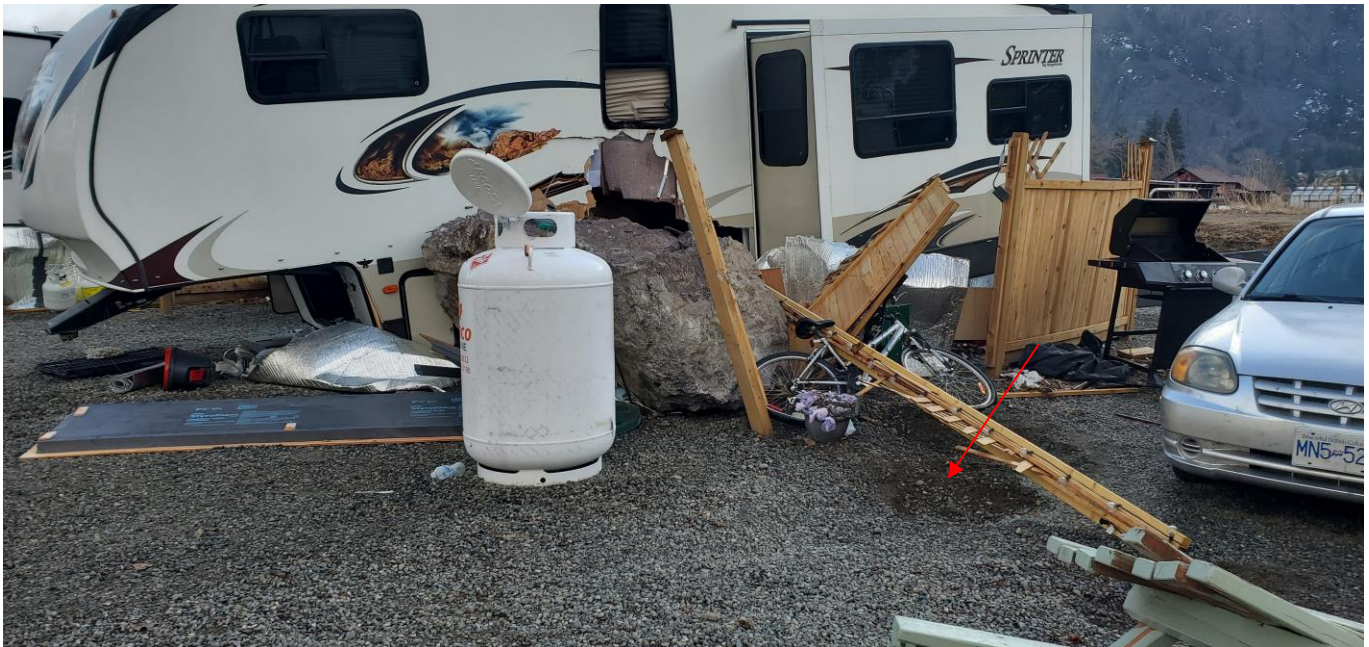
Photo 14 View of Rock Fall #1, looking southeast. Ground impact location on right.

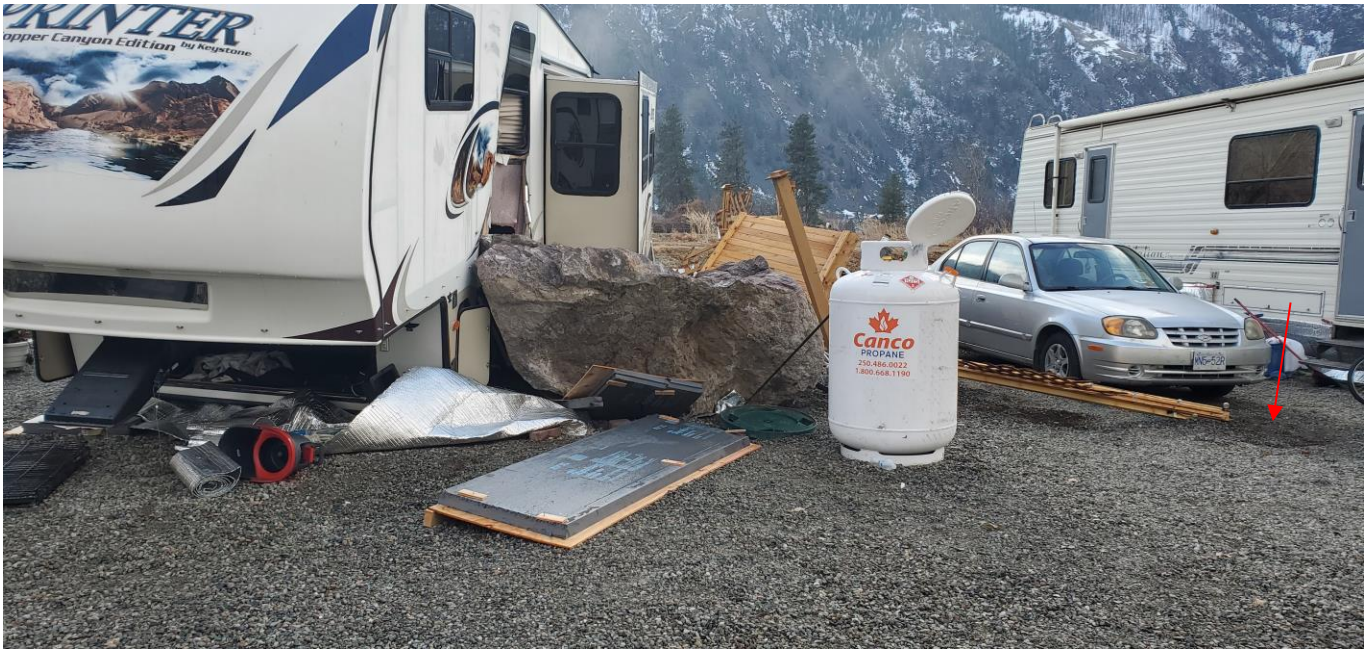
Photo 15 View of Rock Fall #1, looking south. Ground impact location on right.

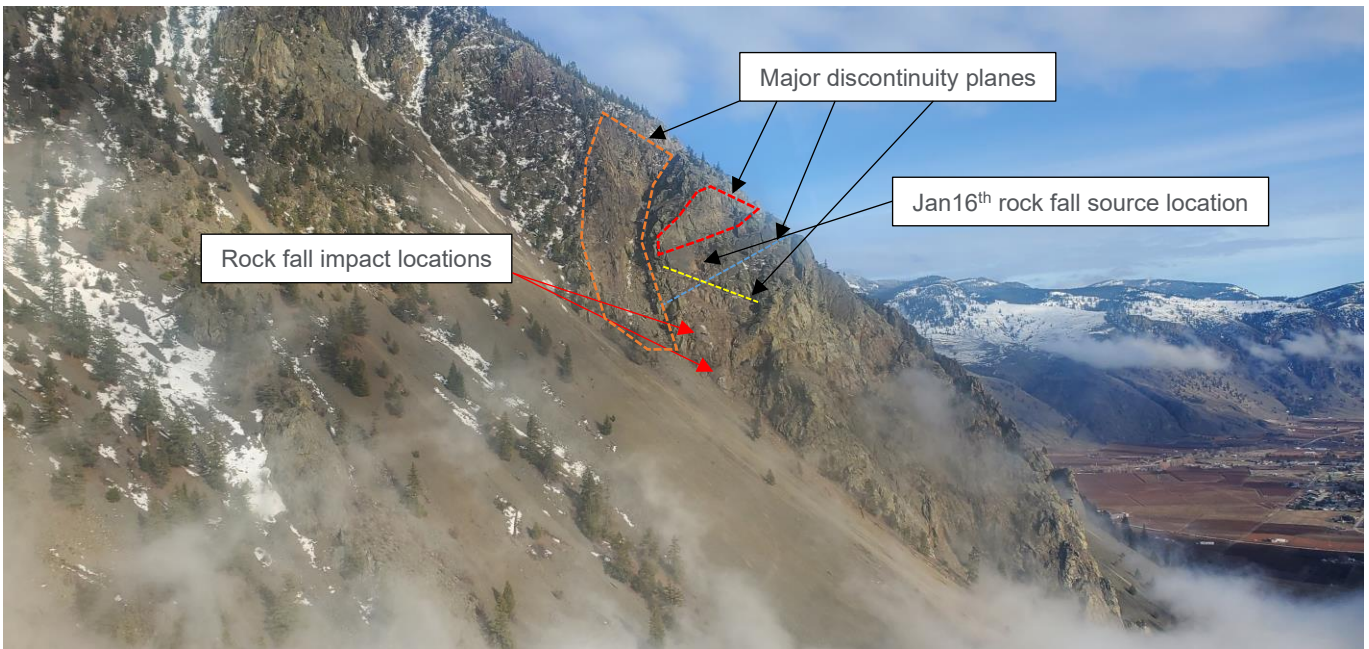
Photo 16 View of talus slopes above 3169 10th Avenue, January 16th rock fall source and impact locations, looking east.
