Ecora File No.: 230018-02

Regional District of Okanagan-Similkameen
101 Martin Street,
Penticton, BC
V2A 5J9

Reference: Emergency Geotechnical Assessment for 3169 10th Avenue, Keremeos, BC

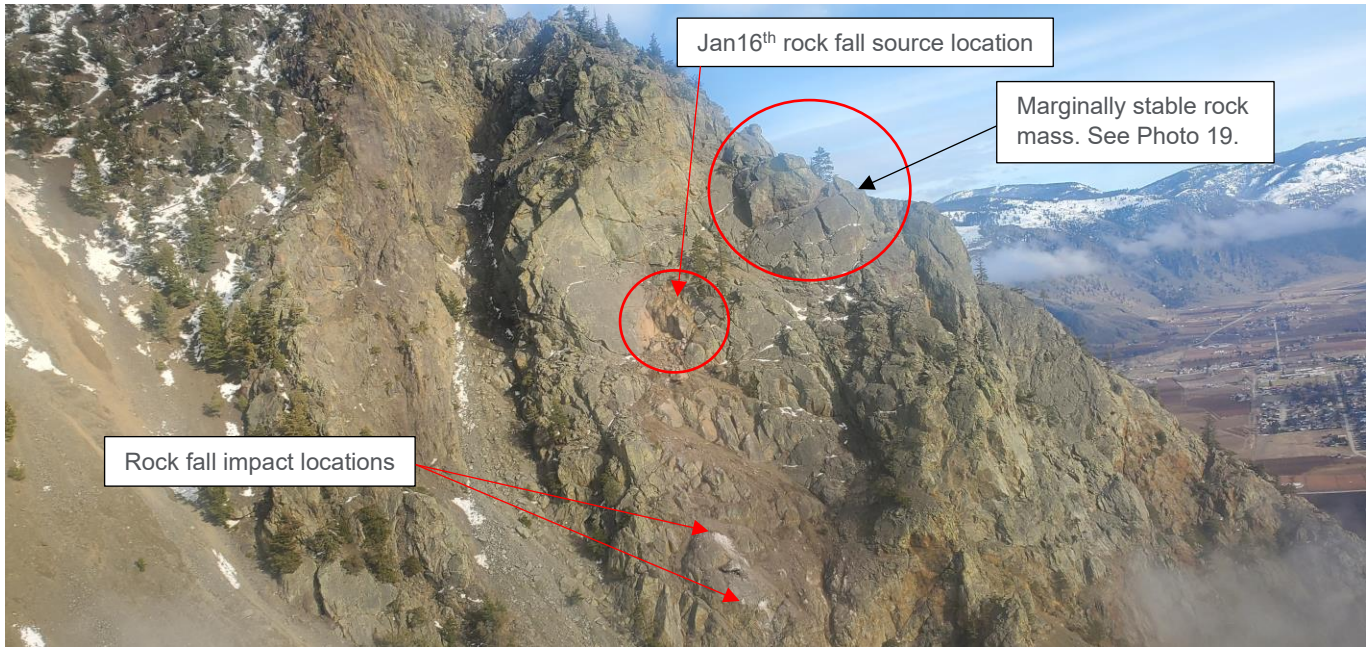
- Multiple other rock fall source zones were identified above the talus fans and included similar joint set orientations (i.e. subvertical) (Photos 19 and 20). One particular location, above the January 16th rock source, contained kinematically unstable blocks (Photos 17 and 19).

Photo 17 View of current rock fall source and impact locations, looking east.

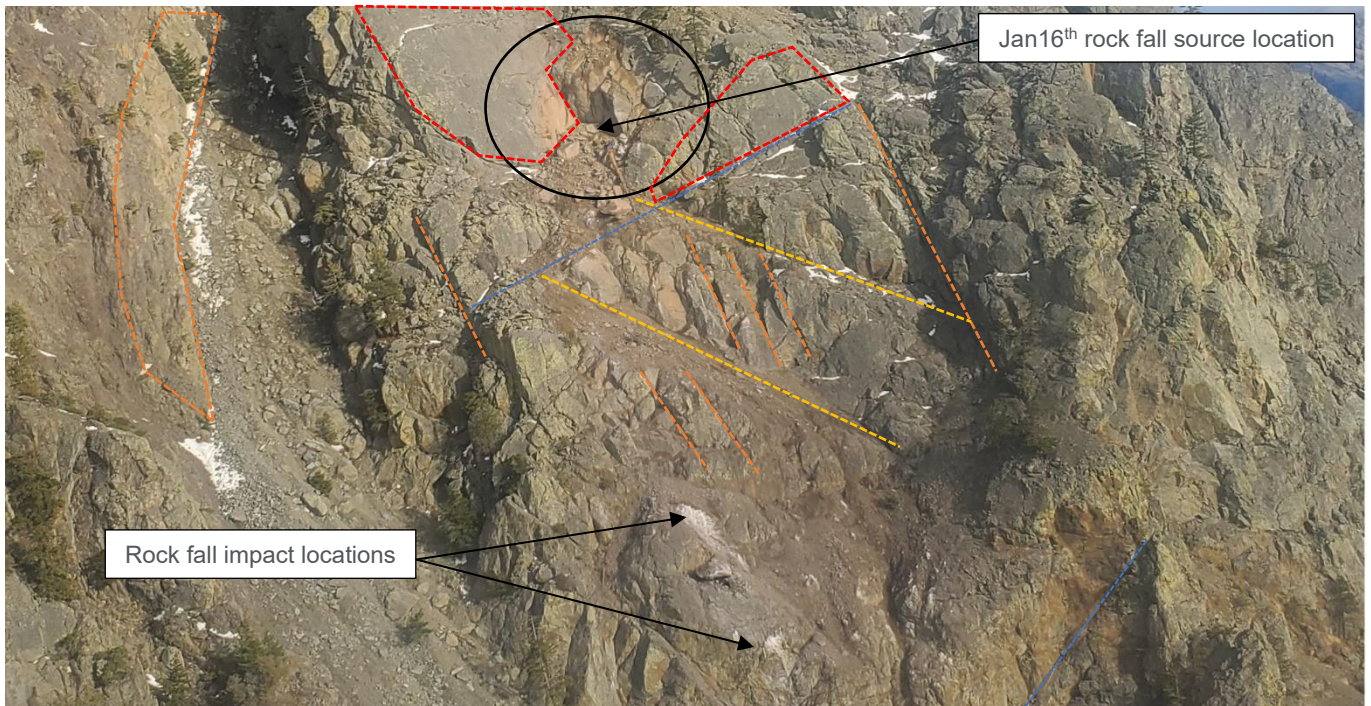
- The rock fall source from the event that occurred January 16th appeared to be located between the talus slopes above the subject property as shown on Figure 1.0. The rock fall source consists of a kinematically unstable (toppling) block along the west side of the bedrock outcrop (Photos 16 to 18). Four distinct joint sets were identified in the rock mass between the talus fans, including two subvertical, perpendicular sets (red and orange in the photos).

Photo 18 View of January 16th rock fall source and impact locations, looking east. Discontinuity sets indicated in red, orange, yellow and blue.

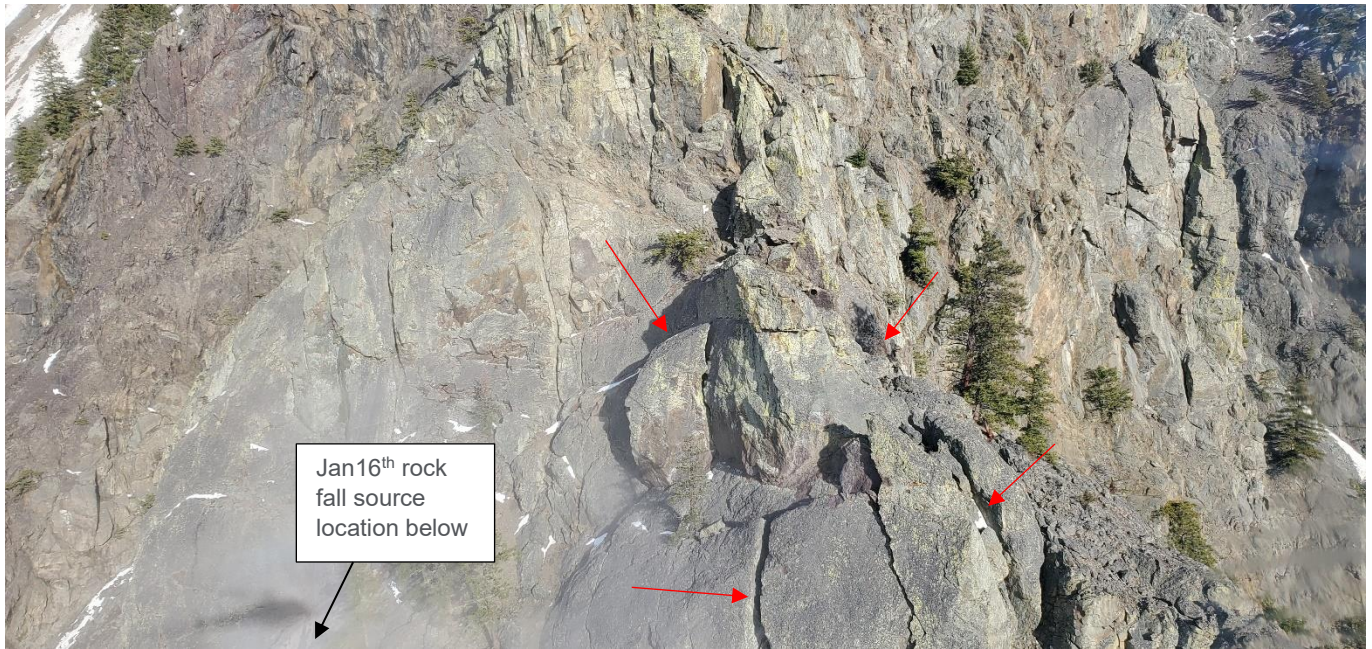
Photo 19 View of marginally stable rock mass above current rock fall source.

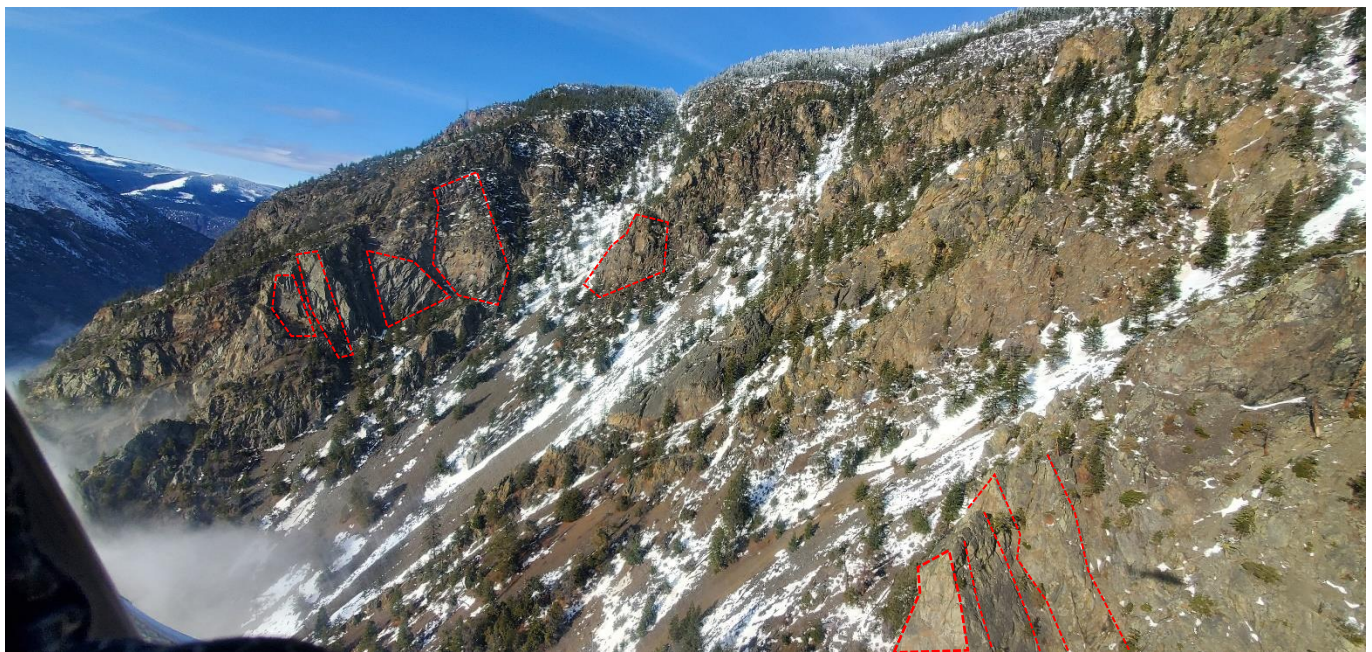
Photo 20 View of rock fall source zones above the talus fans, looking west from the current rock fall source. Subvertical discontinuity planes with significant rock volumes identified in red.
