# Husula Highlands

FIRESMART COMMUNITY ASSESSMENT REPORT

January 2018

Andy Low, RPF

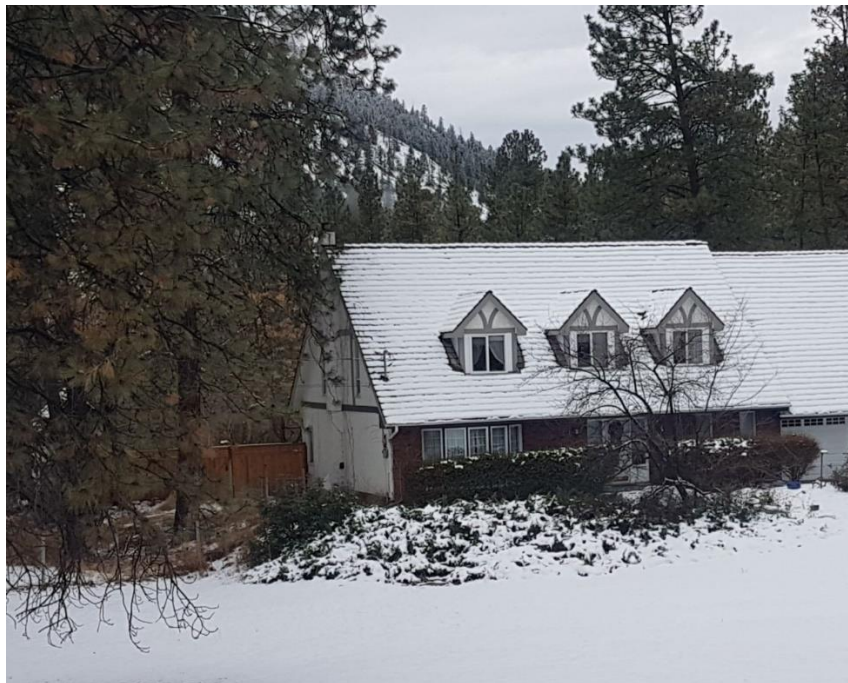
One vegetation feature that is very popular and pervasive in landscaping (including examples in Husula) is the use of arborvitaes (cedar) and juniper shrubs and hedges (Figure 11). The presence of these conifers in Zone 1 needs to be carefully considered, as they are extremely volatile from a fire behaviour standpoint. Having a cedar or juniper shrub growing up against a house could very well be the source of a home ignition in the very likely event that these plants combust during a wildfire. A long cedar hedge that leads up to a house can be viewed as a veritable wick of fuel waiting for a wildfire to light it.

*FIGURE 11 Several homes in Husula are characterized by the presence of volatile vegetation, such as cedar and juniper shrubs, in Zone 1. A wood fence abutting the home can provide a pathway for home ignition should the fence ignite. An unrated wood shake roof offers no fire-resistance.*

- Replace bark mulch with a non-flammable ground cover where it adjoins the home or intersects with a wood structure attached to the home.
- Remove flammable material from under deck spaces. If the space under a deck is to be unsheathed or unscreened, the space must be free of any material that could ignite via ember or direct flame contact.

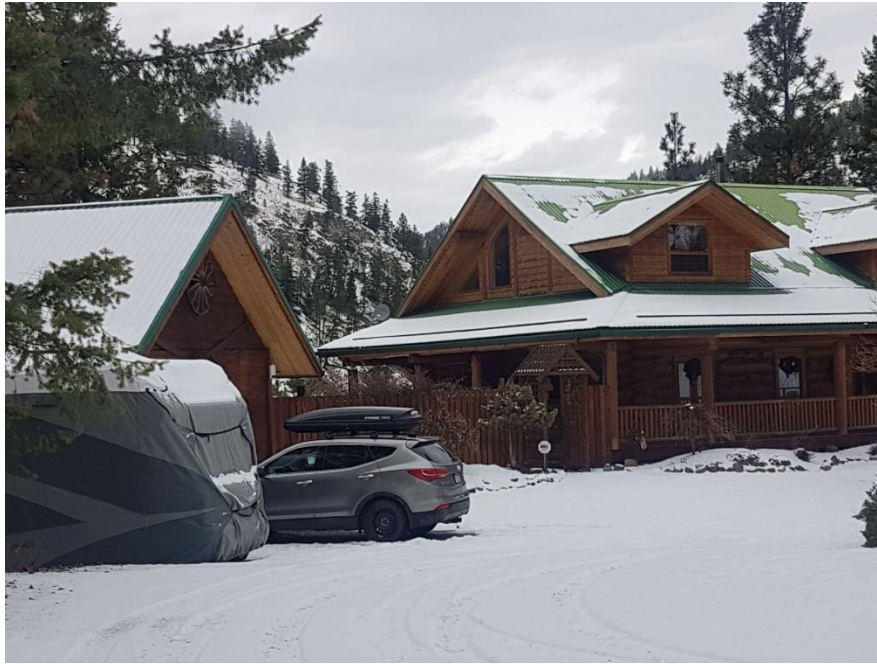
Replacing a roof is one of the single-most expensive FireSmart improvements. Fortunately, Husula is an example of a community where almost all the observed roofs consisted of some type of rated roofing system (Figure 12).

*FIGURE 12 A rated roofing system, such as this metal roof, provides fire-resistance to embers. Any modern roofing system that has a fire-resistance rating can provide this protection. During a wildfire, particularly a high-intensity wind-driven fire, a tremendous amount of embers can be cast into the air, producing an ember shower or ember blizzard.*

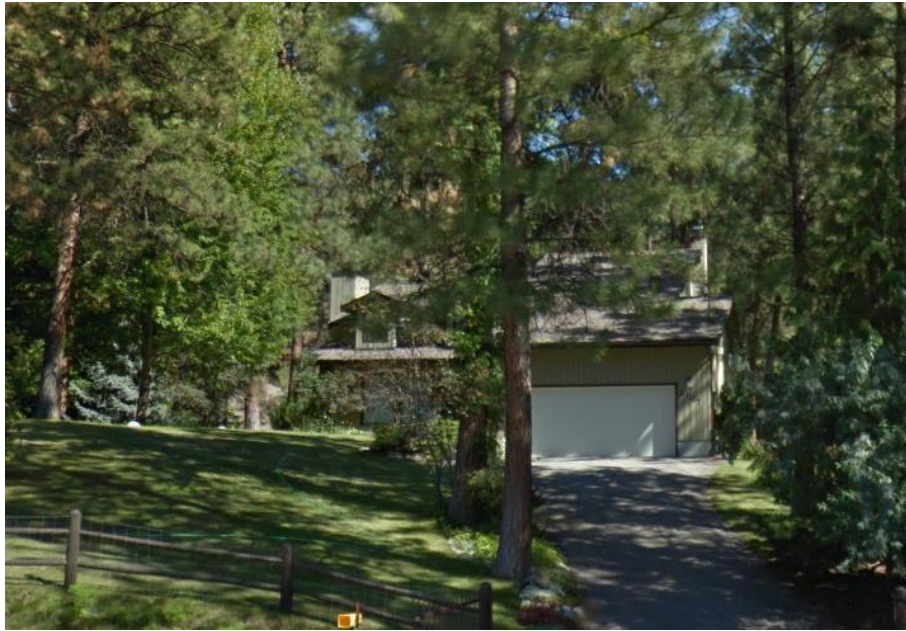
An additional benefit that is illustrated in Figure 13 is the shading that the tree canopy provides to the understory. This shade effect can help to retain moisture in the soil and understory vegetation, when compared to sites exposed to full sun throughout the day. This feature is similar to that known in wildfire management planning as a *shaded fuelbreak* and can have the effect of reducing or limiting fire intensity as fire approaches the fuelbreak.

*FIGURE 13 An example of good defensible space and low-hazard landscaping solutions in Husula. This combination of a green lawn surrounding the home, as well as no flammable vegetation up against the house, help to significantly lower this home's ignition potential. Although this property does have conifer trees within Zone 1, these trees are well-spaced and pruned and have little chance of candling.*
