Final Report for
Naramata Dam
2020 Dam Safety Review Report
For Regional District of Okanagan-Similkameen

February 25, 2021

Naramata Dam - 2020 Dam Safety Review Report

H362819-00000-228-230-0005

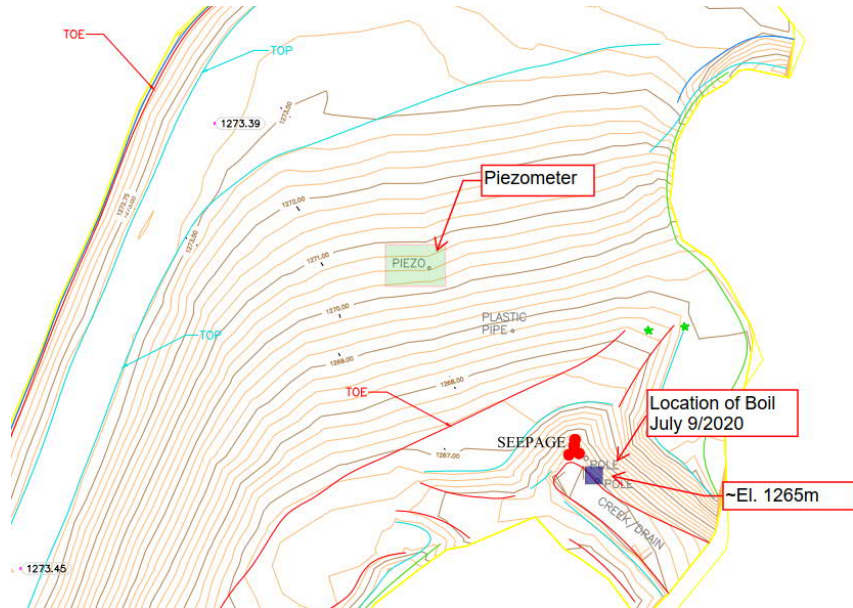
Figure 7-3: Naramata Dam Downstream of Left Abutment

A comparison of a historical site plan (Drawing 226-02-3 R1) and recent surveys suggest that the downstream area of the Naramata Dam has been reworked to a new configuration as shown in Figure 7-3 where the downstream slope is significantly flatter than 4H:1V. During the new construction, a new piezometer was added shown as shown in Figure 7-3.

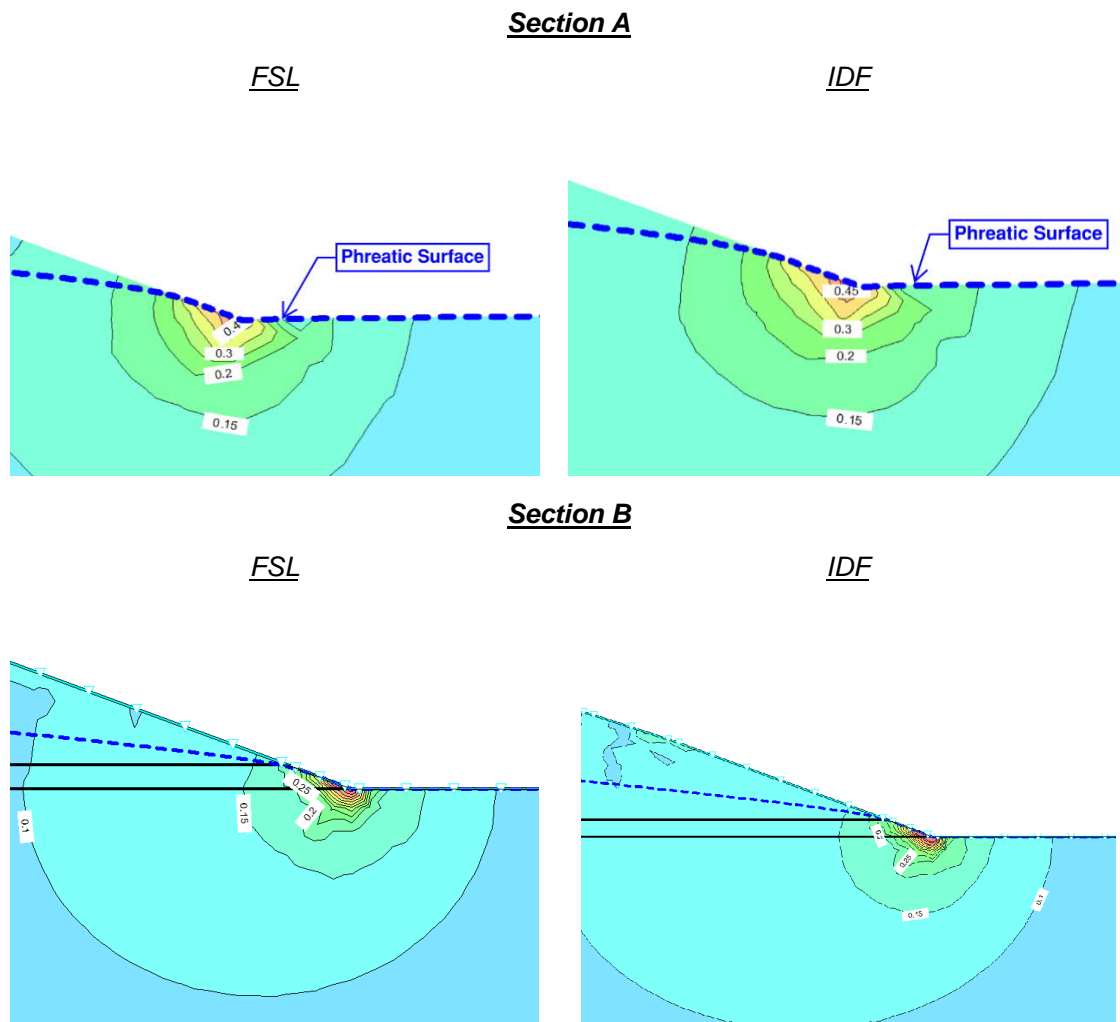
Figure 7-7: Distribution of Exit Seepage Gradients at Existing Dam Toe

The results of the seepage analysis indicate estimated vertical seepage gradients of up to 0.45.

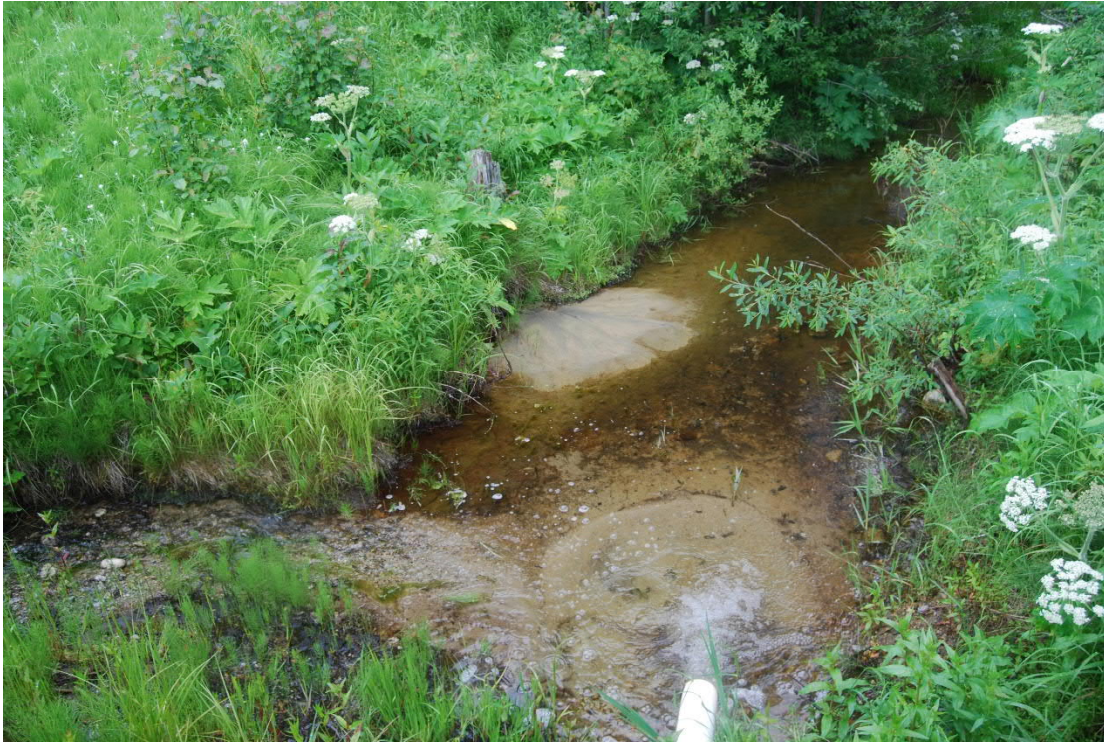
Photo A15: Naramata Dam, boil on the left drainage tailrace channel looking downstream

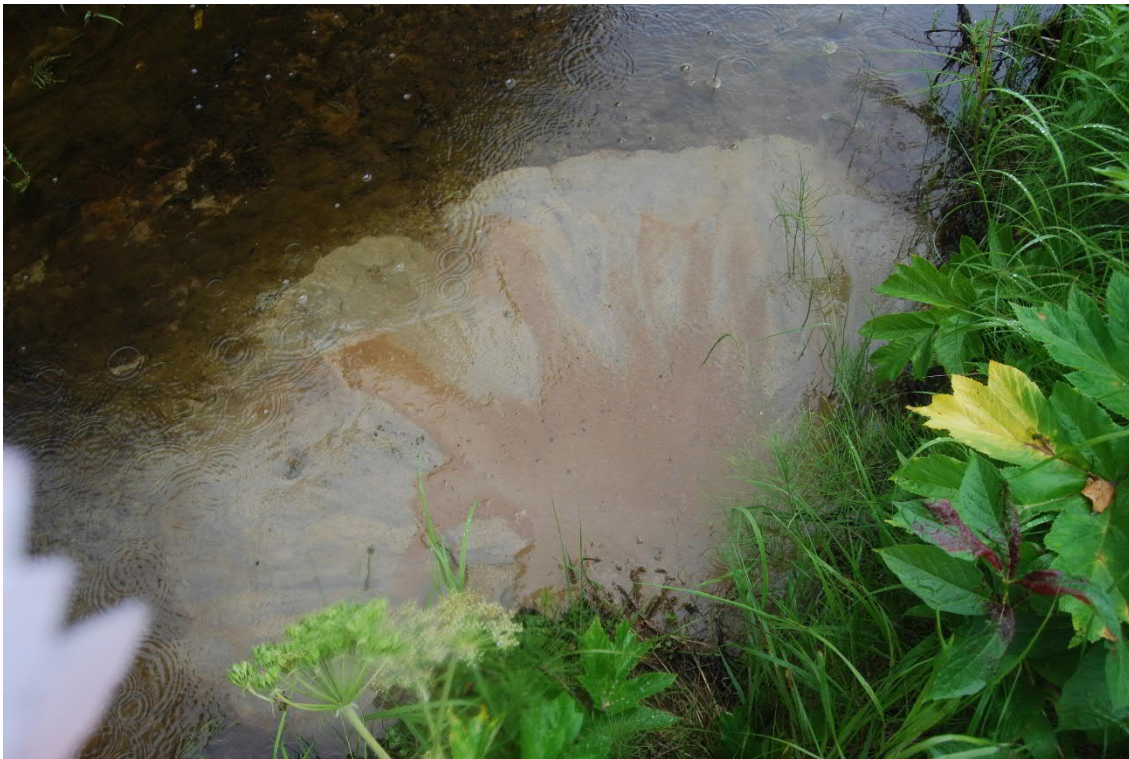
Photo A16: Boil at drainage tailrace channel

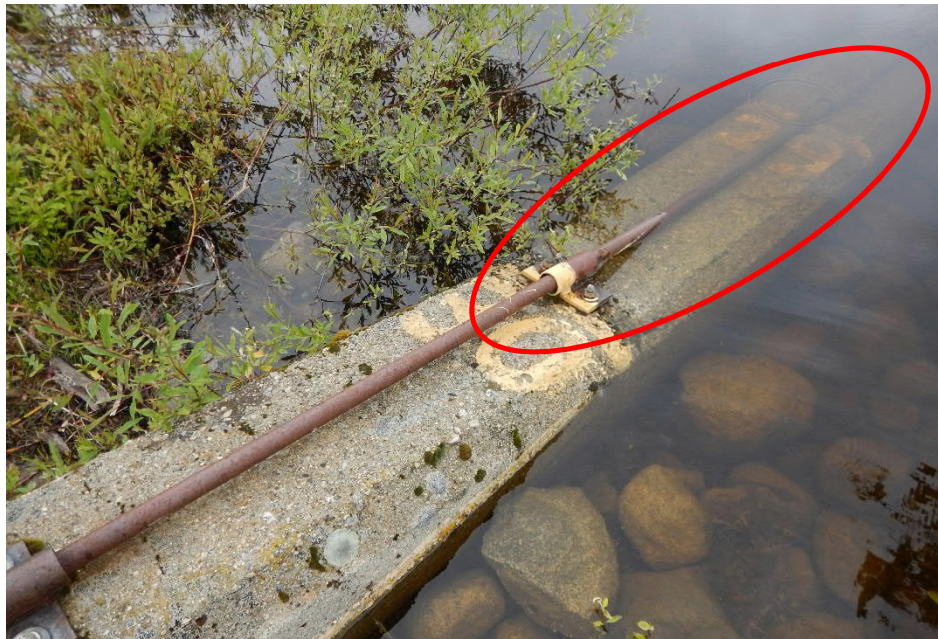
Photo A18: Naramata Dam Bent Intake Gate Stem

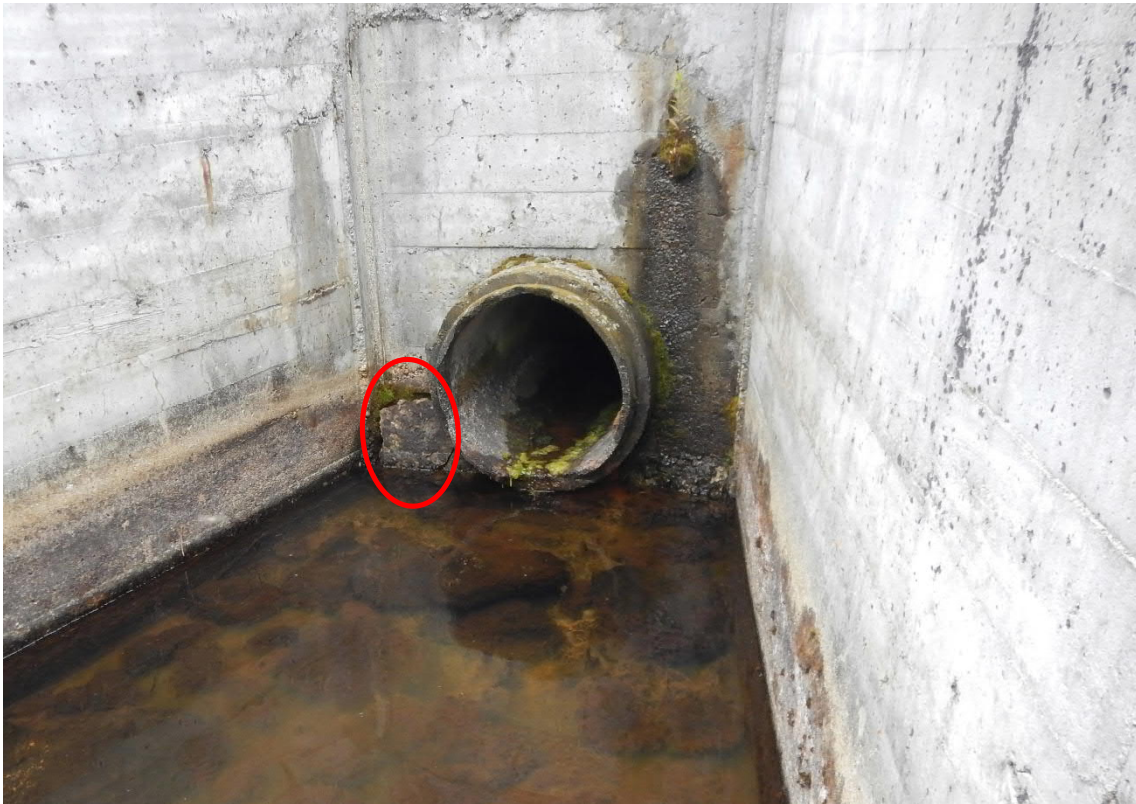
NL-19	Minor concrete cracking in localized area around outlet pipe in LLO structure	2020 DSR	NCm	New	Repair the cracked area of concrete after chipping off the loose and cracked concrete section	Low
All-1	OMS could be improved by including supporting confirmation that highlighted maintenance activities are being completed.	2020 DSR	NCs	New	Regular verification of the completion of maintenance items recorded in the weekly site surveillance form would further support that maintenance items are being completed.	Low
All-2	OMS does not have a table with positions and associated names describing roles and responsibilities.	2020 DSR	NCo	New	Update table in OMS to include positions and associated names describing roles and responsibilities.	Medium
All-3	Routine Dam Inspection Report format does not contain all aspect of BC Dam Safety Office's Site Surveillance Form for weekly inspections.	2020 DSR	NCp	New	Routine Dam Inspection Report format should be improved to more closely follow the BC Dam Safety Site Surveillance Form for weekly inspections.	Low

Photo A19: Naramata Dam Minor Concrete Damage in Outlet Structure
