**Regional District of Okanagan-Similkameen**

**DAM SAFETY REVIEW — BIG MEADOW LAKE DAM**

**K13101459.001**

**December 17, 2010**

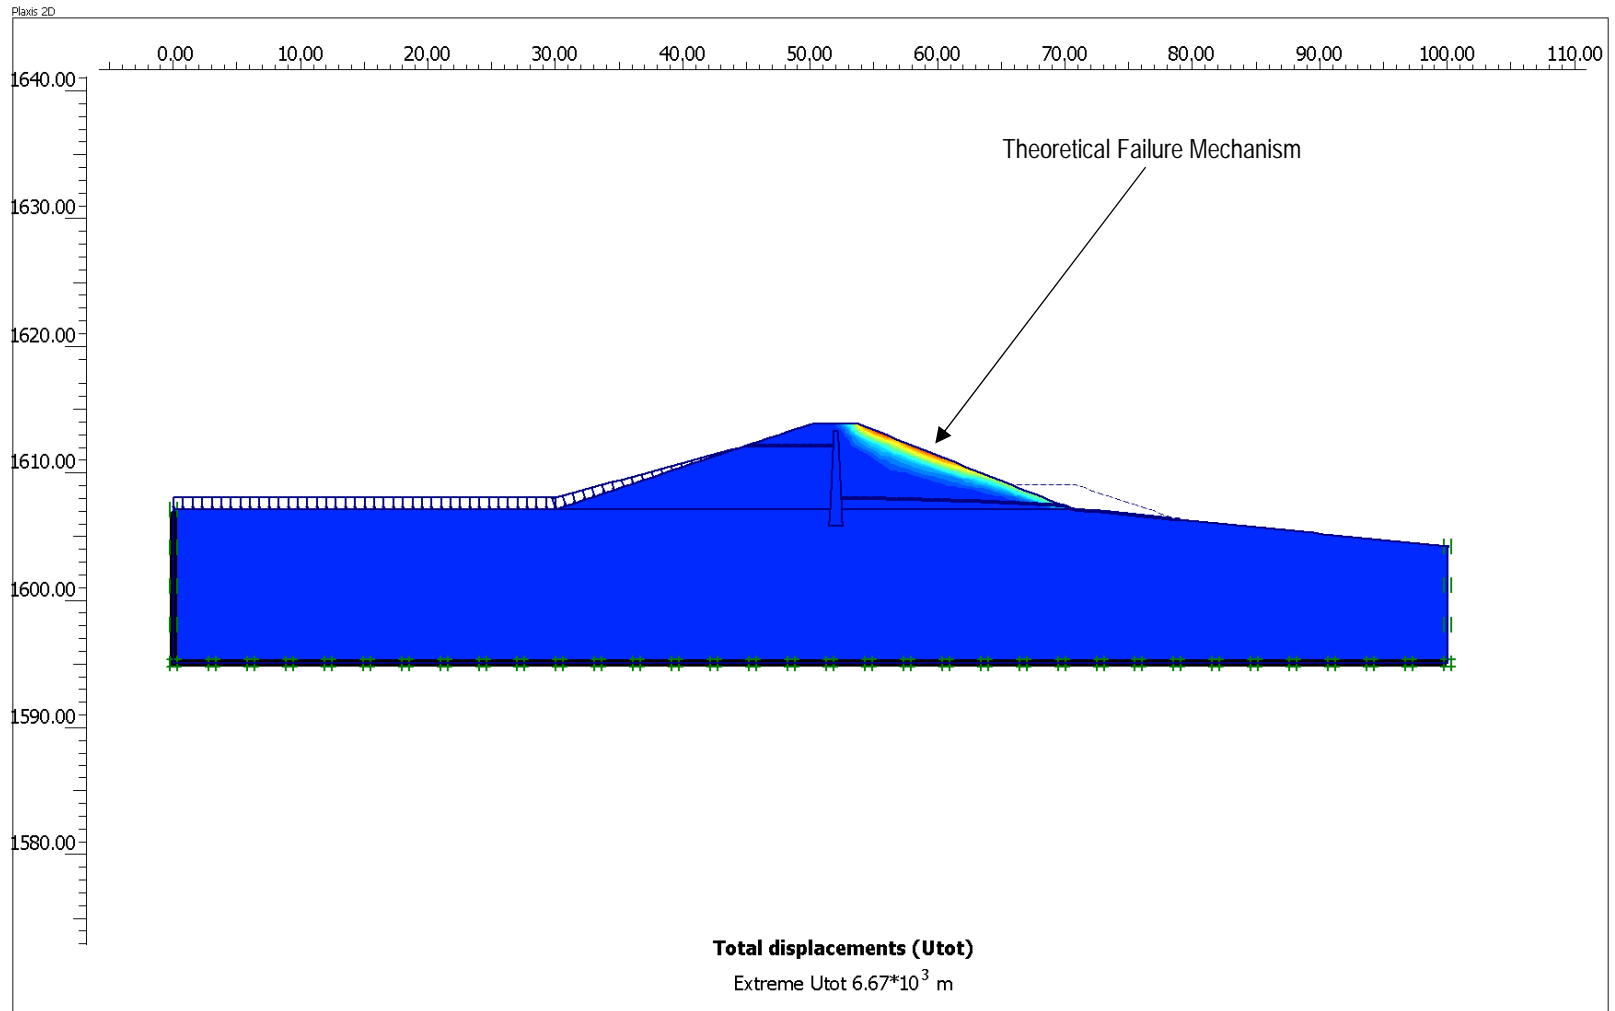
Figure 7

The stability review of the Big Meadow Lake Dam was considered at its maximum height with the geometry and soil profile of the model based on the embankment cross section shown attached Figure 4. The results of the analysis indicate that the downstream slope of the dam is marginally stable for the cracked core case under both static and seismic loading conditions. Therefore this case was reanalyzed with the inclusion of a free draining toe berm on the downstream slope of the dam which resulted in significantly improved factors of safety. The results of the analysis are summarized are in Table 10 below and presented on the attached Figures 7 to 13 inclusive.

<small>Finite Element Code for Soil and Rock Analyses</small> <small>Version 9.0.1.1182</small>	Project description				Big Meadow Lake Dam Static FOS=1.75	
	Project name	Step	Date	User name		
	Big Meadow Dam	108	11/12/10	EBA Engineering Consultants Ltd.

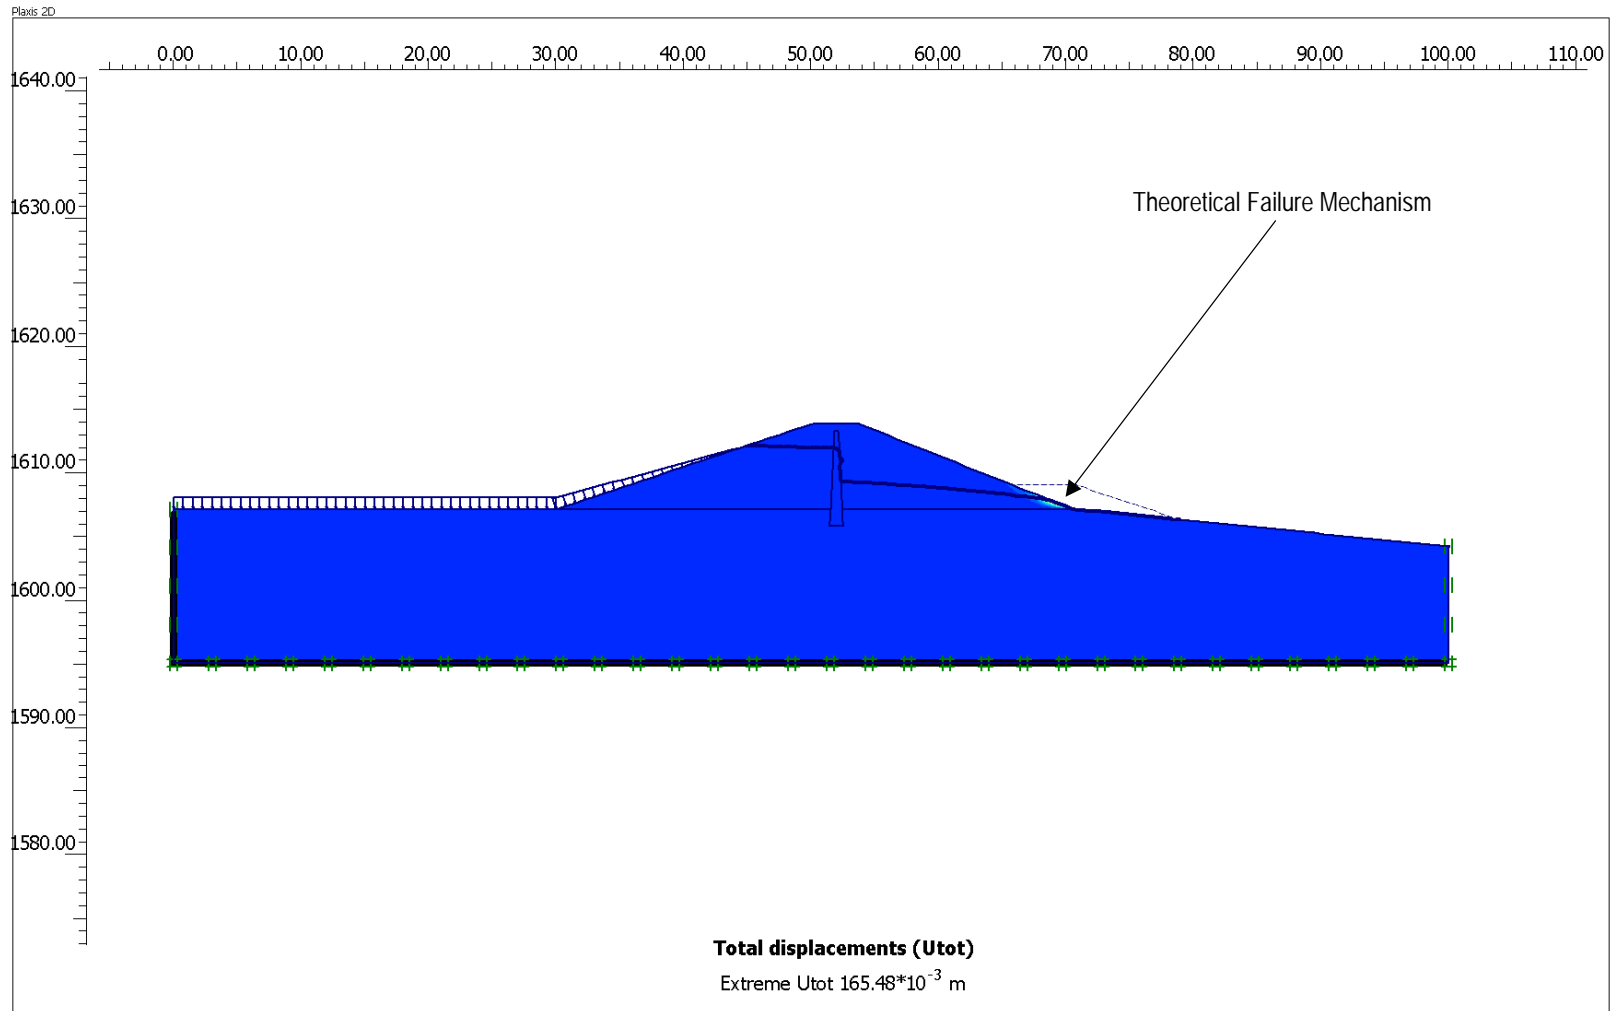
Figure 8

<small>Finite Element Code for Soil and Rock Analyses</small> <small>Version 9.0.1.1182</small>	<i>Project description</i>				
	Big Meadow Lake Dam Static FOS=0.93				
<i>Project name</i>	<i>Step</i>	<i>Date</i>	<i>User name</i>		
Big Meadow Dam	677	11/12/10	EBA Engineering Consultants Ltd.

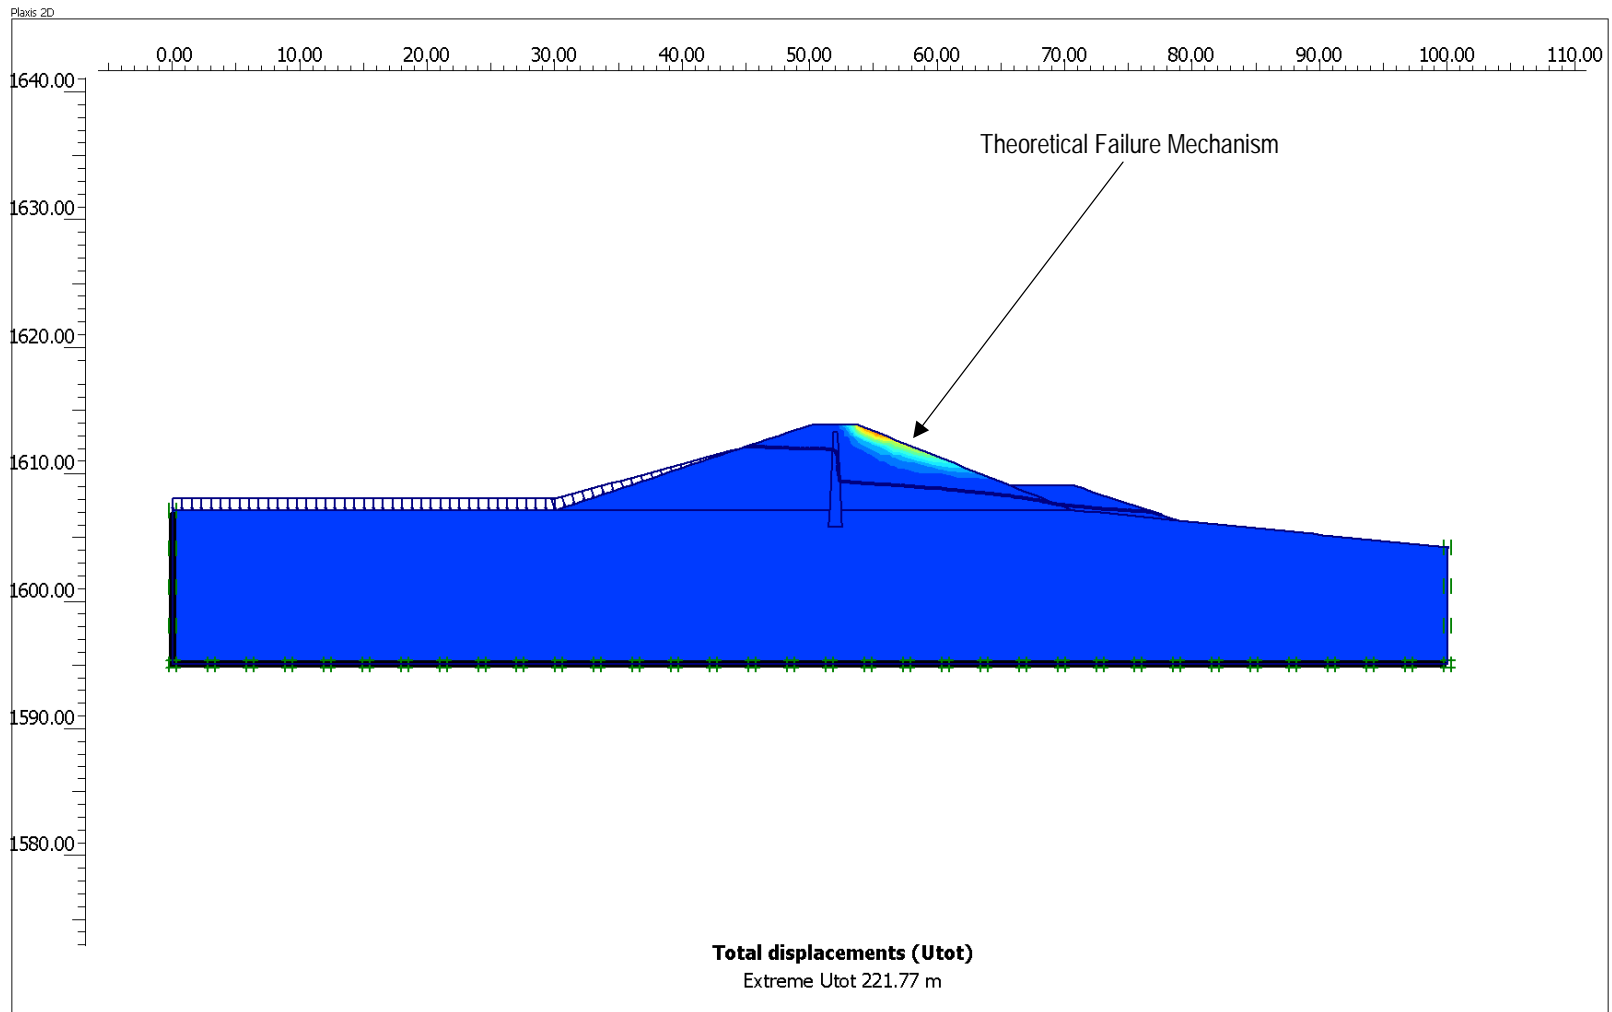
Figure 9

<small>Finite Element Code for Soil and Rock Analyses</small> <small>Version 5.0.1.1182</small>	Project description			
	Big Meadow Lake Dam With Toe Berm Added Static FOS=1.96			
Project name	Step	Date	User name	
Big Meadow Dam	781	11/12/10	EBA Engineering Consultants Ltd.

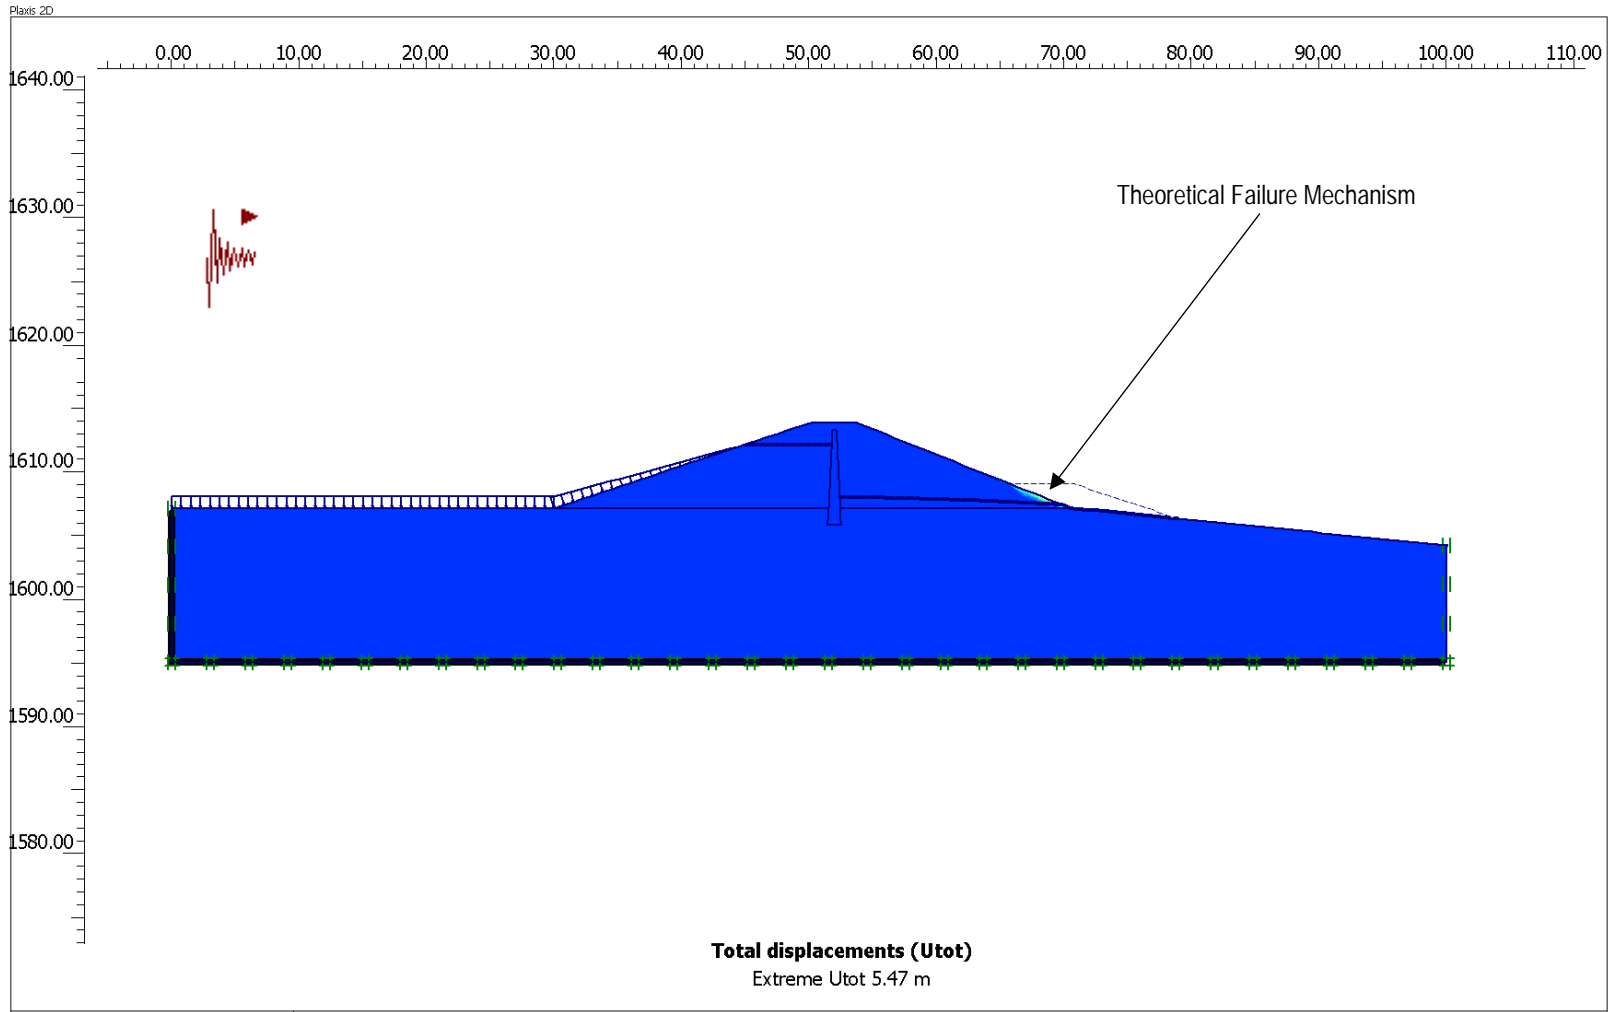
Figure 10

Project description				
Big Meadow Lake Dam Downstream Seismic FOS=1.04				
Project name	Step	Date	User name	
Big Meadow Dam	231	11/12/10	EBA Engineering Consultants Ltd.

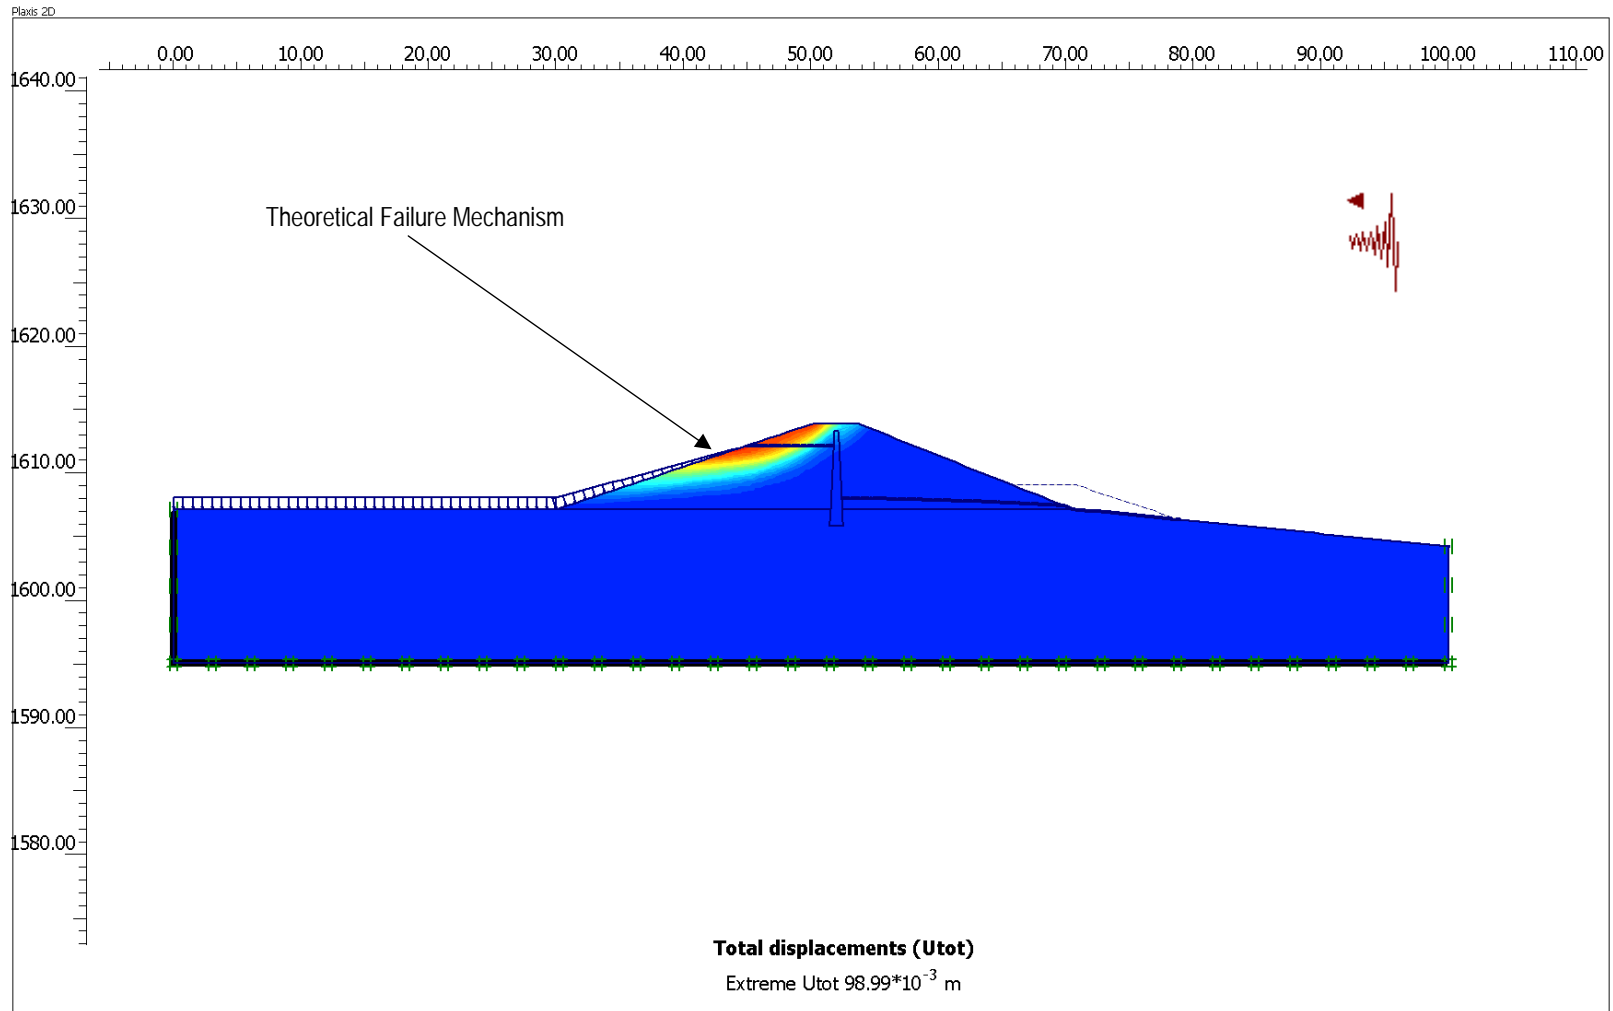
Figure 12

Seismic pseudo-static (PGA, steady state seepage, normal reservoir level)	Uncracked	1.06	Upstream
Post seismic residual shear strength (steady state seepage, normal reservoir level)	Cracked	1.01 <sup>3</sup>	Downstream & Upstream

<small>Finite Element Code for Soil and Rock Analyses</small> <small>Version 9.0.1.1182</small>	Project description			
	Big Meadow Lake Dam Upstream Seismic FOS=1.06			
Project name	Step	Date	User name	
Big Meadow Dam	340	11/12/10	EBA Engineering Consultants Ltd.

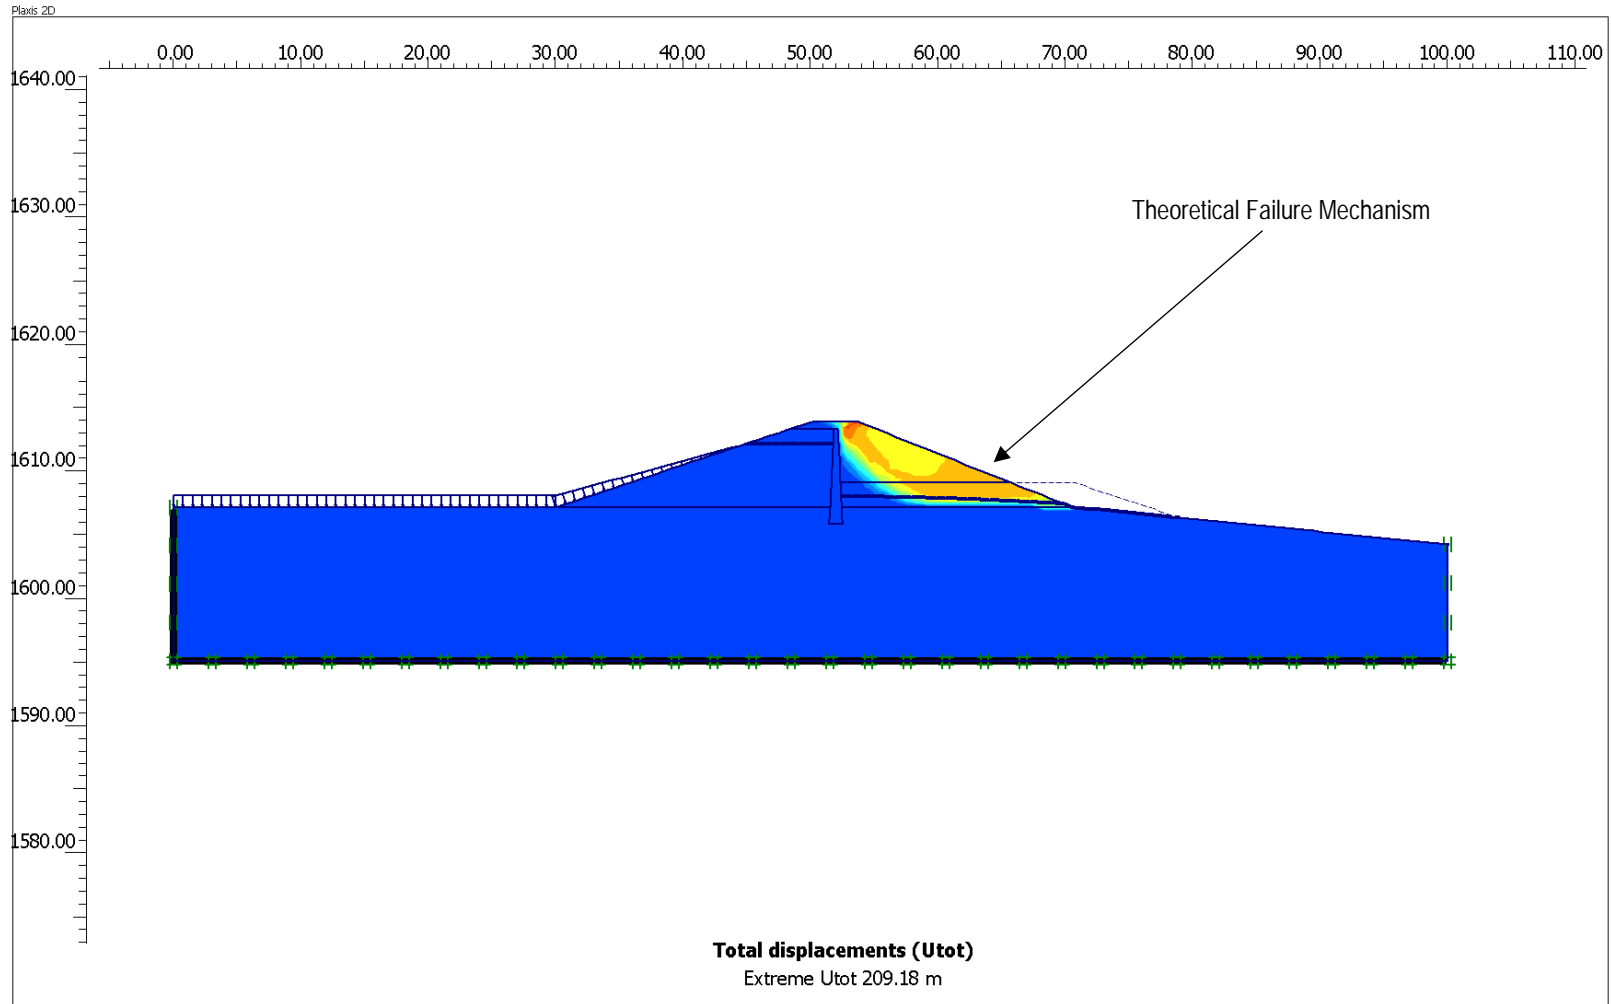
Figure 13

Project description					Big Meadow Lake Dam Post Seismic FOS=1.01				
Project name		Step	Date	User name					
Big Meadow Dam		974	16/12/10	EBA Engineering Consultants Ltd.

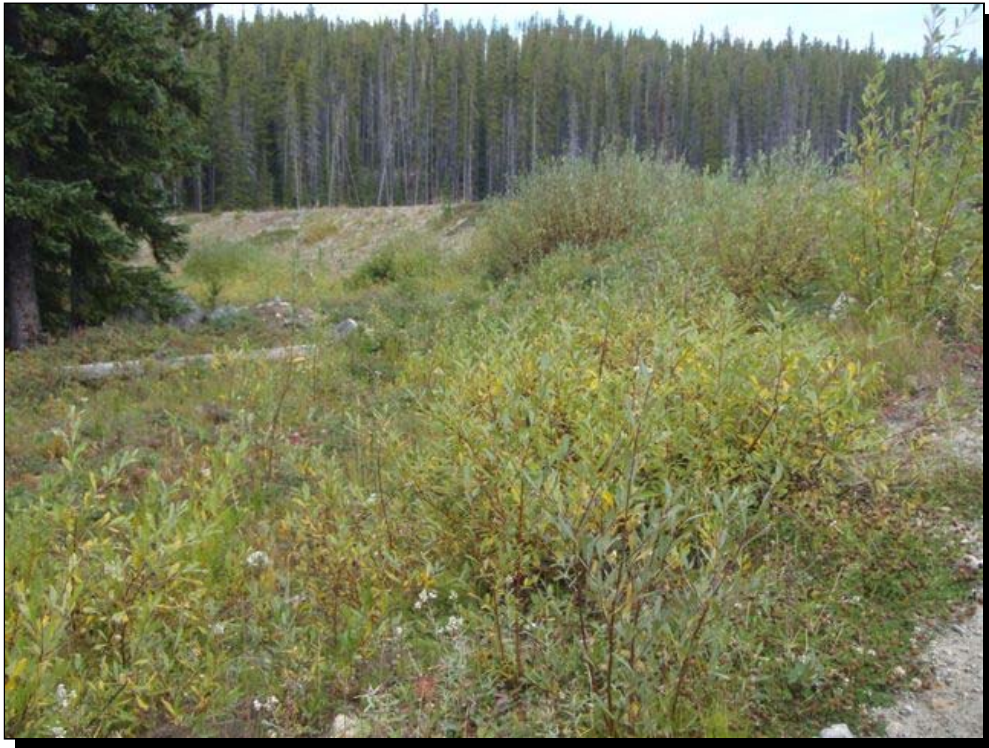
**Photo 3**  
Big Meadow Lake Dam — Vegetation growing on left side of Downstream Face

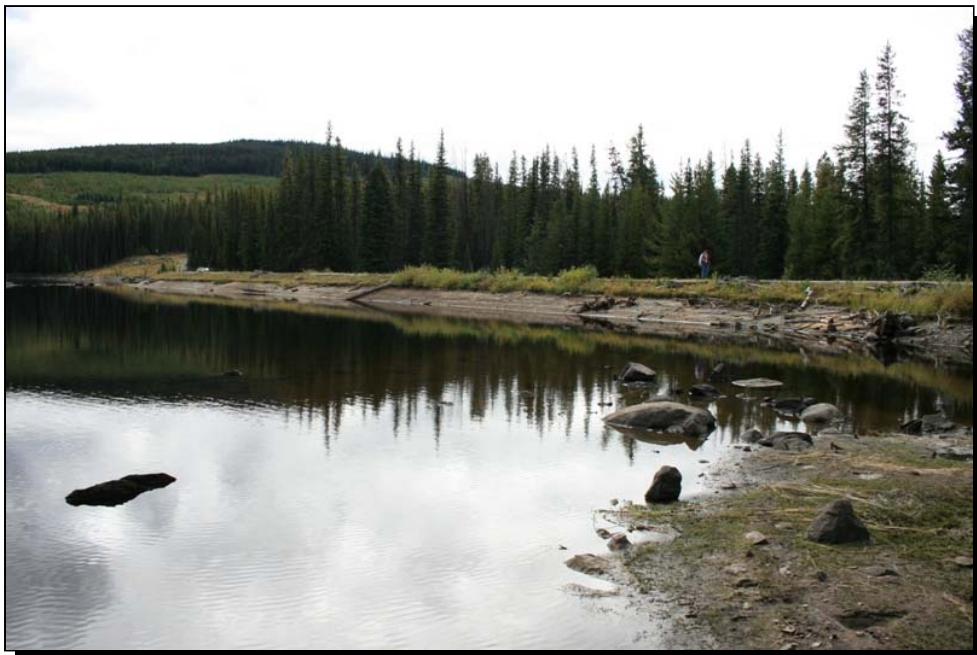
- Beaching was noted along the crest of the upstream face and some minor woody debris accumulation (Photo 4).
- Erosion, causing oversteepening of upstream face of the dam embankment, and woody debris accumulation was noted adjacent to the right abutment (Photo 13).

**Photo 4**  
Big Meadow Lake Dam — Upstream Face from right abutment

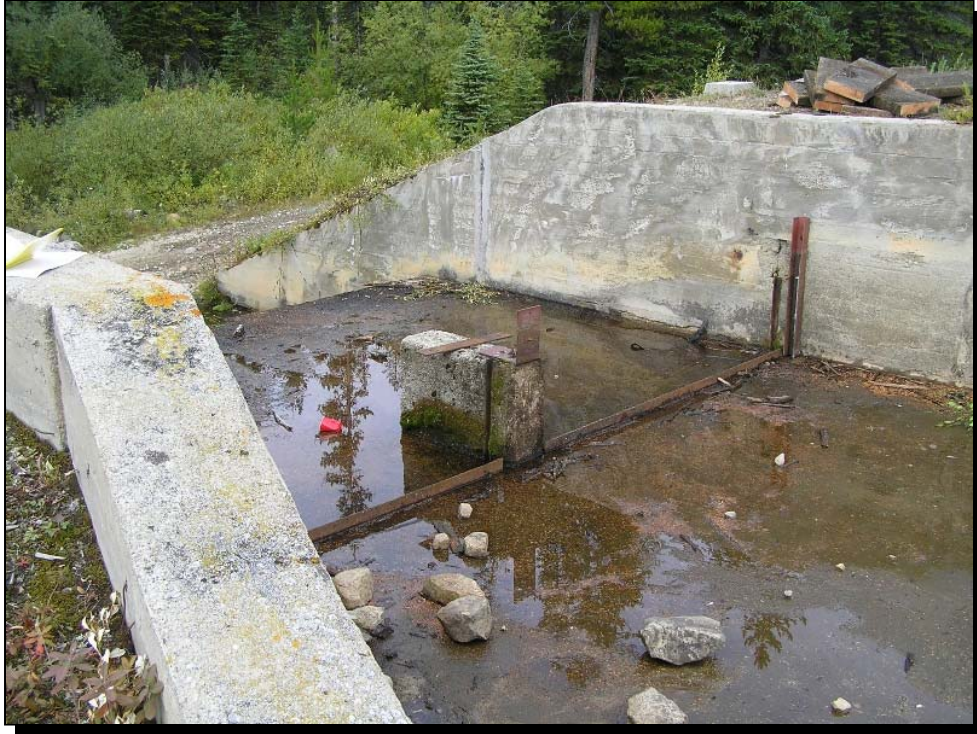
Photo 7  
Big Meadow Lake Dam — Spillway structure with Stop logs removed

- Some minor honeycombing was observed in the concrete surface of the spillway structure (Photo 7).
- Clear seepage was observed along the left hand side (LHS) of the spillway structure on the downstream face

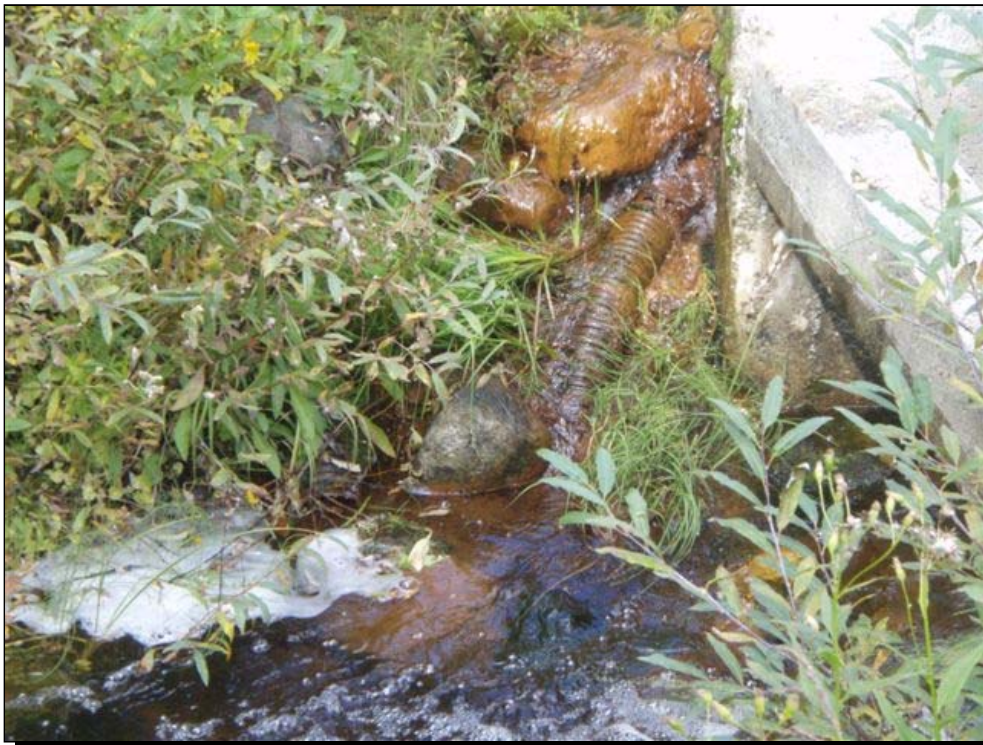
- Clear seepage was observed along the right hand side (RHS) of the low level outlet structure on the downstream face (Photo 10).
- Woody debris had accumulated in the weir downstream of the low level outlet structure.

**Photo 10**  
Big Meadow Lake Dam — Seepage from right of low-level outlet structure

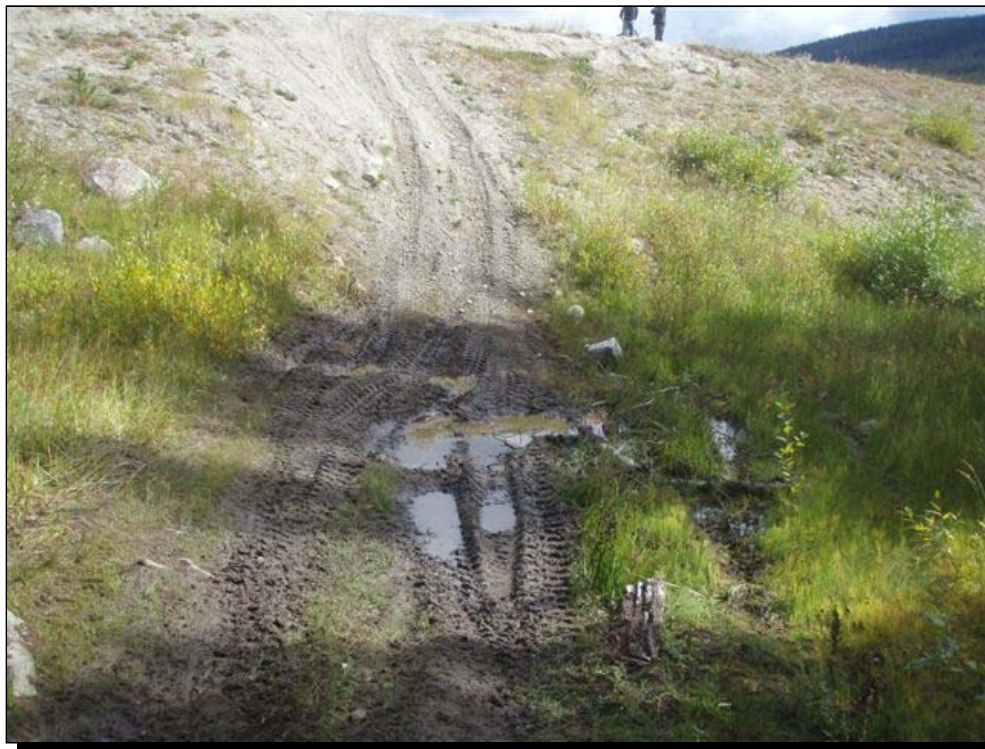
**Photo 11**

- Erosion and rutting was observed on the downstream face above the low level outlet structure, from ATV or Skidoo traffic (Photo 11).
- Some scrubby vegetation is growing on the left hand side of the downstream face (Photo 15).

Big Meadow Lake Dam — ATV tracks on Downstream Face adjacent to low-level outlet structure

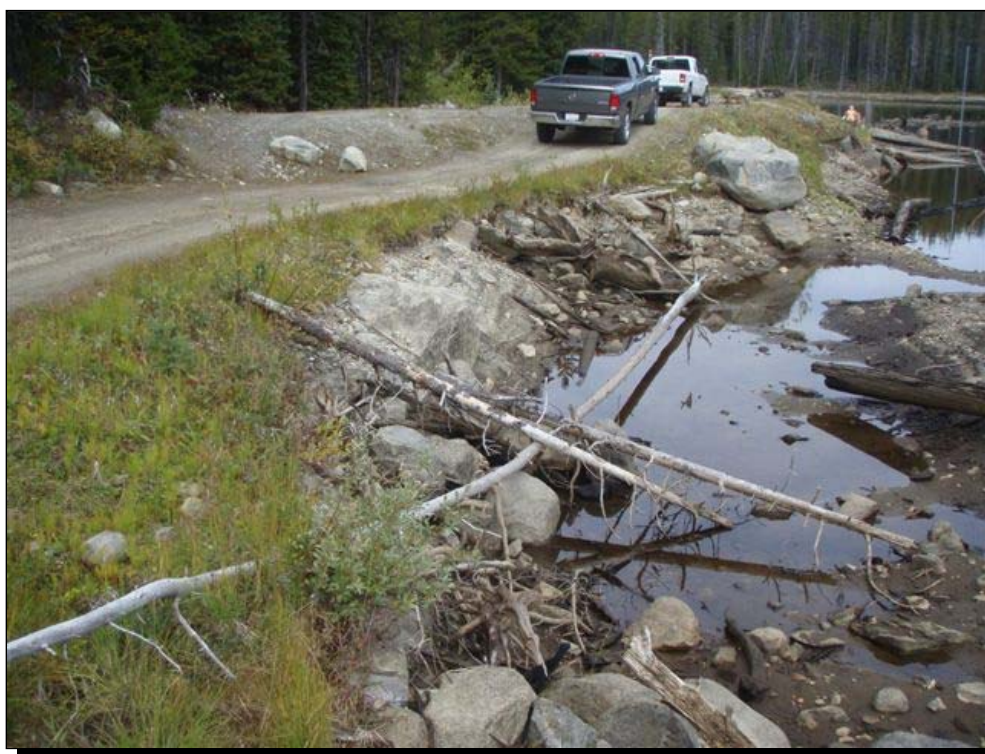
**Photo 12**

- Minor rutting from vehicle movement was noted along the dam crest.
- Some loss of freeboard (estimated to be in the order of 0.3 m) of the embankment was noted at the left abutment most likely due to the construction of the temporary access road during the Okanagan Mountain Park fire (Photo 12).

Big Meadow Lake Dam — Left abutment loss of freeboard due to vehicle traffic

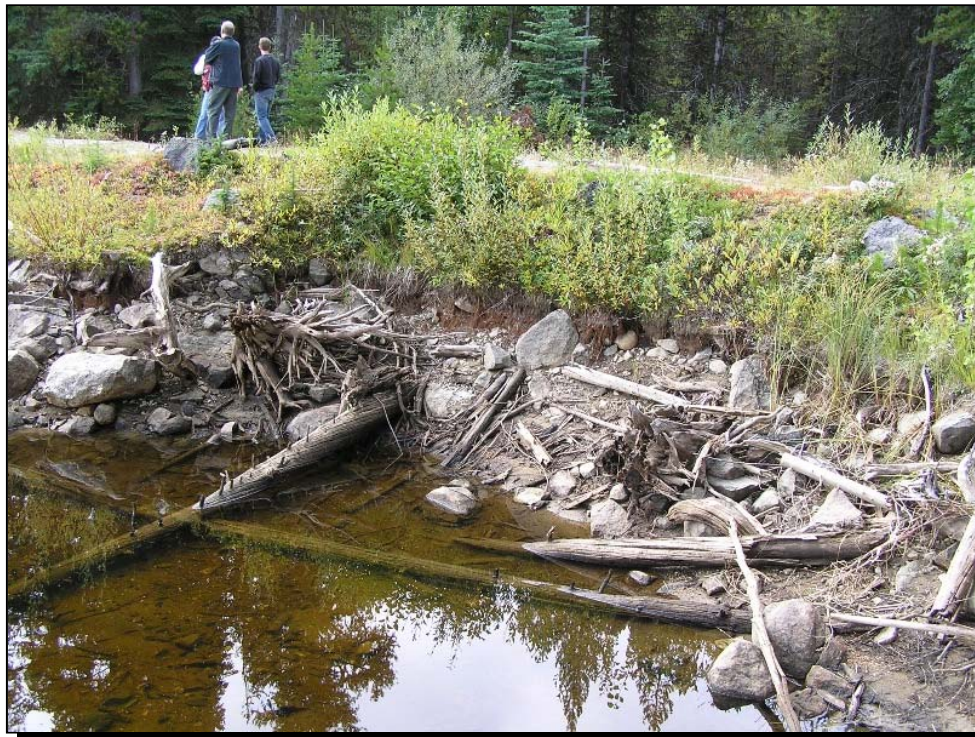
**Photo 13**

Big Meadow Lake Dam — Erosion of upstream face and accumulation of debris adjacent to right abutment

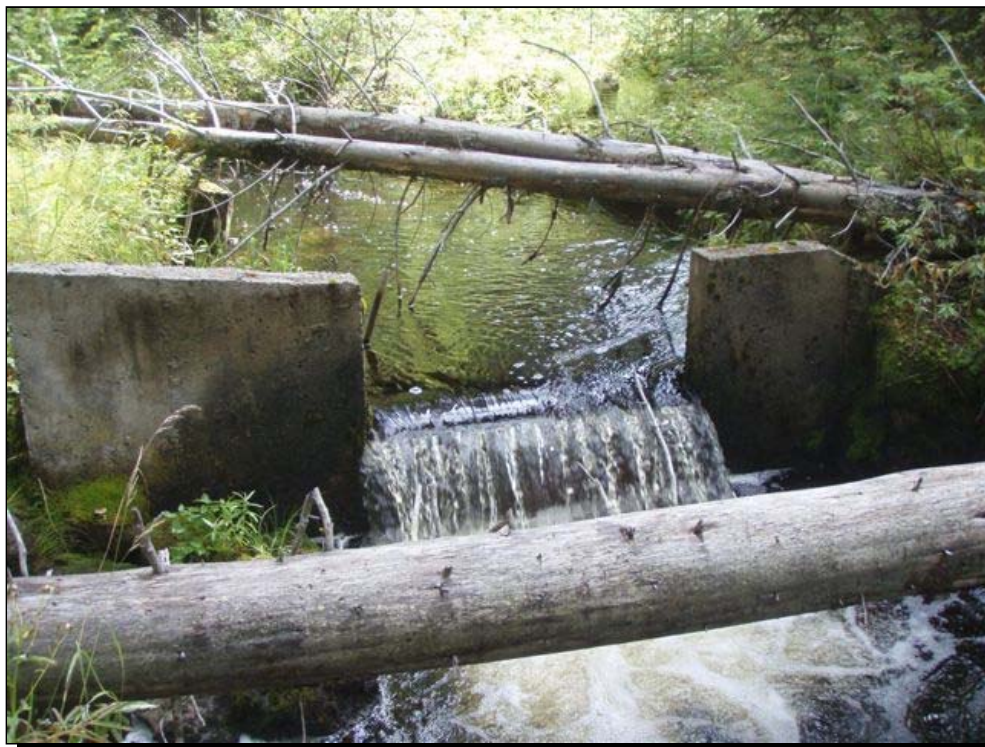
**Photo 14**

Big Meadow Lake Dam — Wood debris in Weir downstream of low-level outlet

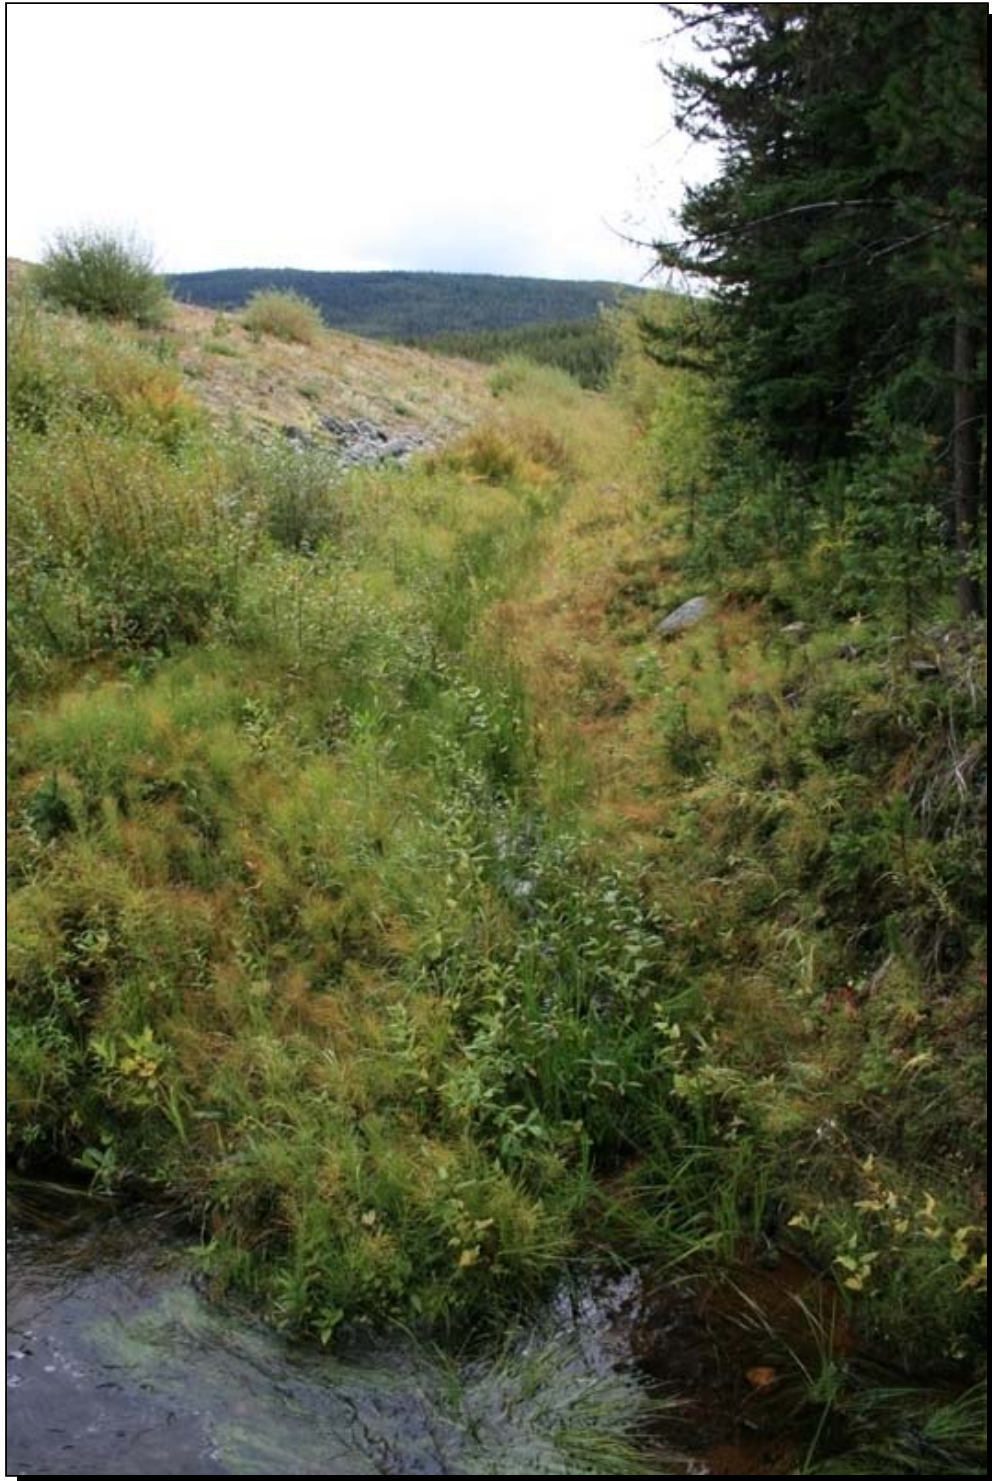
- Noticeable clear seepage (estimated to be in the order of 1000 to 2000 l/min) was observed from the LHS and RHS toe drains (Big-O pipe) into the low level outlet channel (Photo 15).

**Photo 15**  
Big Meadow Lake Dam — Toe drain left-hand side of downstream face
