Regional District of Okanagan-Similkameen

**DAM SAFETY REVIEWS FOR
ELINOR LAKE NORTH (SADDLE) DAM AND
ELINOR LAKE SOUTH DAM**

K13101459.001

December 17, 2010

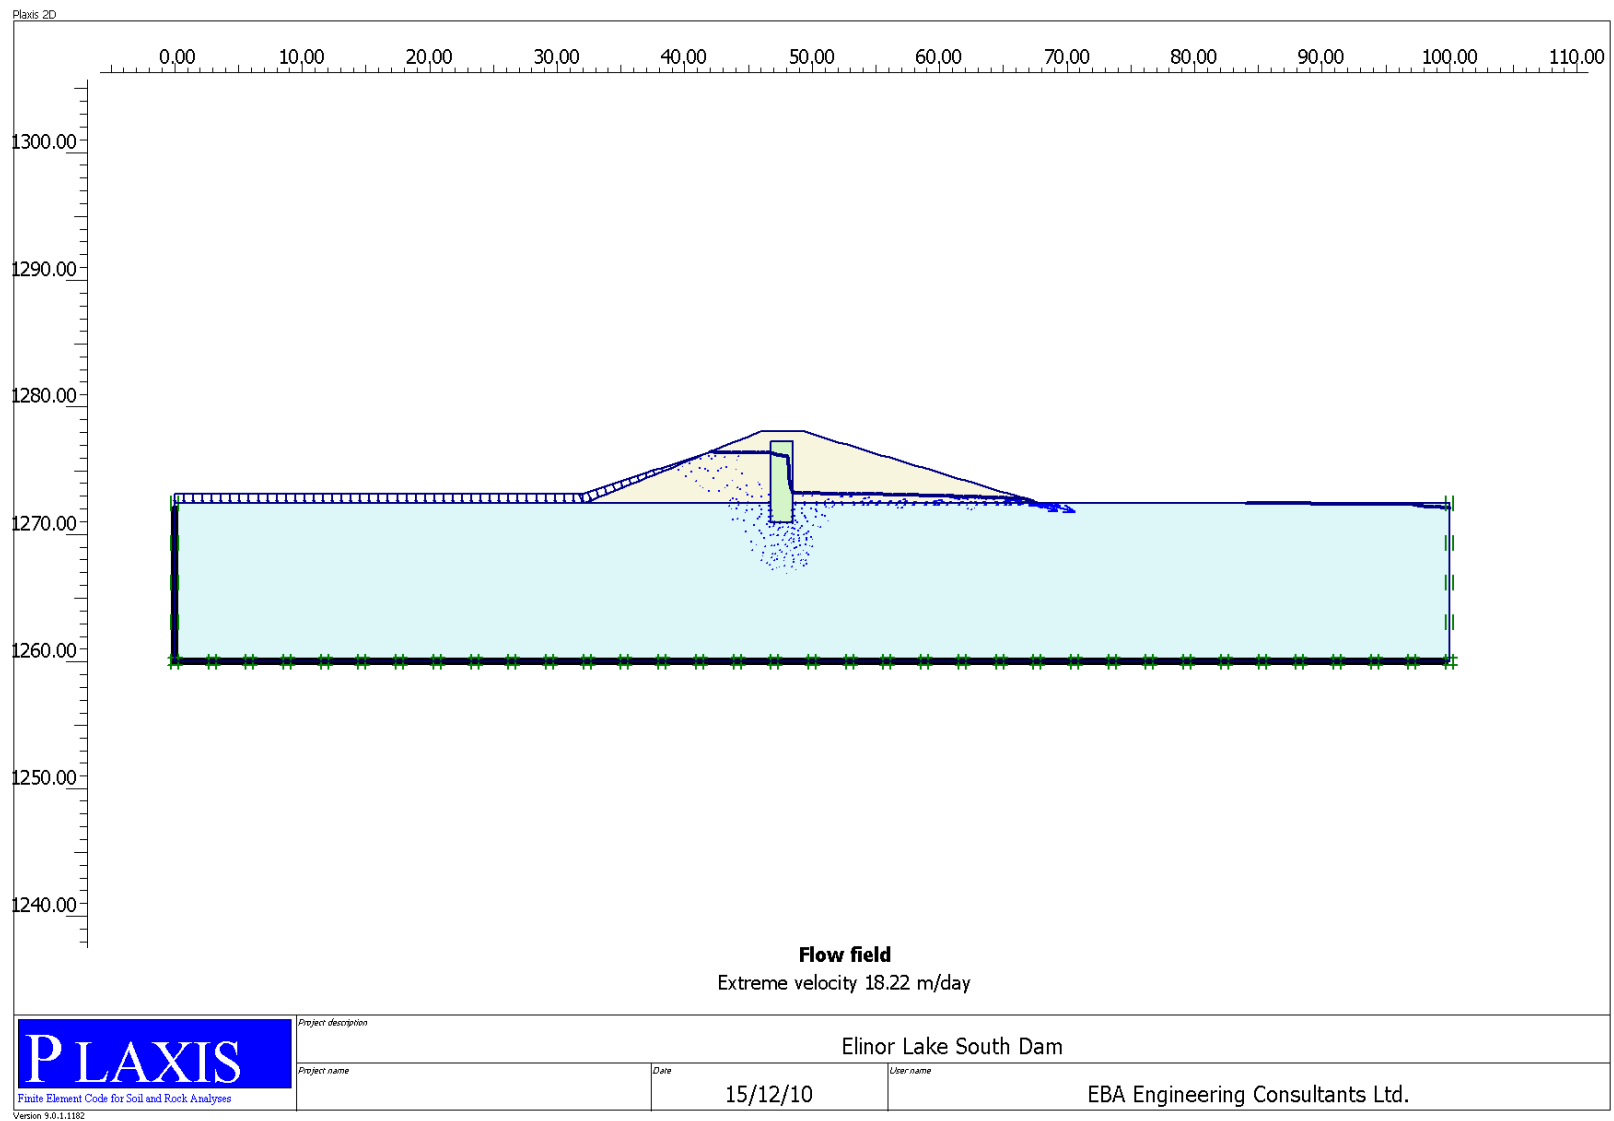
Figure 5

The rate of toe seepage calculated at the South Dam is summarized in Table 7 below. It should be noted that the analysis was undertaken at the dam's maximum height and reduced seepage rates are anticipated where the embankment height is less.

Toe seepage of 10.49 m³/day/m (7.28 l/min/m) calculated.

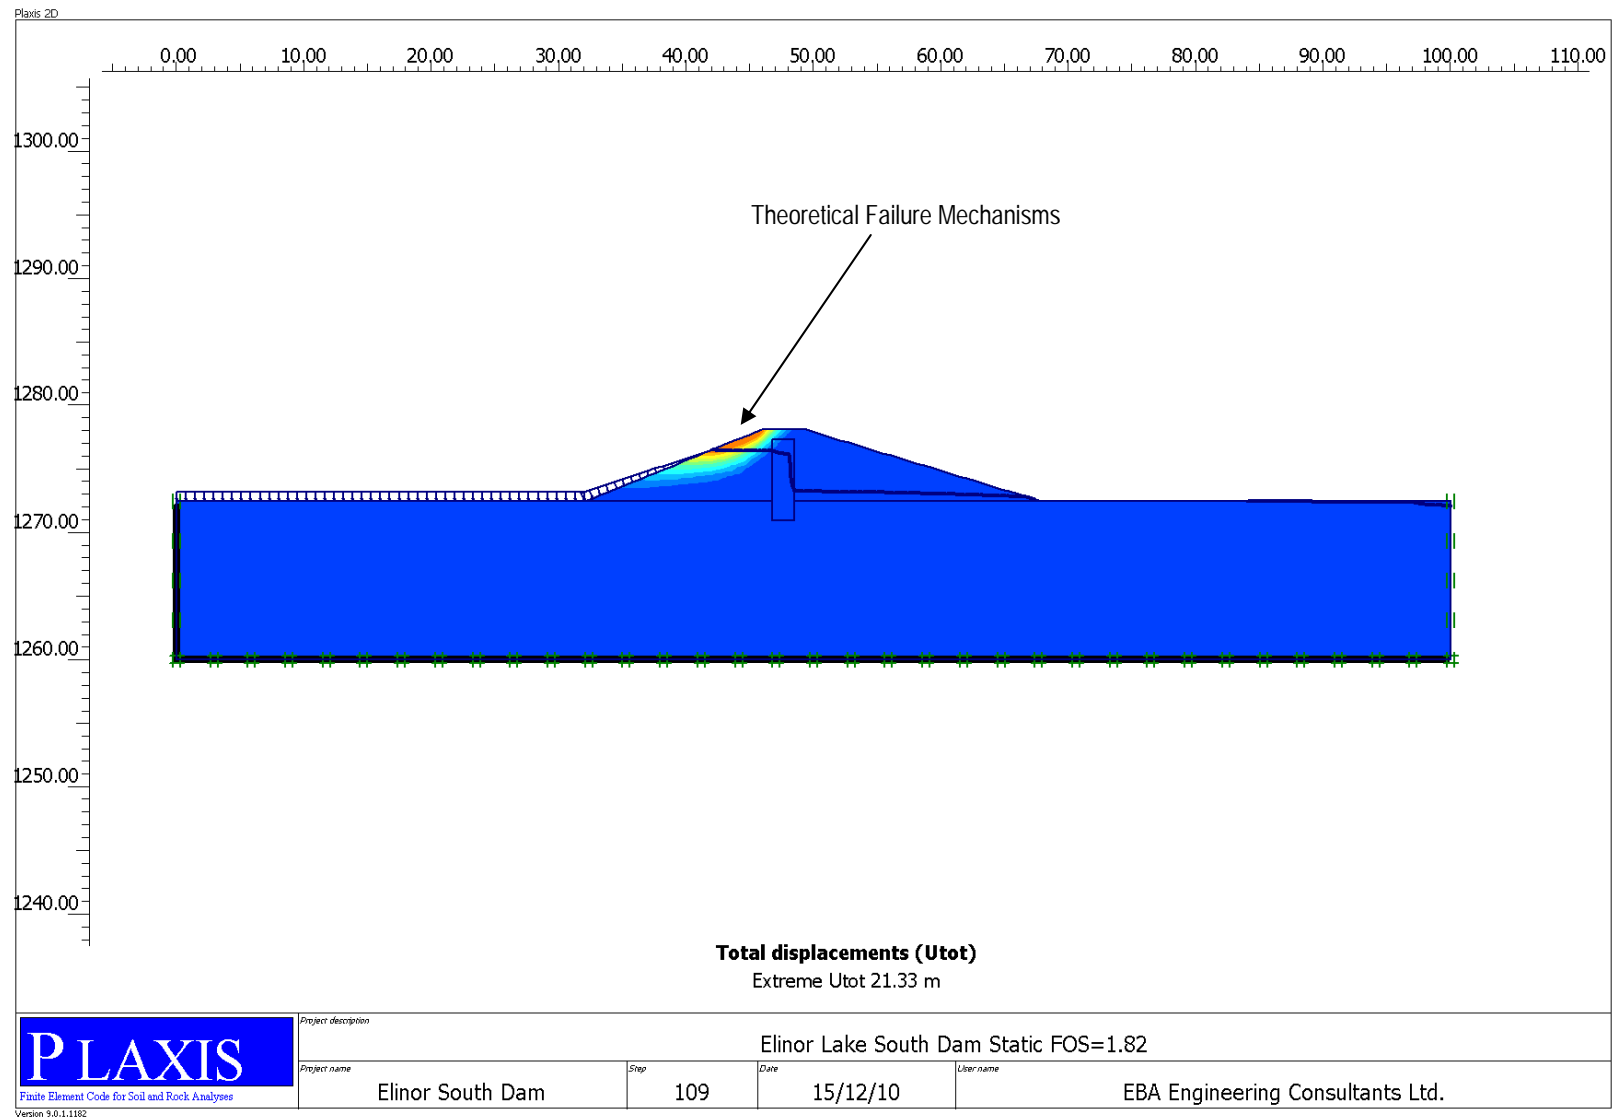
Figure 6

The phi-c reduction procedure in PLAXIS® generates additional, large, non-physical displacements with the shape of the deformed mesh and pattern of the displacements giving an indication of the shape of the theoretical failure mechanism.
Downstream FOS>1.82.

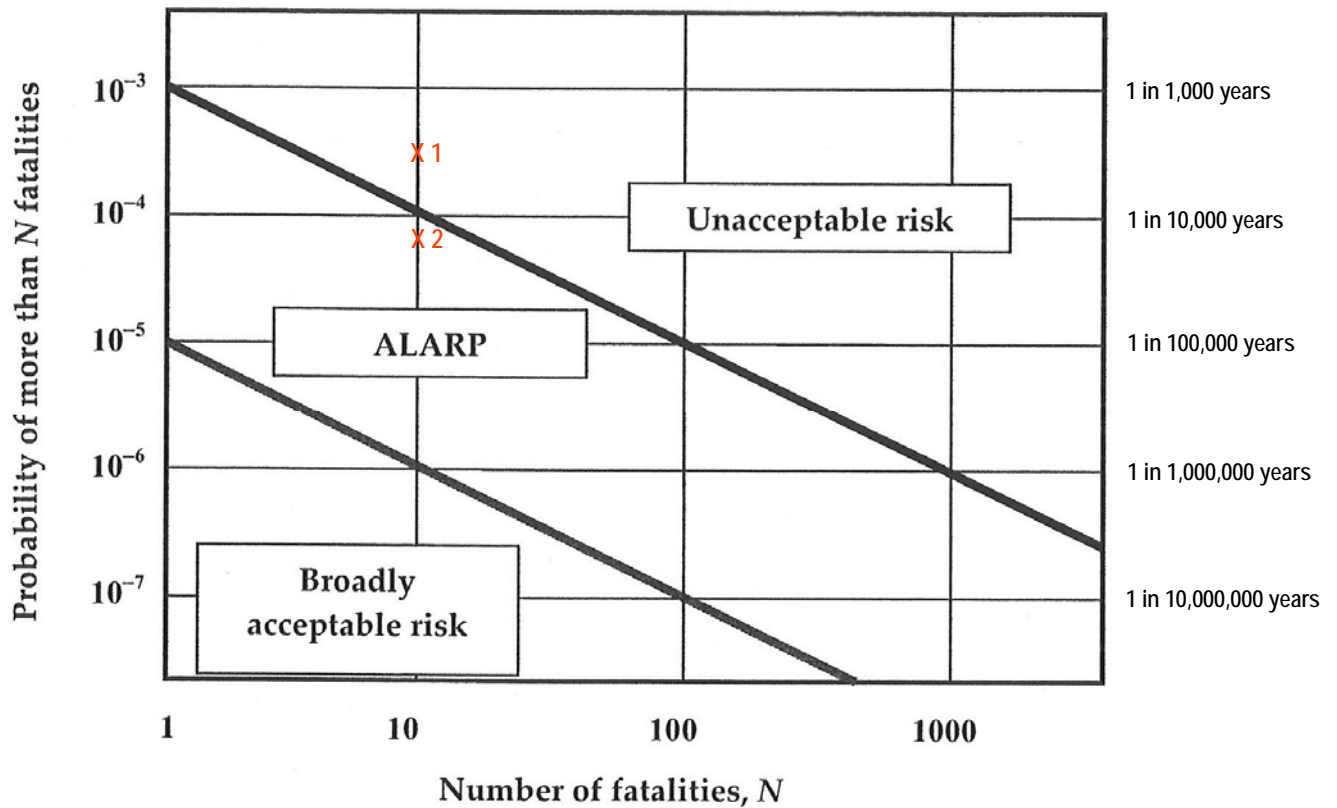
Calculated Annual Likelihood of Piping Failure:

1. Elinor Lake Dam's existing.
2. Elinor Lake Dam's with a toe berm incorporating a filter, an improved seepage monitoring program and conformation of a low plasticity clay central core.

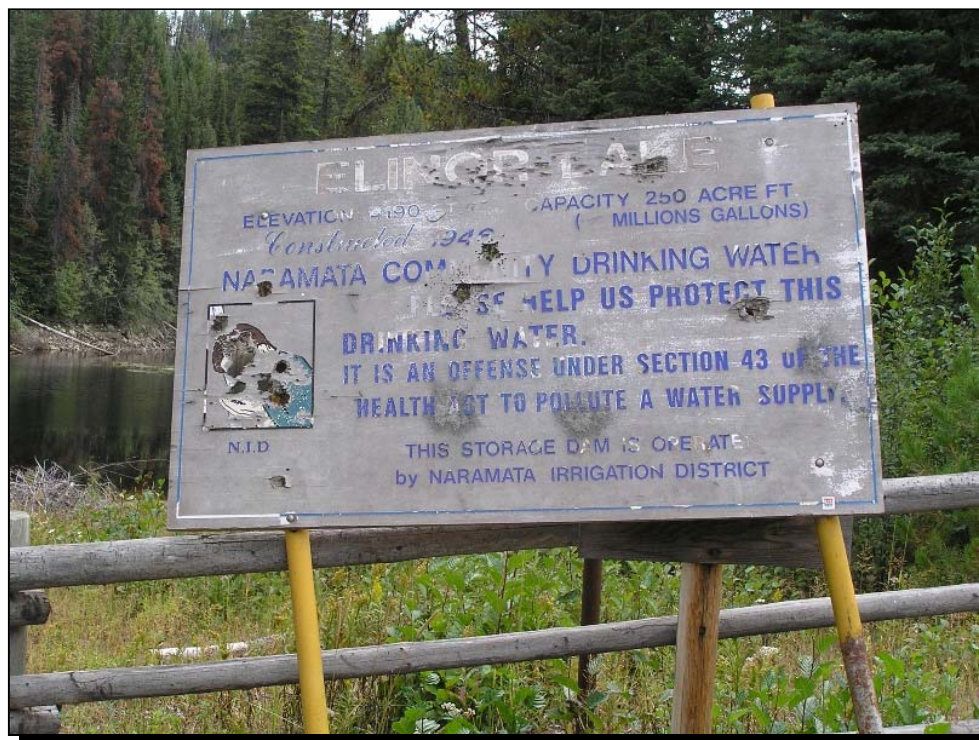
- The dam information sign was badly deteriorated (Photo 1).
- The reservoir level was approximately 3.6m below the dam crest at the time of the inspection (Photo 2).
- There was beaching along the crest of the upstream face and some minor woody debris accumulation (Photo 2).
- There was some scrubby vegetation is growing on the left-hand side of downstream face (Photo 3).
- The downstream and upstream slopes are approximately 2.75H:1V and 2.75H:1V respectively, however the downstream slope adjacent to the left abutment is reduced to approximately 3.75H:1V (Photo's 4 and 6).
- Rock outcropping was noted adjacent to the right abutment (Photo 5).
- There is minor rutting from vehicle movement along crest (Photo's 6 and 7).
- Erosion and heavy rutting was noted on the downstream face from vehicle traffic (Photo 7).
- Signs of small burrowing animal activity along the embankment toe.

Photo 1
Elinor Lake North (Saddle) Dam — Information Board

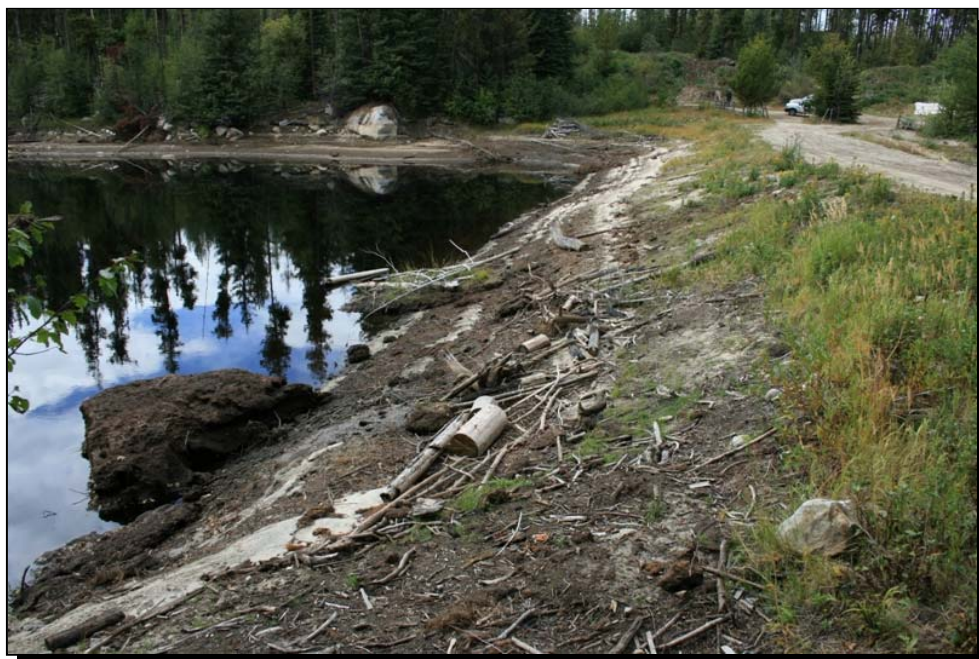
Photo 2
Elinor Lake North (Saddle) Dam — Upstream Face from right abutment

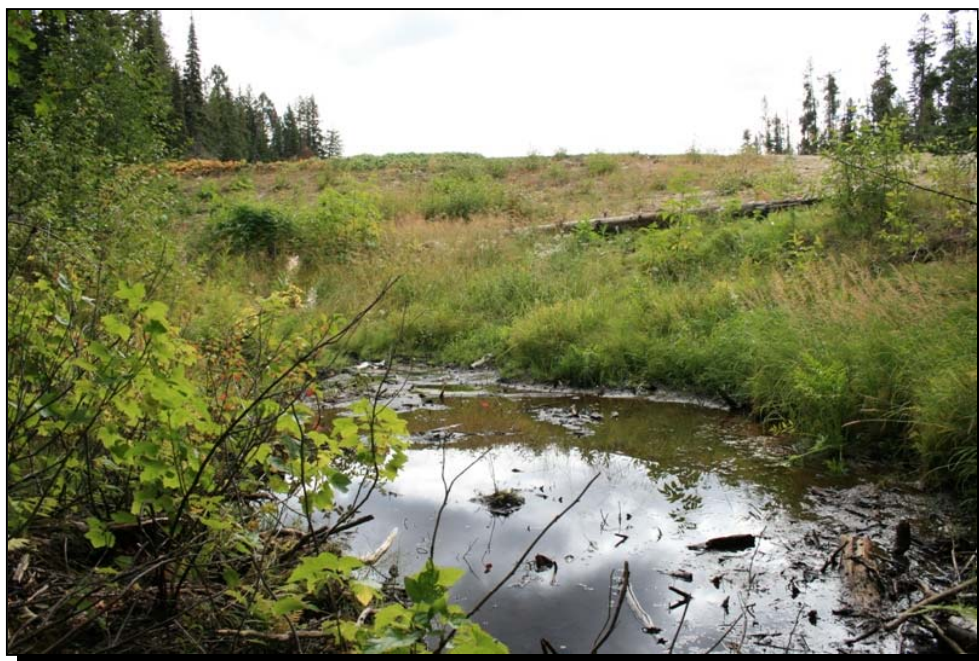
Photo 3
Elinor Lake North (Saddle) Dam — Downstream Face

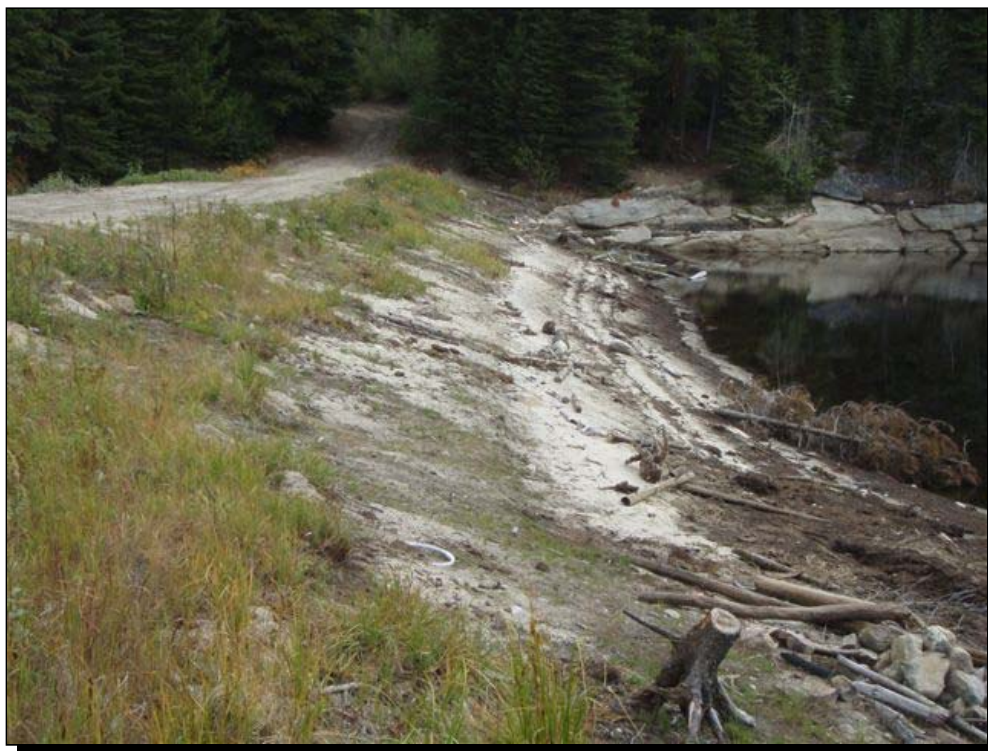
Photo 4
Elinor Lake North (Saddle) Dam — Upstream Face from left abutment

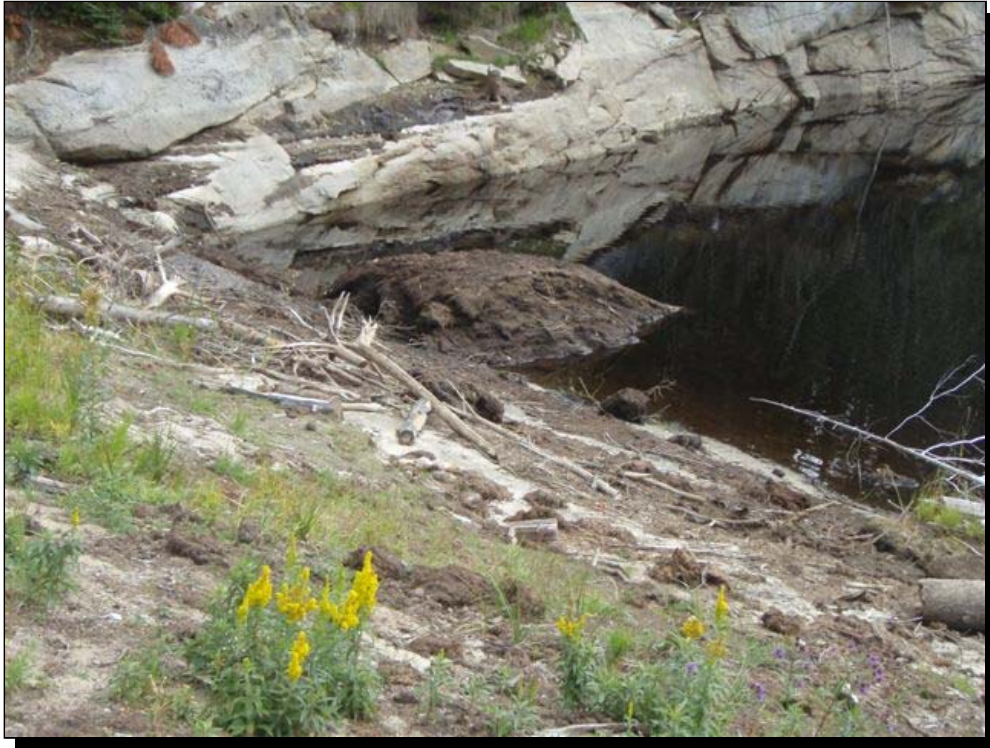
Photo 5
Elinor Lake North (Saddle) Dam — Rock outcrop adjacent to right abutment

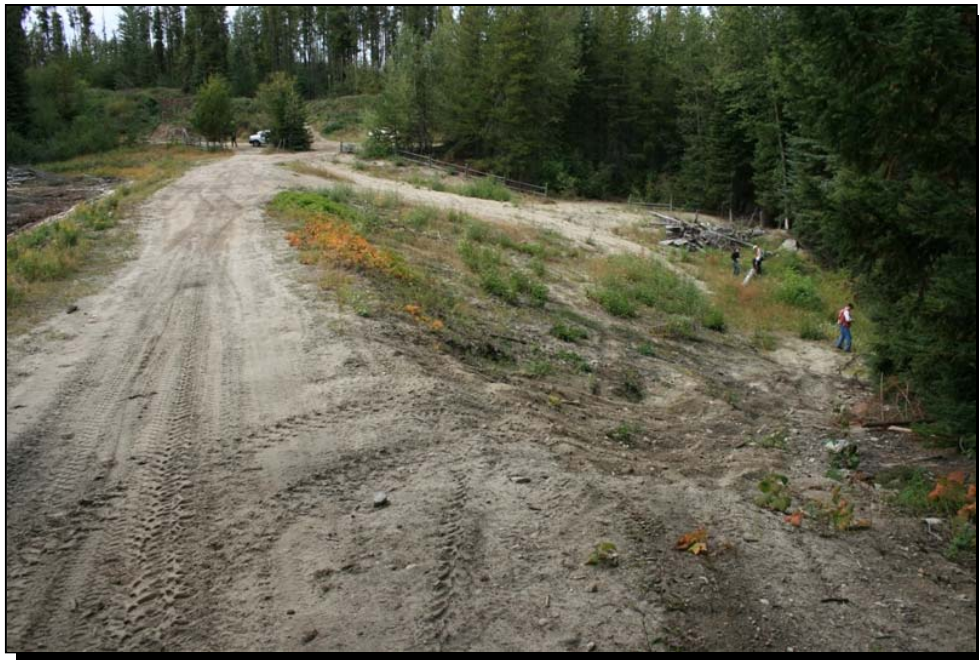
Photo 6
Elinor Lake North (Saddle) Dam — Crest and downstream face from right abutment

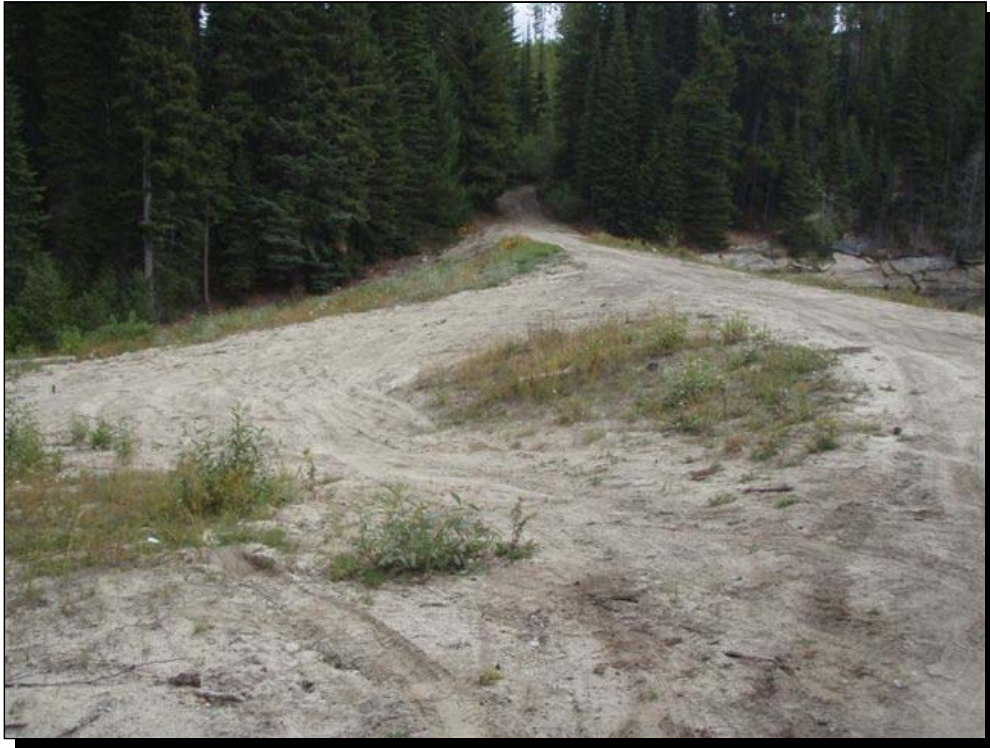
Photo 7
Elinor Lake North (Saddle) Dam — Crest and downstream face from left abutment

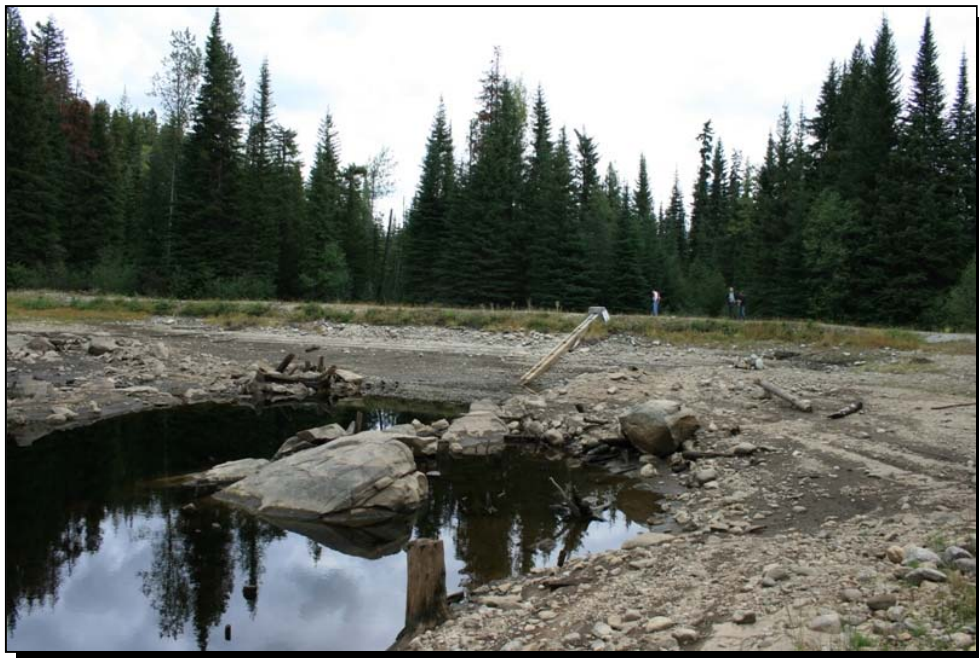
- The dam information sign was badly deteriorated.
- The reservoir level was approximately 3.6m below the dam crest at the time of the inspection (Photo 8).

Photo 8
Elinor Lake South Dam — Upstream Face

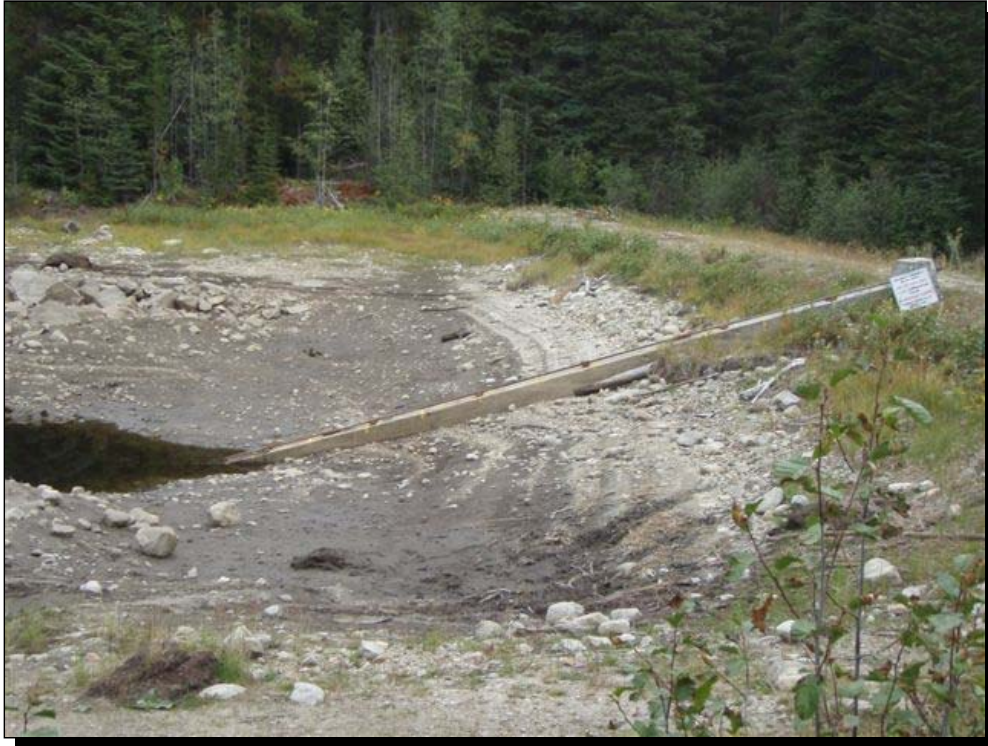
Photo 9
Elinor Lake South Dam — Upstream Face from right abutment

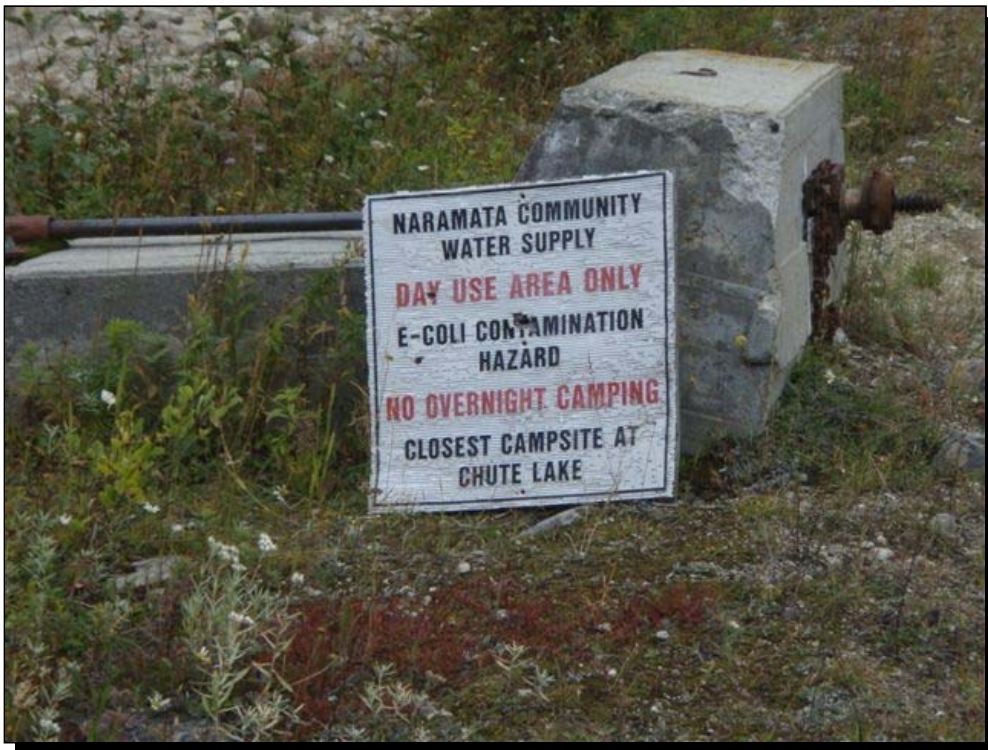
Photo 10
Elinor Lake South Dam — Gate Hoist Headblock

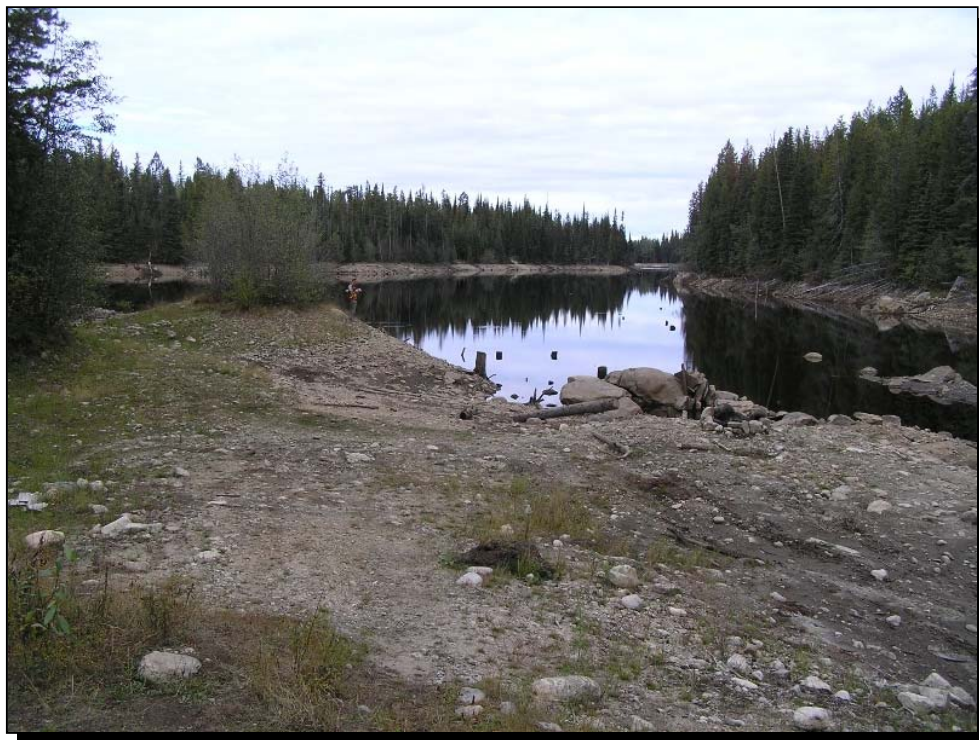
Photo 11
Elinor Lake South Dam — Reservoir

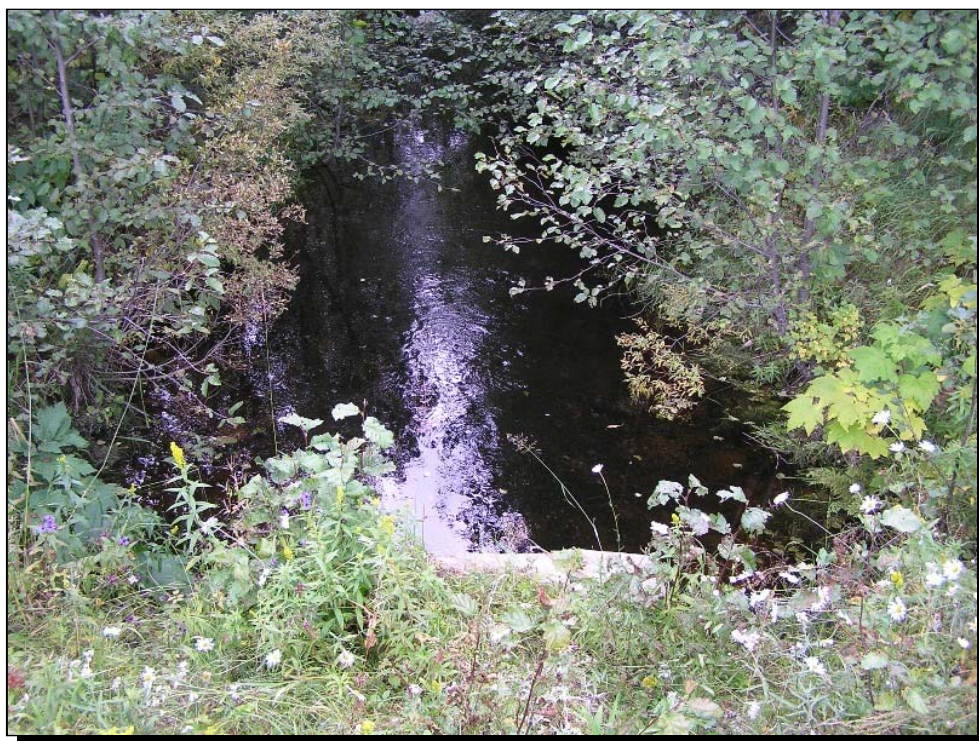
Photo 12
Elinor Lake South Dam — Low-level outlet channel

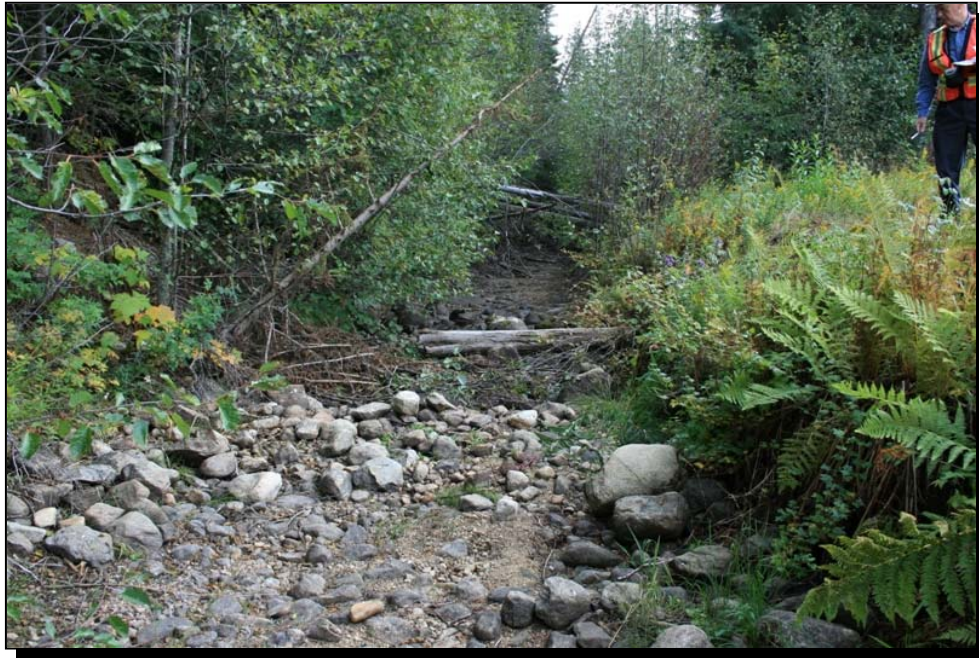
Photo 13
Elinor Lake South Dam — Wood debris in spillway channel

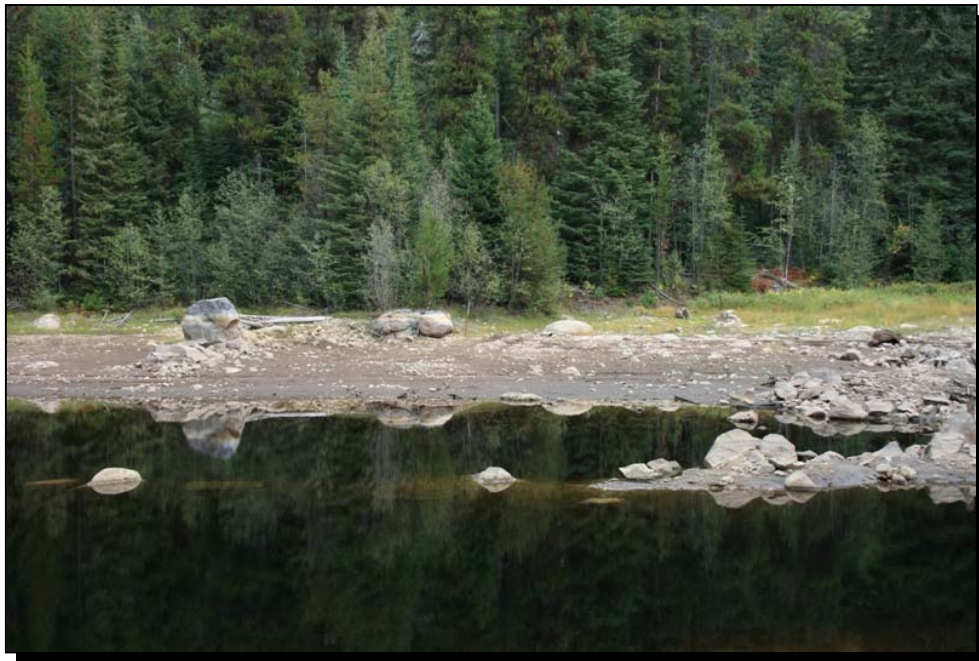
Photo 14
Elinor Lake South Dam — Spillway channel entrance, no log boom and accumulation of silt

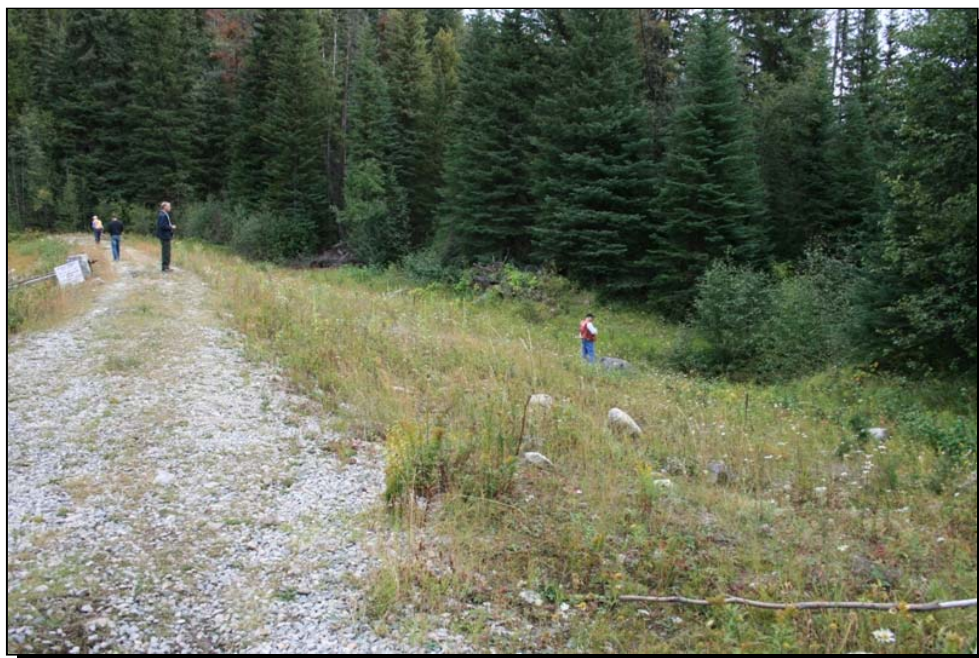
Photo 15
Elinor Lake South Dam — Downstream face

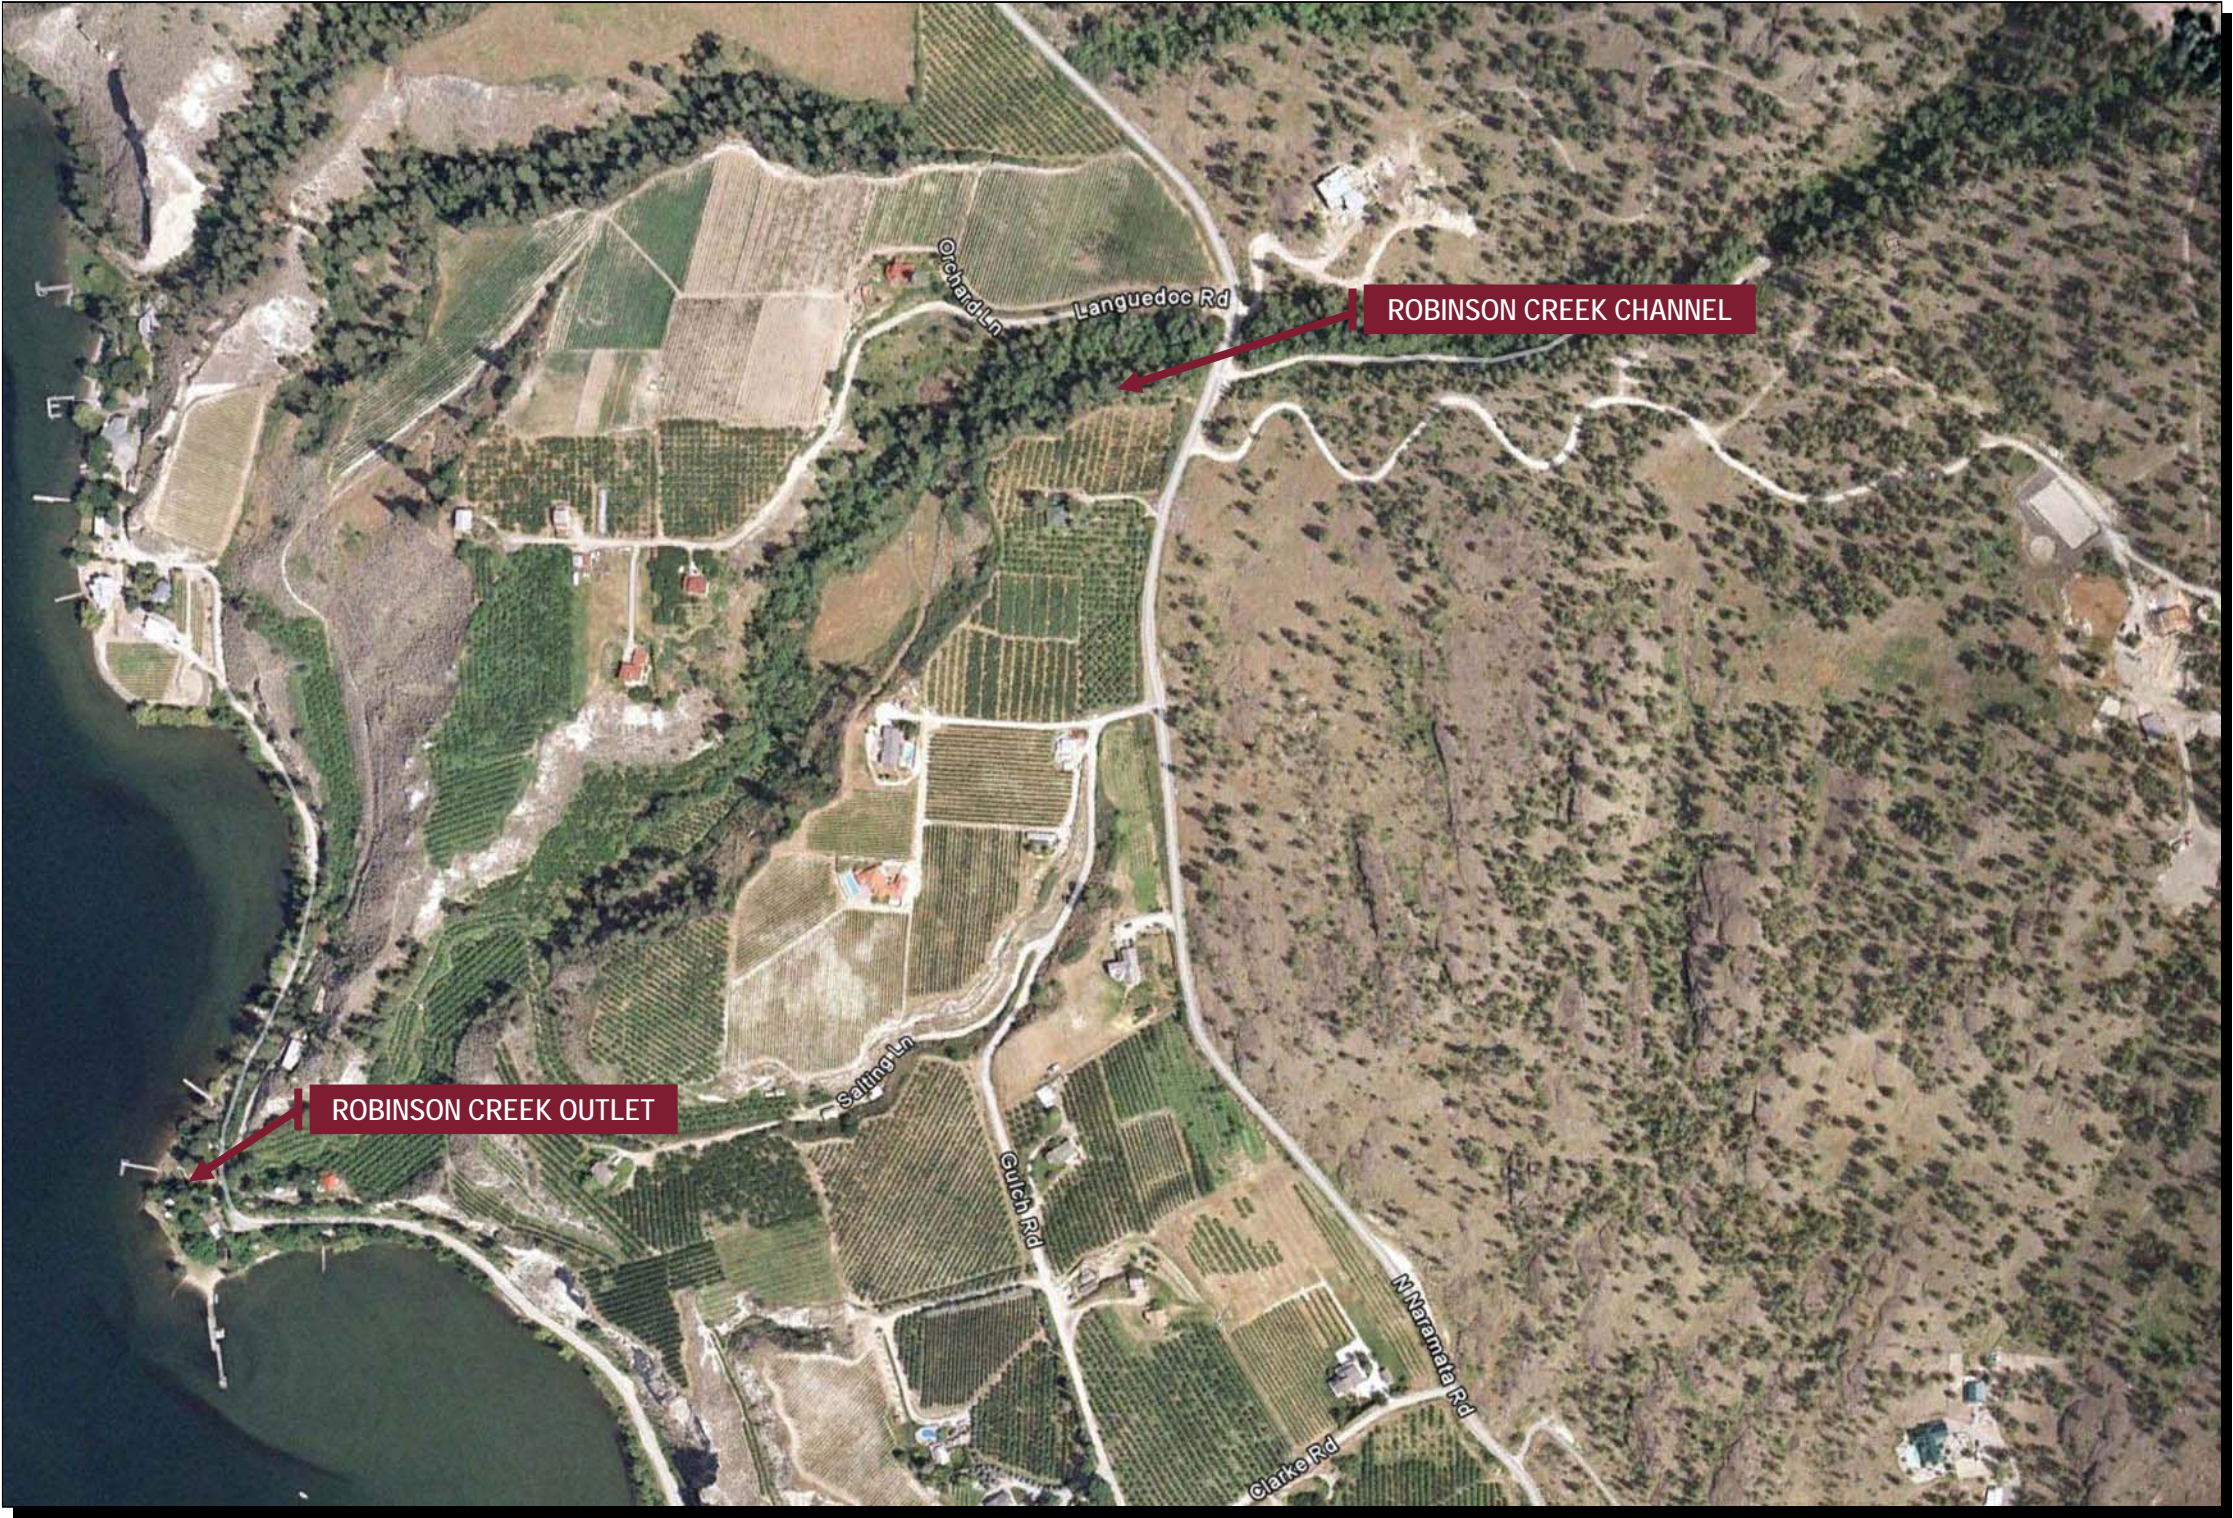
Photo 16
Robinson Creek Outlet

into Lake Okanagan, as shown on the attached Photo 16. Economic losses including dam replacement and downstream rehabilitation costs in the event of a dam failure could be in the \$1M to \$10M range. The potential loss of life could be in the 1 to 10 range (see Table 3). Therefore, this places the dams in the High (Low) category of the BC Dam Safety Regulation and the High category of the CDA guidelines.
