Vintage Views Wastewater System Assessment Report

Dated: February 2024

Ecora File No.: 230122

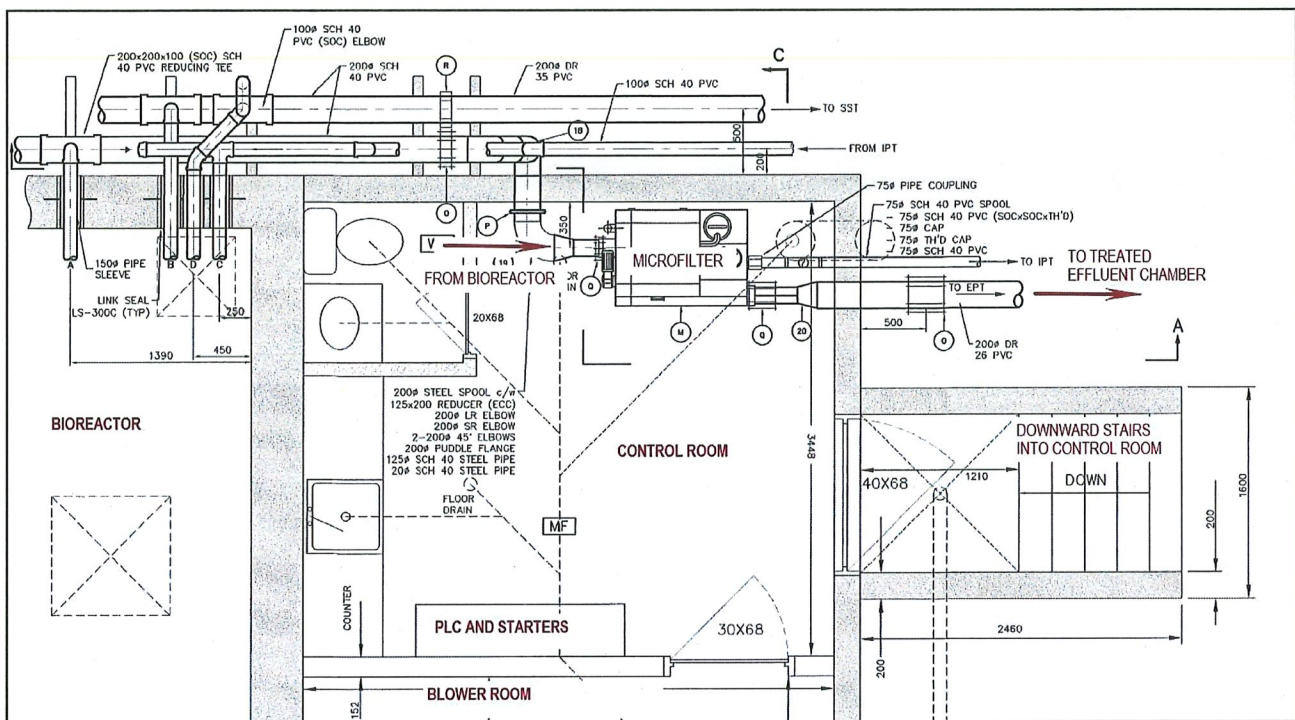
Figure 6: Microfilter in the Control Room

- The flow and volume readings from the effluent pump station are not connected to the existing PLC.
- The PLC is an older model with limited input and output capabilities. It is installed in the same enclosure as the electrical blower starters.
- There are dissolved oxygen analyzers installed in the wastewater in the biological reactor. The dissolved oxygen readings are recorded by the PLC.
- The stop and start of the air blowers are controlled by a timer that is set beforehand by the operator.

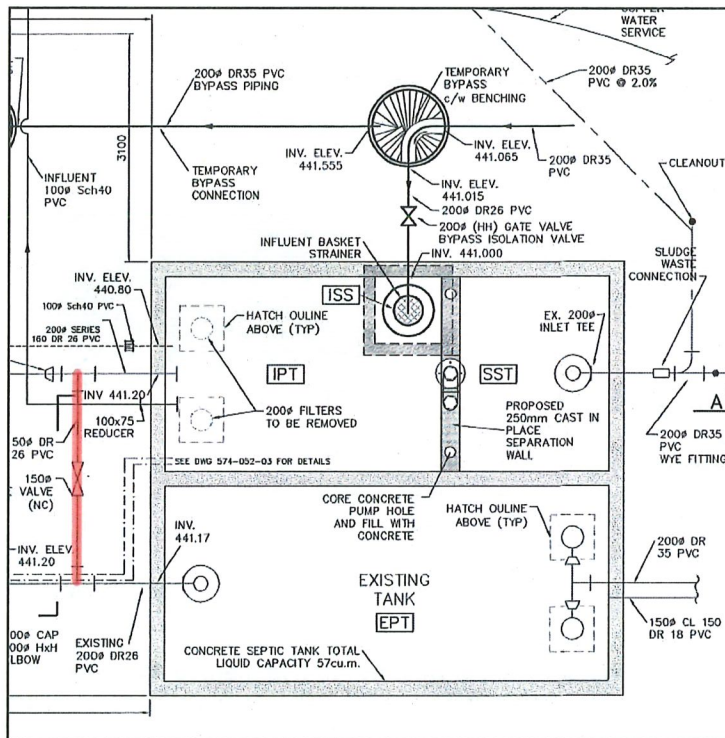
Figure 7: Existing bypass from the inlet chamber to the treated effluent chamber

- Bypass: There is an open bypass between the inlet chamber and the treated effluent chamber. If the inflow is higher than the pumping capacity of the two existing pumps in the inlet chamber, or if the pumps become clogged or fail, then the water level will rise, and the raw wastewater bypasses the bioreactor. The bypass pipe is highlighted in red in Figure 7 below. The current operator only works at the WWTP on a part-time basis and is not notified if bypassing is occurring. Raw wastewater will pollute the groundwater around the existing infiltration field should bypassing occur.

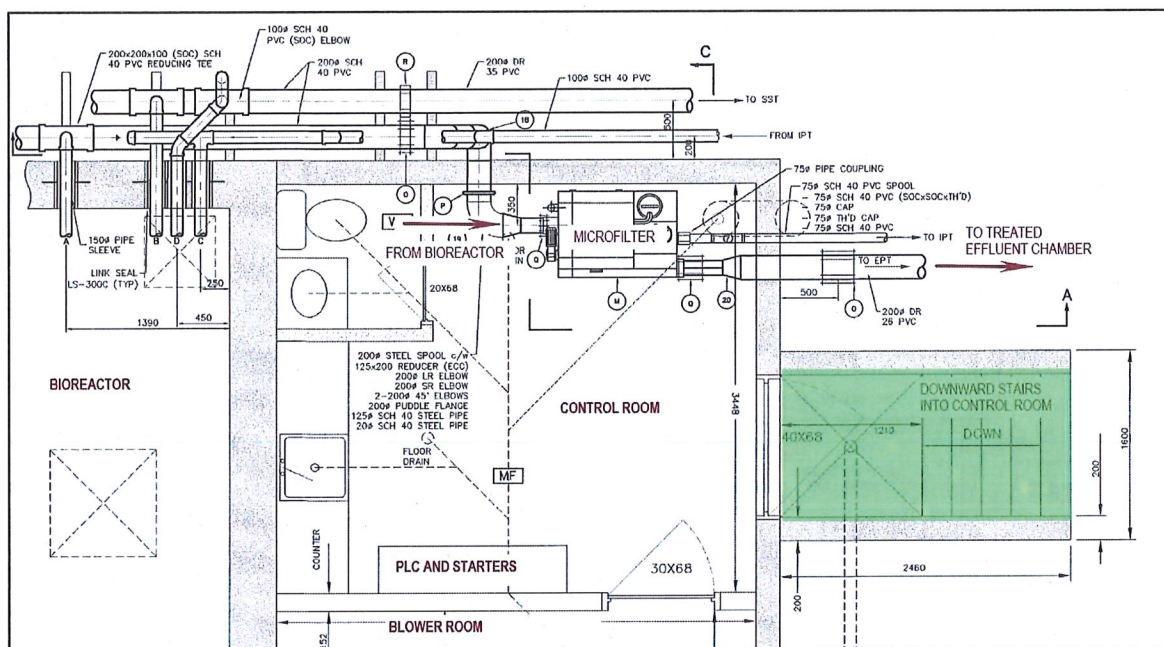
Figure 8: Location of stairs

- Concrete structure: The existing bioreactor, control room, and blower room consist of cast-in-place concrete. No visible leaks or cracks were detected. A photograph of the reactor roof slab is presented in Figure 10.
- The downward stairs into the control room and landing are not covered by a roof and fill up with snow during winter. The location of the existing stairs is highlighted in green in Figure 8 below. This is a nuisance to the operator and a safety concern.

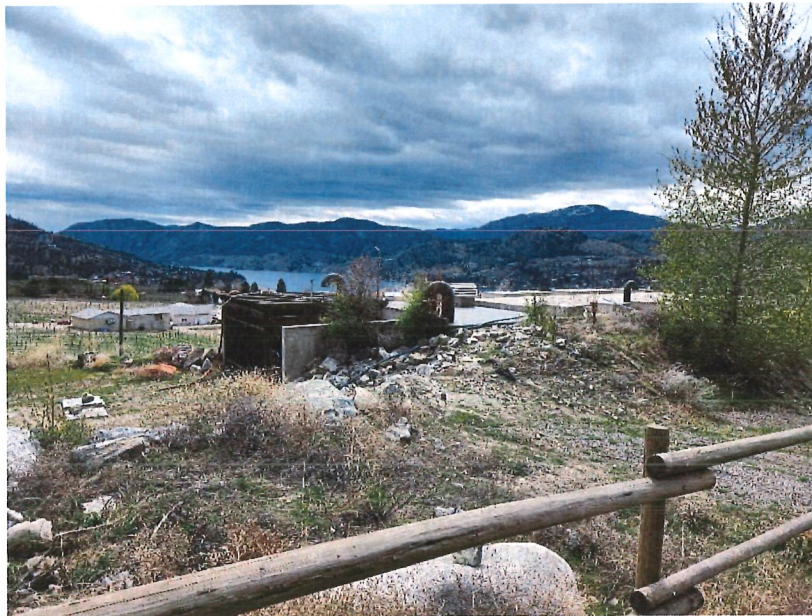
Figure 9: Vintage Views WWTP: Existing fencing in the foreground

- Unauthorized access/fencing: Children and animals should be prevented from entering the site due to safety reasons. There is a low wooden fence around the site, but no access gate. There is a risk that a child or animal might fall into a manhole or wet chamber. A children's park is situated adjacent to the WWTP site. A photograph of the current fence is presented in Figure 9 below.
- There is no access to the infiltration field. The vineyard is fenced off. The operator needs to open and close valves in the infiltration field. The operator is required to measure groundwater levels and to take samples from monitoring wells. Currently, the operator must drive around to the farm entrance to gain access to the infiltration field.

- Civil & building improvements:
 - Fencing should be provided around the site. This is both a safety and a security issue. It is to prevent theft, and vandalism, and prevent children and animals from entering the site. A security system is also recommended for the building.
