Greater West Bench Geotechnical Review

December 22, 2021

191010

Stephen Juch (sjuch@rdos.bc.ca)
 Development Engineering Supervisor
 Regional District of Okanagan-Similkameen
 101 Martin Street
 Penticton, BC V2A 5J9

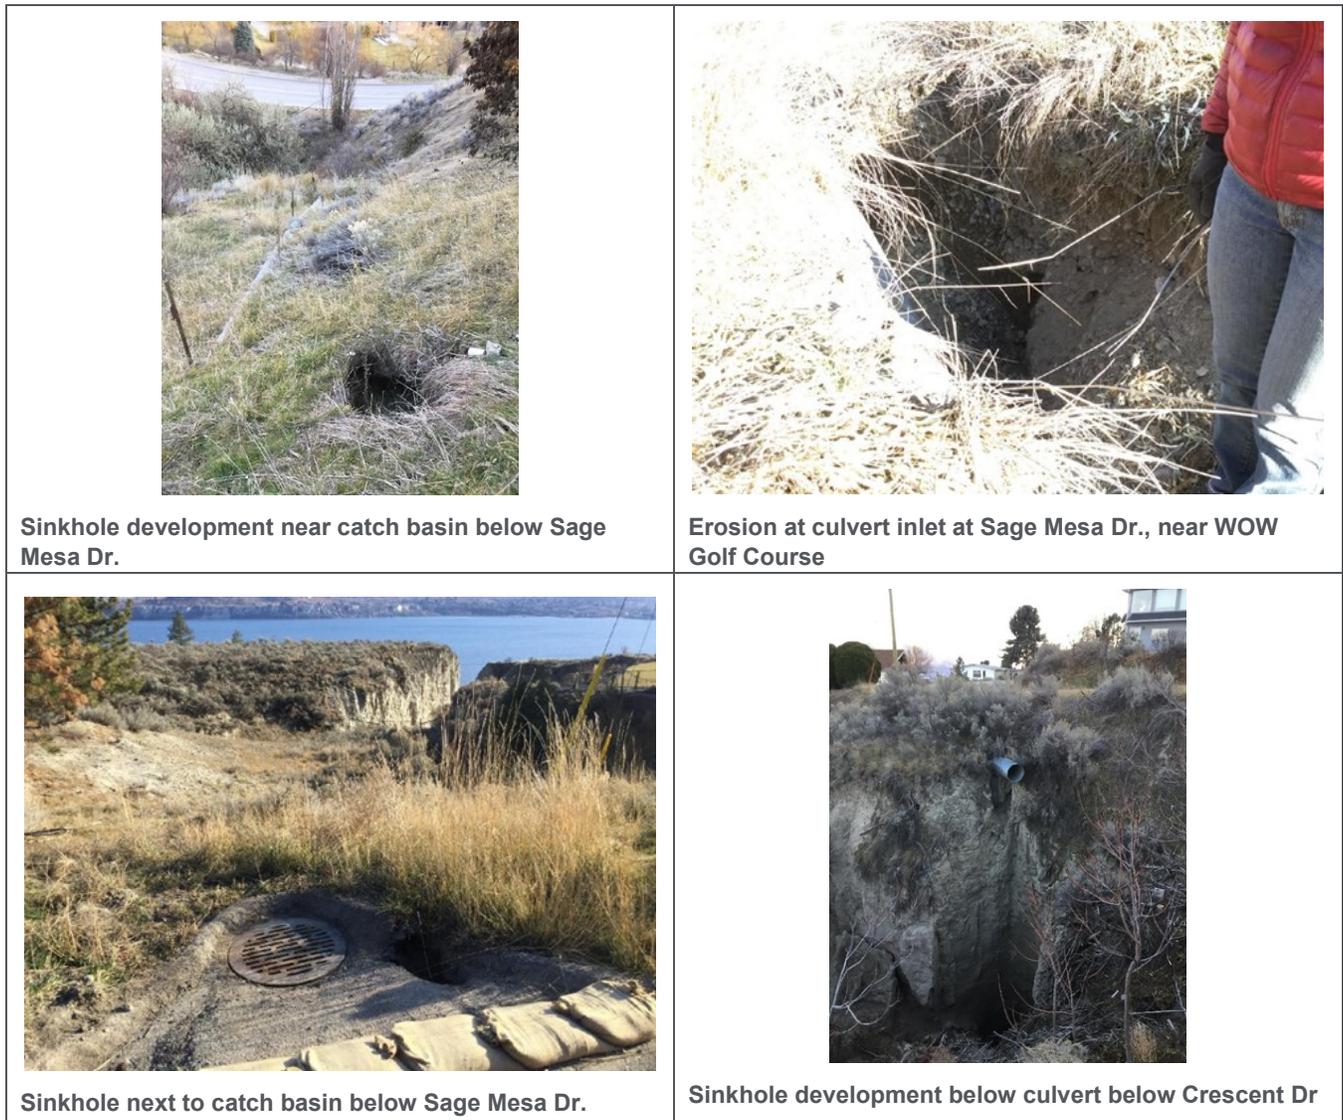
During the field review, several instances of soil erosion (i.e., piping) were observed and considered to be associated with storm drainage. Figure 4.3.a shows photographs of several examples of sinkhole development and erosion.

Figure 4.3.a Photographs of Example Sinkholes and Erosion Features Associated with Stormwater Management in the GWB Study Area

There is a clear connection between concentrated stormwater runoff and soil stability issues. As a result, further investigation of existing erosion issues is required, and development of an integrated Stormwater Management Plan (SWMP) for the area is recommended.

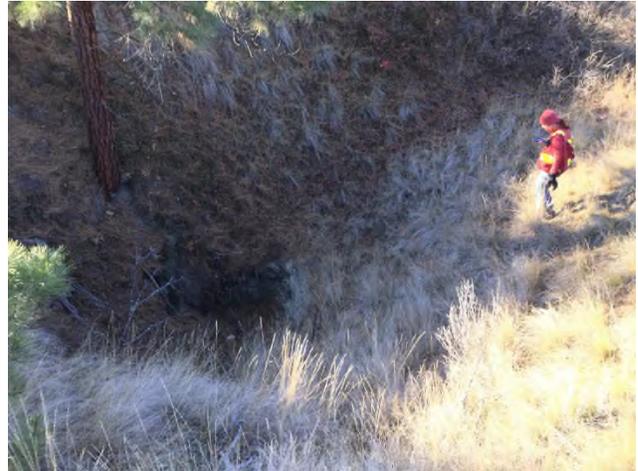
Photo 2 Large (pre-existing) sinkhole in Sage Mesa area

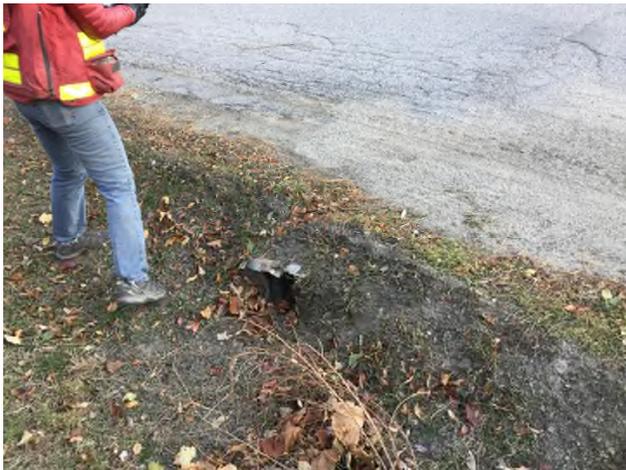
Photo 3 Damaged culvert inlet (Sage Mesa)

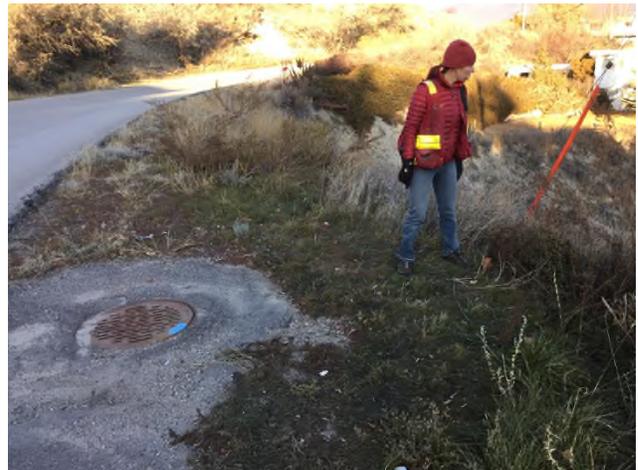
Photo 4 Catch basin above Sage Mesa Road at top of steep embankment (showing signs of instability)

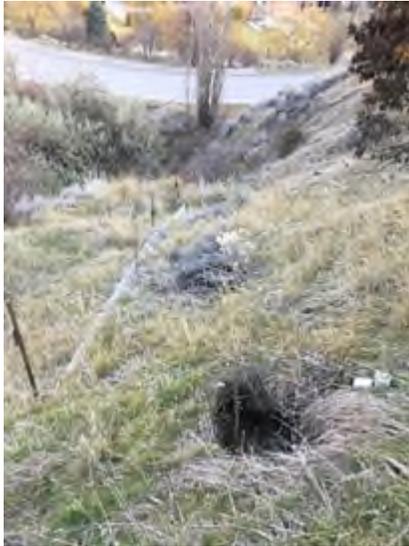
Photo 5 Sinkhole and tension crack near catch basin (see Photo 4)

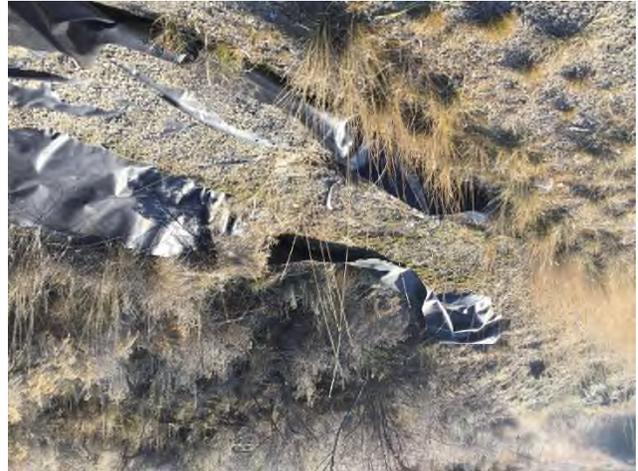
Photo 6 Ditch line maintenance measures in disrepair, on Sage Mesa Rd above WOW Golf Course

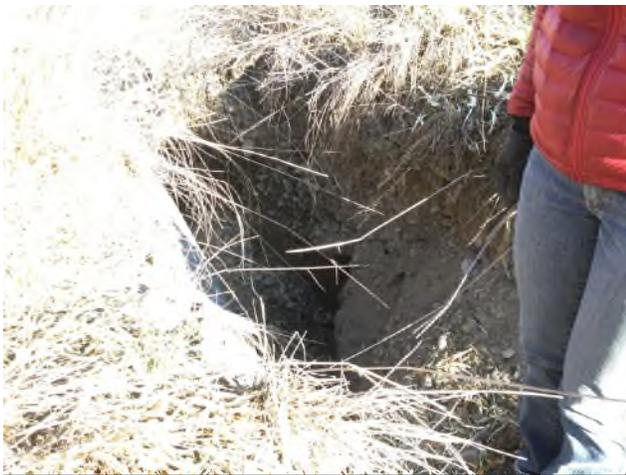
Photo 7 Erosion at Culvert Inlet at Sage Mesa Rd crossing (near WOW GC)

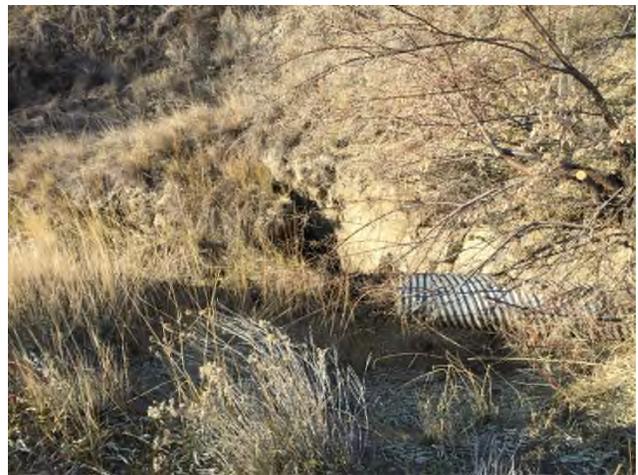
Photo 8 Erosion at culvert outlet at Sage Mesa Rd crossing (near WOW GC)

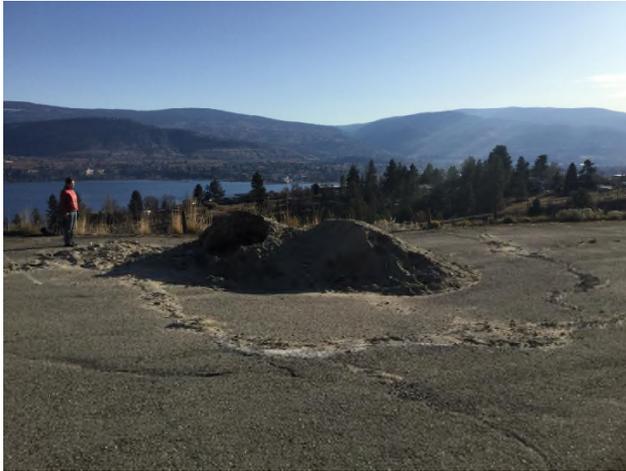
Photo 9 Large sinkhole forming in parking lot (WOW GC)

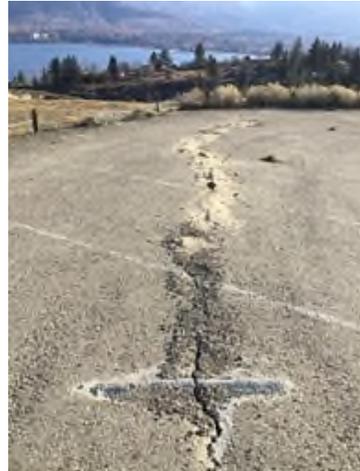
Photo 10 Pavement cracking at WOW GC

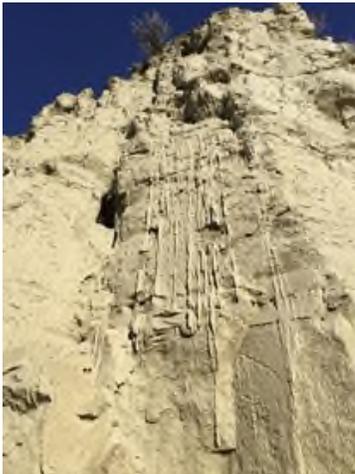
Photo 11 Silt Bluff at north end of study area – showing “wax like” flow of saturated silt

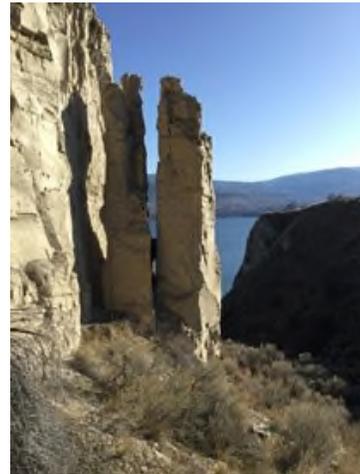
Photo 12 Vertical jointing in silt bluffs and high degree of stability when dry

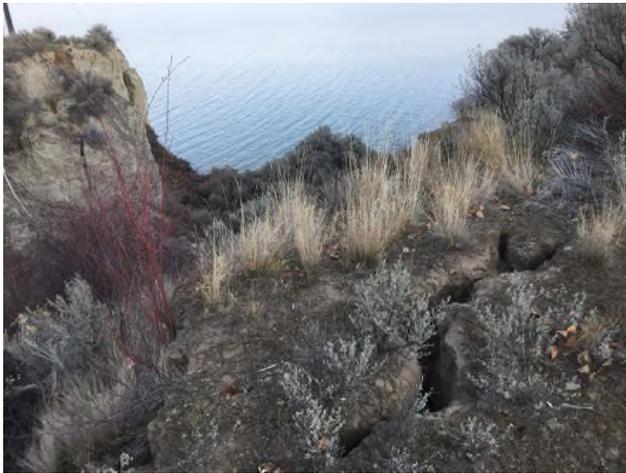
Photo 13 Tension crack at gully edge (Sage Mesa)

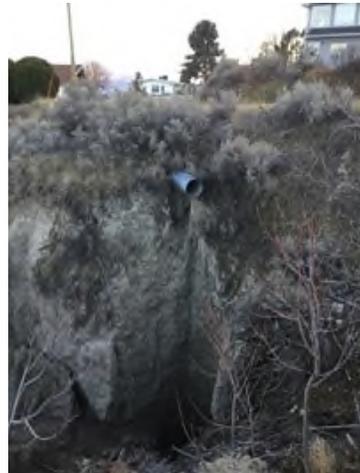
Photo 14 Massive sinkhole at culvert outlet (adj to Photo 13 Sage Mesa)

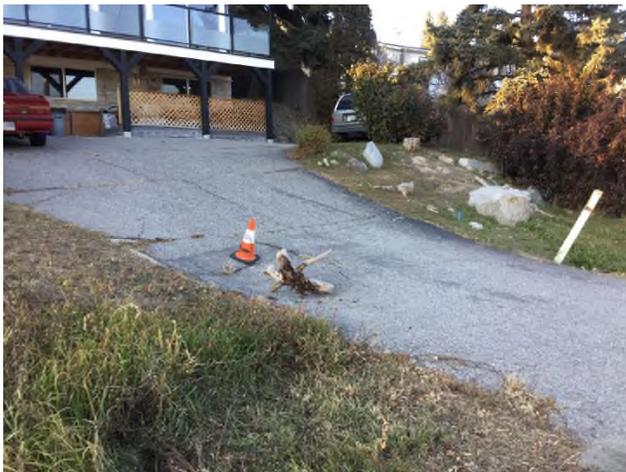
Photo 15 Small sinkhole in driveway (Sage Mesa)

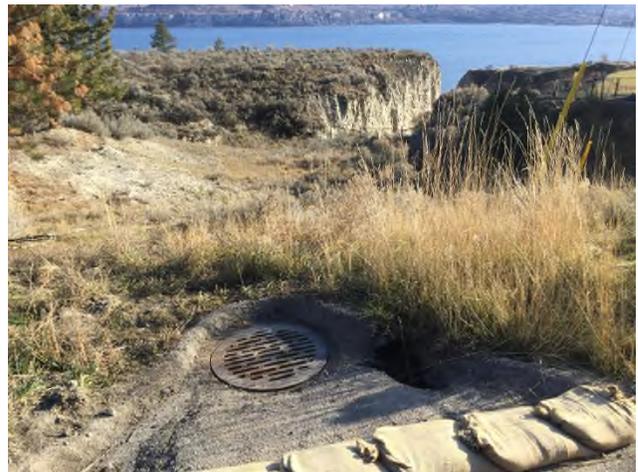
Photo 16 Sinkhole next to catch basin, with sandbags blocking runoff

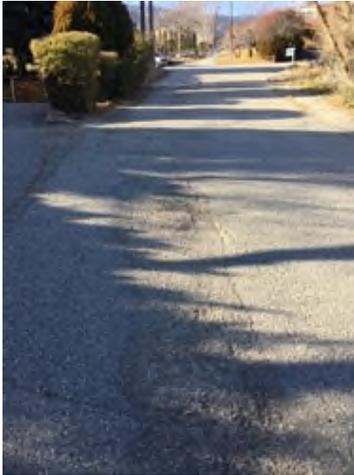
Photo 17 Depressions in road (end of Duchess Dr)

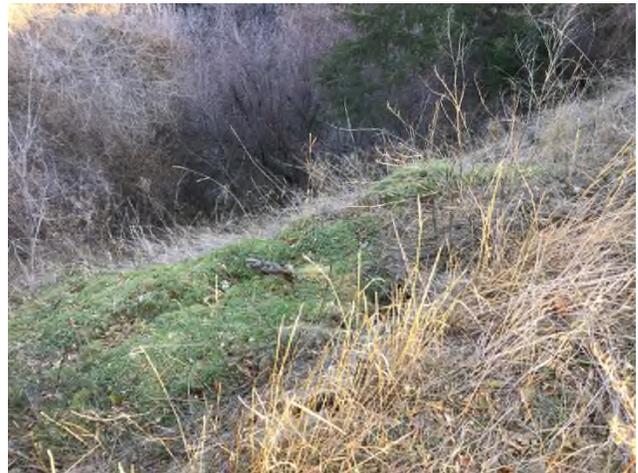
Photo 20 Tension cracks and landslide activity along crest of gully (Newton Dr and Duchess Dr.)

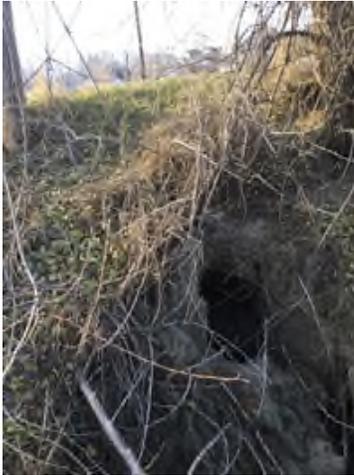
Photo 21 Sinkholes at gully crest (Newton Dr and Duchess Dr)

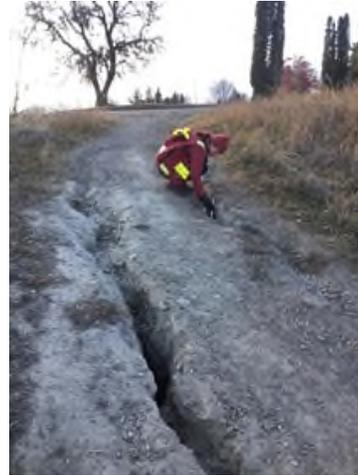
Photo 22 Subsurface erosion and deep cavity on access to KVR at Newton Road

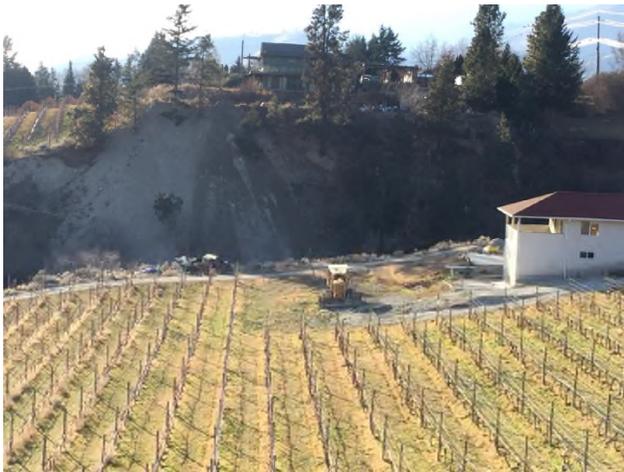
Photo 23 Fill dumping and shallow instability along gully slope (end of Moorpark Dr.)

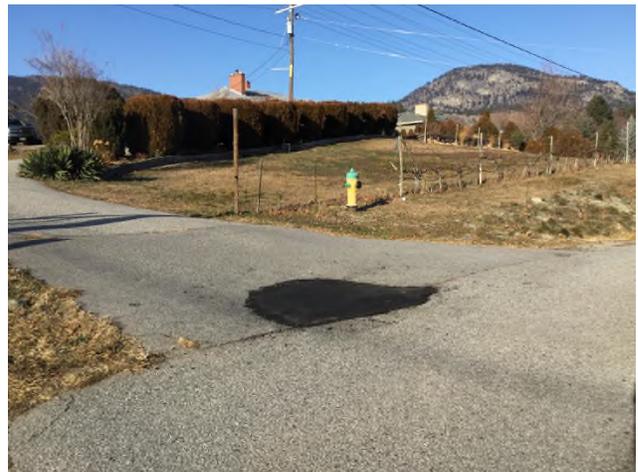
Photo 24 Recent (2019) sinkhole repair due to leaking water valve (Sparton Road)

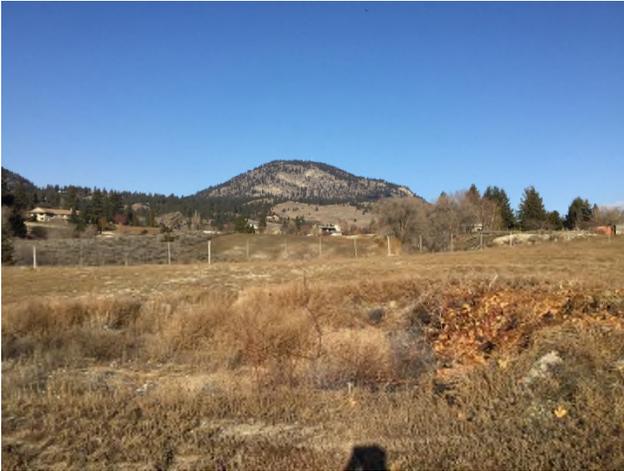
Photo 25 Partly infilled sinkhole on private property (off Sparton Road)

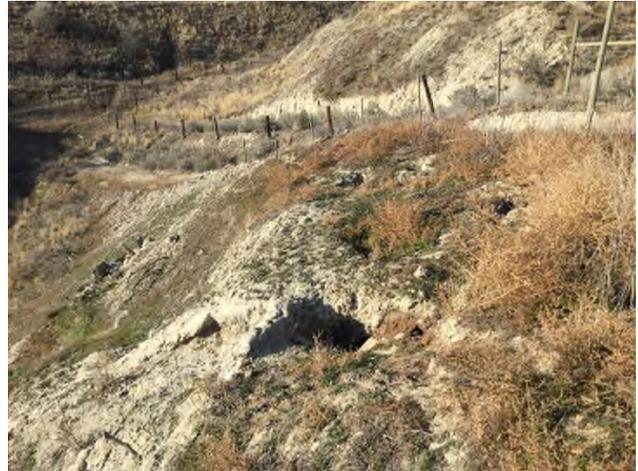
Photo 26 Sinkhole visible within gully (off Sparton Road)
