Elinor Lake North Dam 2020 Dam Safety Review Report

For Regional District of Okanagan-Similkameen

February 25, 2021

H362819-00000-228-230-0003

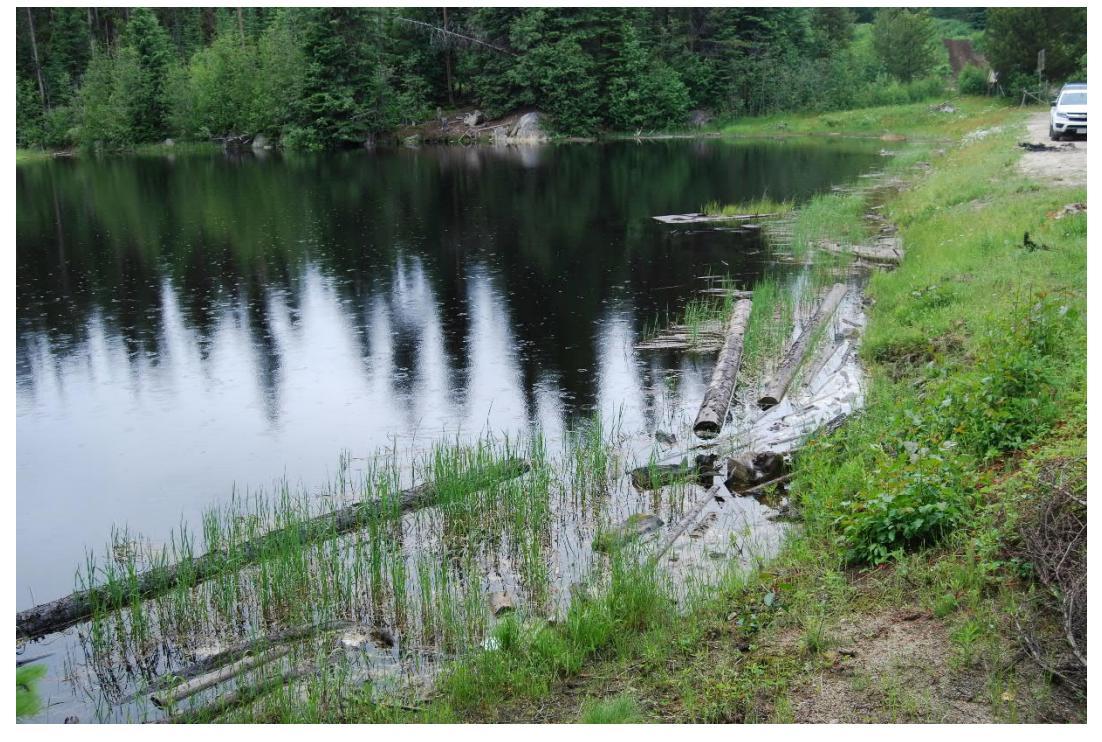
Photo A1: Elinor Lake North Dam Upstream Slope, Looking from Right Abutment

The upstream face of the dam is comprised of sand and gravel with no riprap. Minor vegetation growth was observed on the upstream slope which was comprised of grass and short bushes (see Photos A1 and A2).

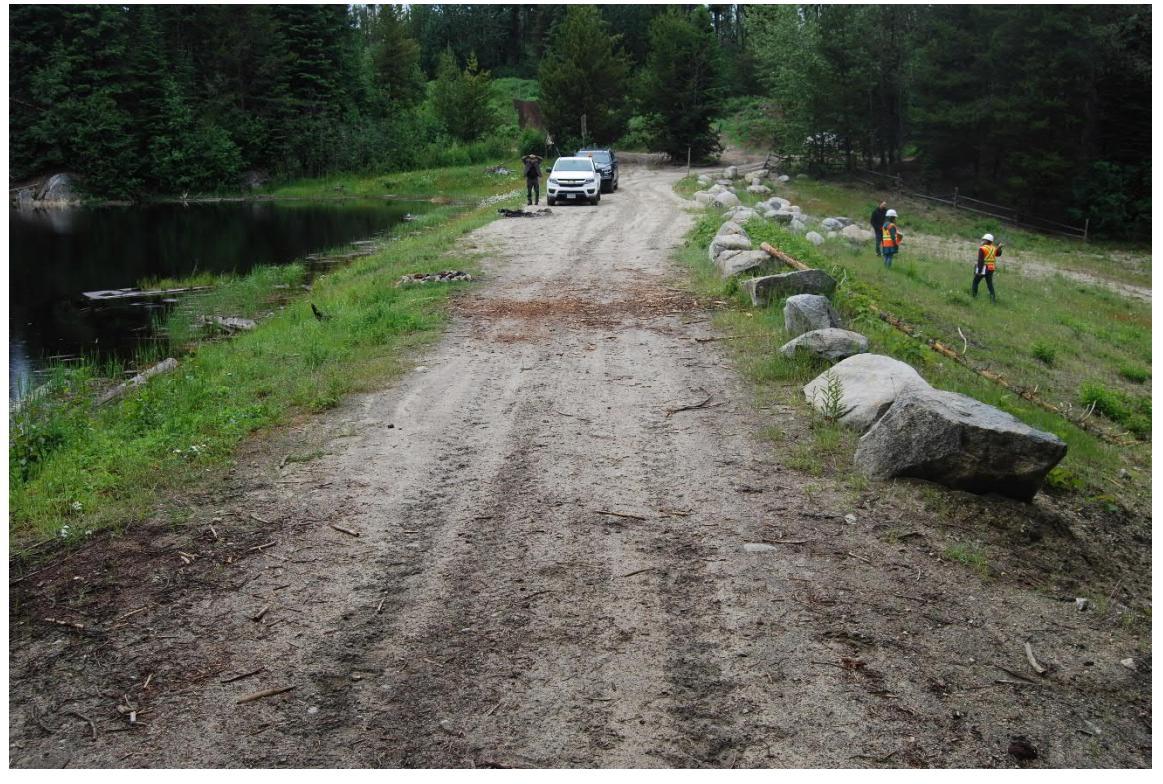
Photo A3: Elinor Lake North Dam Crest, looking from Right Abutment

The crest itself is frequented by recreational ATV traffic. Significant rutting of the crest was observed due to this traffic.

The crest of the Elinor North Dam is a publicly accessible road and was observed to be in fair condition. No sign of distress, crack, or significant erosion could be found in the road. The crest of the dam appeared to be relatively lower in elevation in areas in the middle of the dam as indicated by 2012 topographical survey. The dam crest is at El. 1277.31 m close to the middle of the dam and gradually rises to higher elevations towards the abutments.

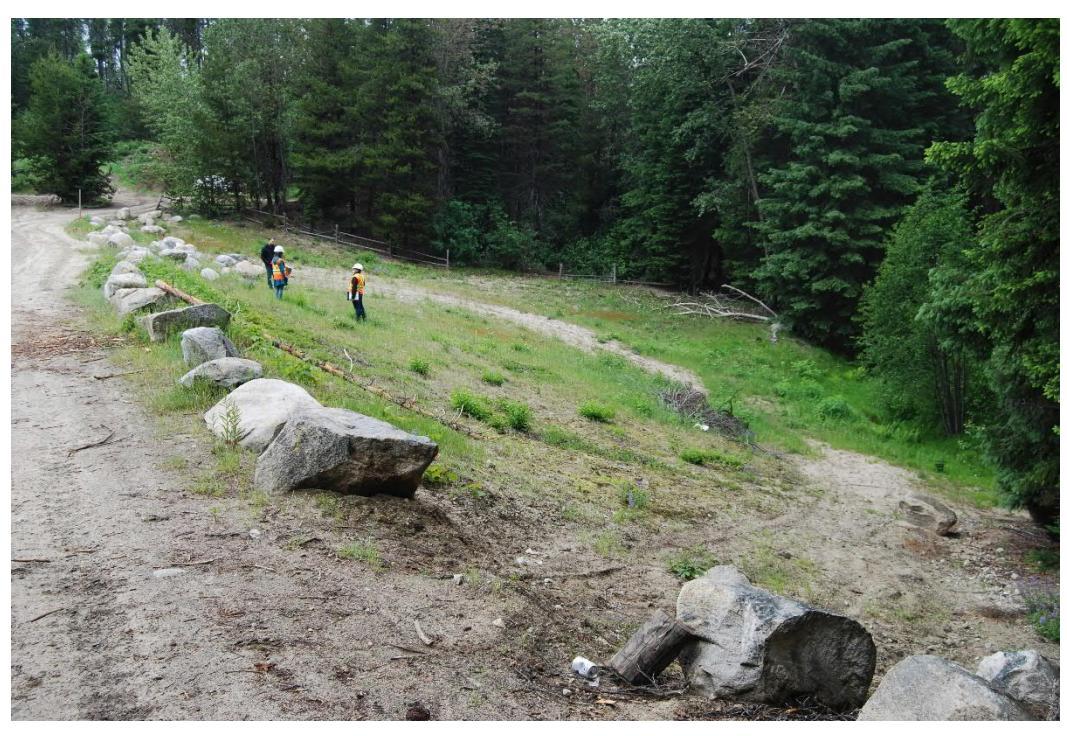
Photo A4: Elinor Lake North Dam Downstream Slope, looking from Right Abutment

The downstream face of the embankment was found to be used commonly by ATVs with some signs of rutting and erosion. Large boulders were observed laying on the downstream slope, possibly intended to prevent ATV access to the site.

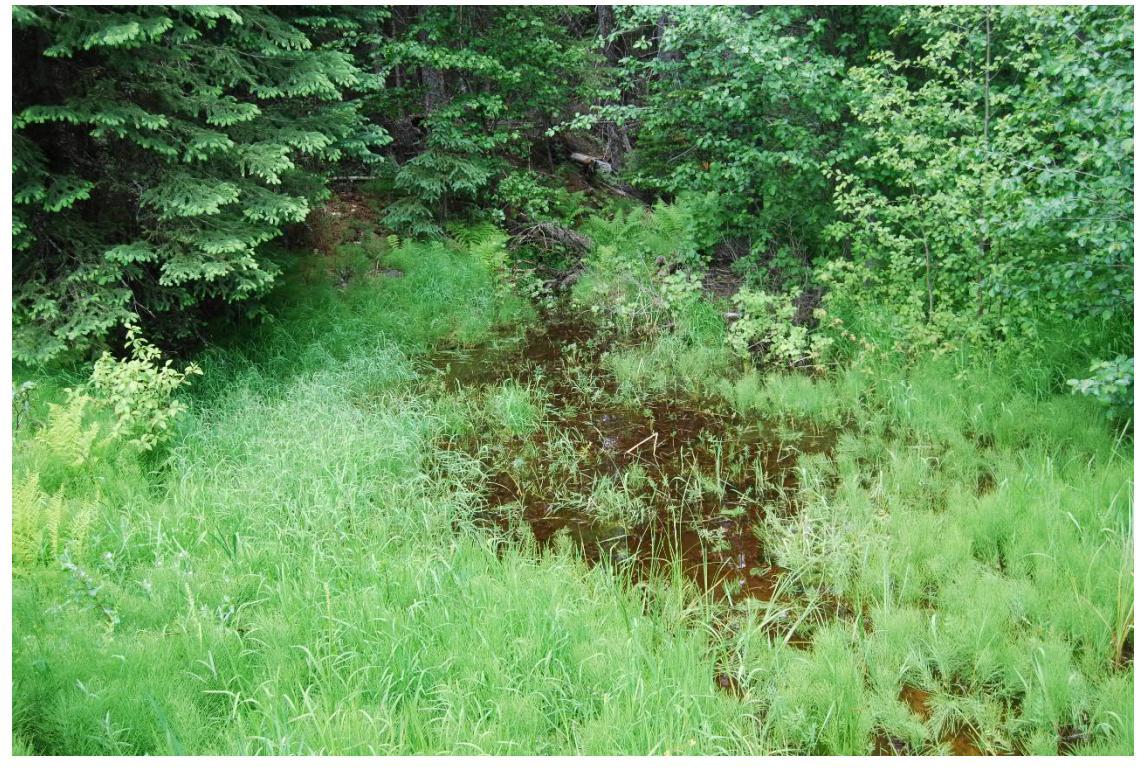
Photo A7: Elinor Lake North Dam, Downstream Toe Area Pond

A small wet area was found at the toe of the embankment which was covered with dense vegetation and trees (see Photos A7 to A9). The downstream toe area should be cleared of trees and shrubs for continuous inspection for seepage, piping, boiling, and turbidity. This is also prudent to keep downstream vegetation small in order to avoid the potential for root growth to cause a preferential seepage paths to develop.

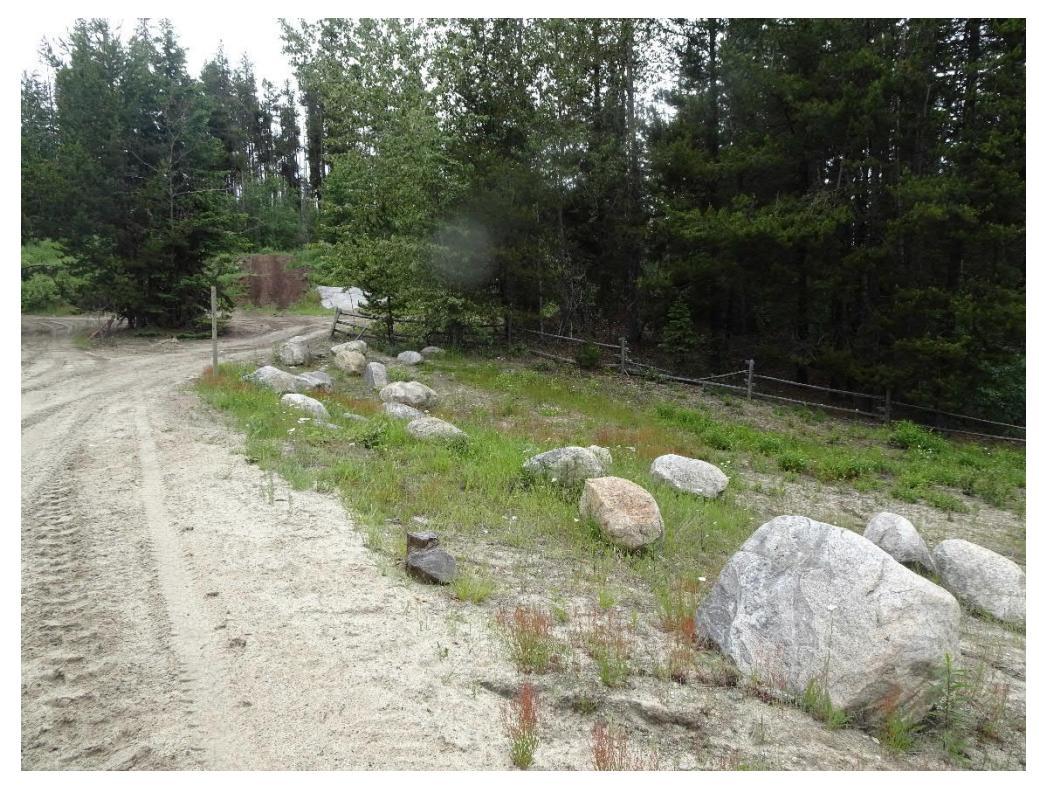
Photo A10: Elinor Lake North Dam, Left Abutment at the Downstream Side

The 2012 survey conducted by Okanagan Survey (2012) shows that the dam abuts to relatively high ground on the left and right abutments. An inspection of the dam abutments reveled no sign of distress, failure, or instability (see Photo A10 and A11). EBA (2010) noted bedrock on the right abutment, on the upstream side of the dam. Bedrock could be found on the right side as in existing site photos or site inspection.
