Kaleden Hotel

Statement of Significance

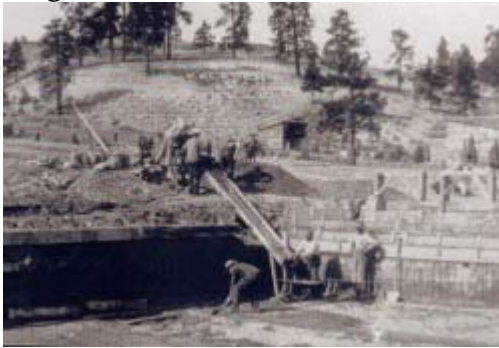
Early Stages of Construction

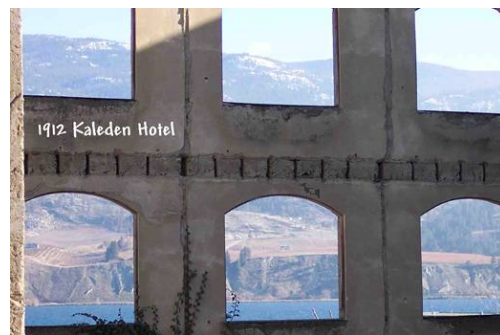
Submitted Photo, looking through the hotel shell towards Skaha Lake.

The concrete “shell” is all that remains and may be viewed as an “Exoskeleton”; it is believed that in its original condition there was an internal timber construction which existed almost as a separate weatherproof building within the concrete outer shell.
