2265 NARAMATA ROAD, NARAMATA

ENVIRONMENTAL ASSESSMENT

Ecoscape Environmental Consultants Ltd.
#102 – 450 Neave Court
Kelowna, B.C.
V1W 3A1

File No. 21-3948

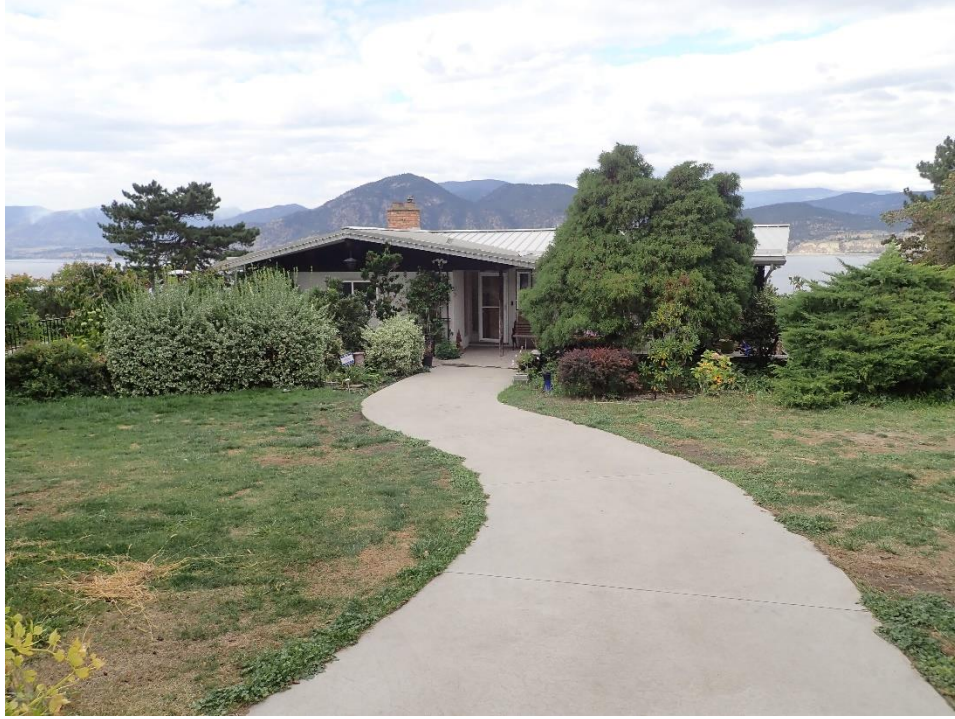
Photo 1. View facing west of the existing family residence. Photos 1-7 taken August 31, 2021.

The proposed works include the construction of a tram southwest of the existing residence from the edge of the orchard to the beach area adjacent to Okanagan Lake in order to access the foreshore from the subject property (**Photos 1 and 2; Figure 2; Appendix A**). The tram will be built at an approximate 36-degree incline followed by a 41-degree incline consistent with the existing bank grade and will be approximately 96.01 m long. The carriage dimensions will be 1.524 m by 1.219 m. The upper landing of the tram will be located southwest of the existing residence with an open track design. A few native shrubs and grasses are the only vegetation throughout the path of the proposed tram other than the invasive tree of heaven (*Ailanthus altissima*) located at the lower landing of the tram (See Section 6.0; **Photo 3**). The upper landing of the tram is located at the edge of the orchard in the backyard, bordering the northern boundary of the property, with a proposed new deck extending to the rear entry of the upper landing of the tram (**Photo 4**). The proposed lower landing of the tram will be approximately 3.0 m² and a small set of five stairs will extend from the side exit of the lower landing down to the beach area (**Photo 5**). The entirety of the tram will be constructed above the high-water level (HWL) of Okanagan Lake. The tram alignment will use a total of 16 sets of screw piles all spaced approximately equidistant. The shear frame of the tram will be anchored to a newly poured concrete block (**Appendix A**). A

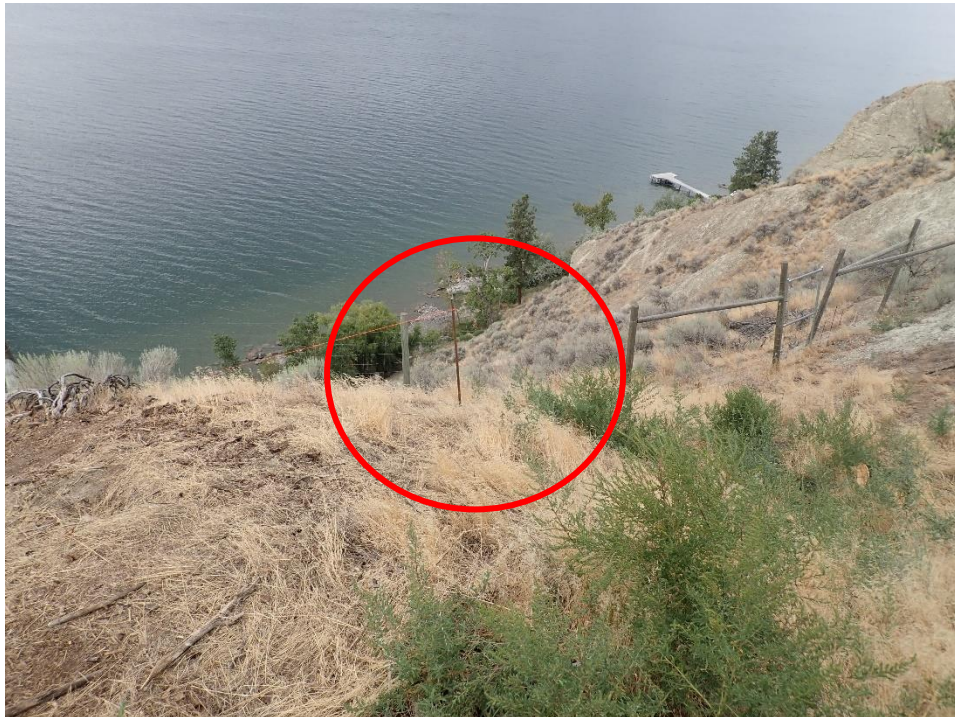
Photo 2. View facing northwest of the corner of the existing orchard where the proposed upper landing platform of the tram will be installed (represented by the red circle).

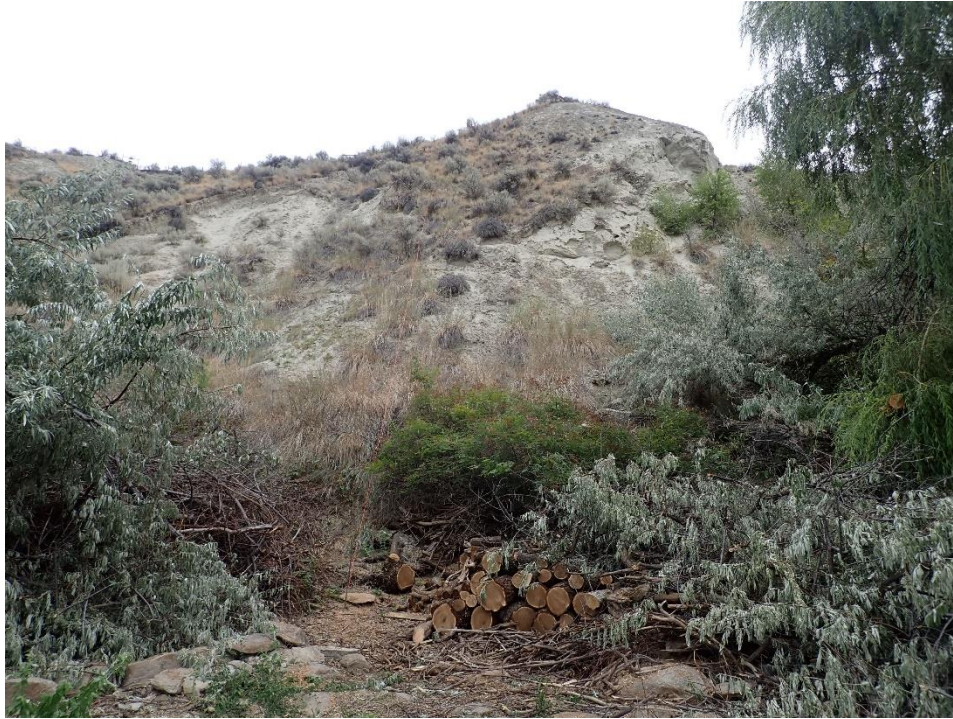
Photo 3. View of invasive species located to the south of the proposed tram.

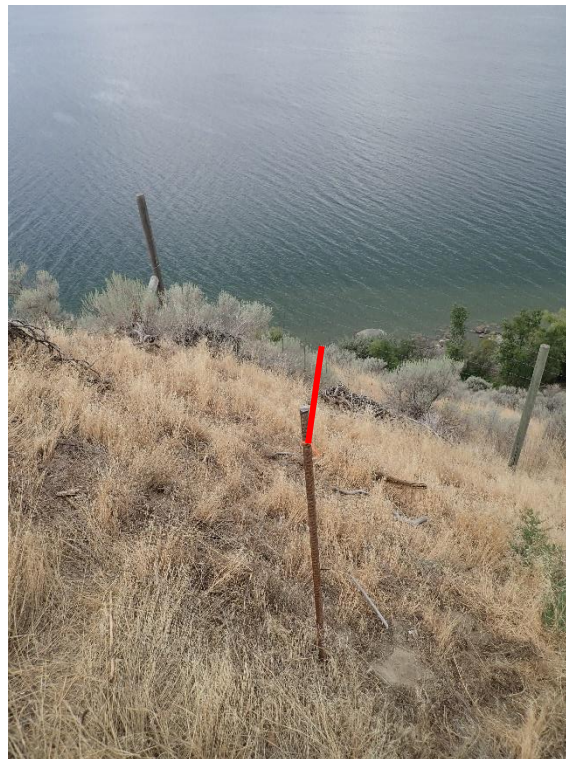
Photo 4. View facing southwest of the approximate tram location (represented with a red line) looking down towards Okanagan Lake.

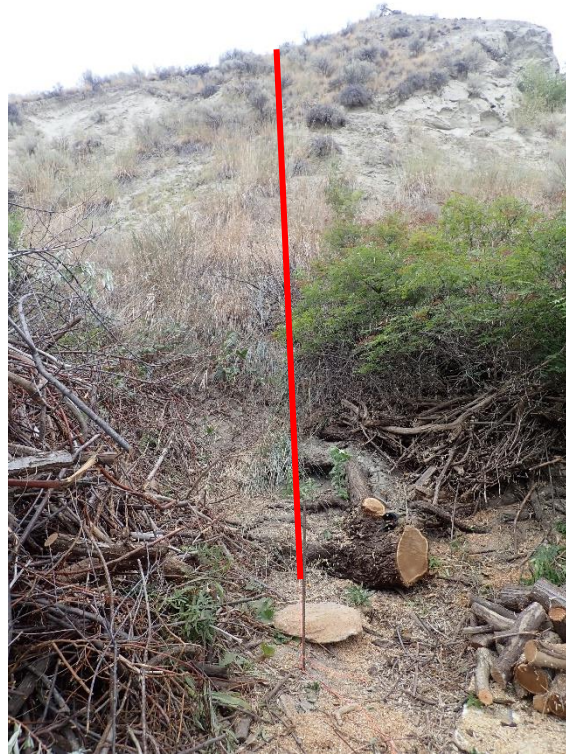
Photo 5. View facing northeast of proposed tram location (represented with red line) looking up towards the residence.

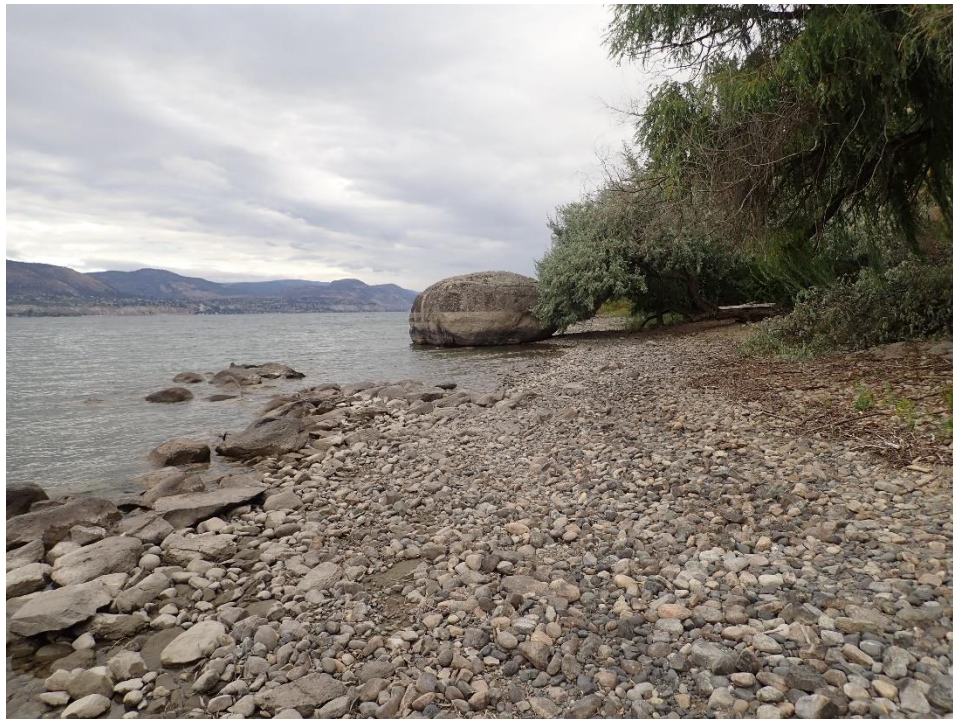
Photo 6. View of existing foreshore area.

The subject property occurs within an agricultural area along the eastern shoreline of Okanagan Lake and contains an existing single-family dwelling. The subject property is bounded by Okanagan Lake to the west, residential properties to the north and south, and Naramata Rd to the east. A dirt path provides crossing over to the neighbor's property, which provides foreshore access down the hill to the beach area (**Photos 6**).

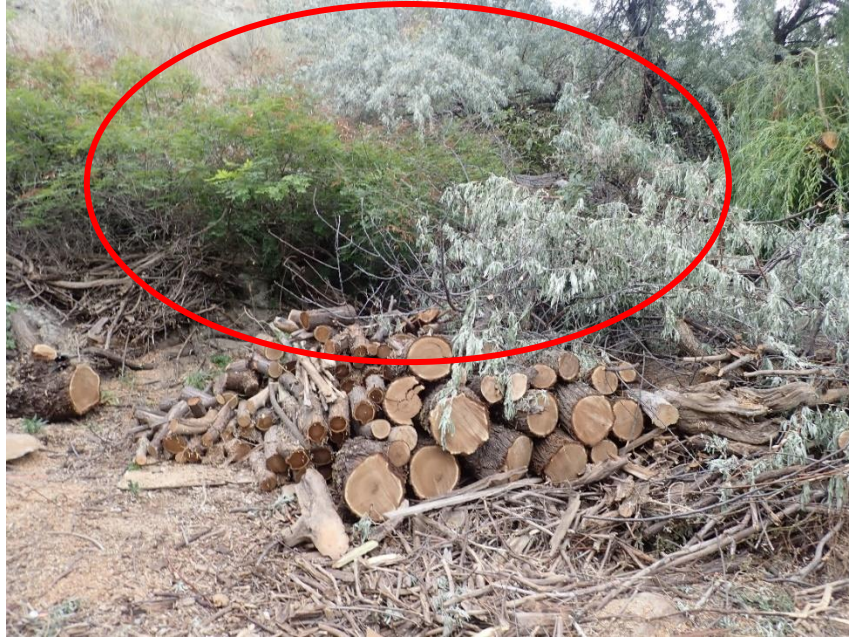
Photo 7. View of invasive tree of heaven and Russian olive (circled in red) and wood stockpiles and cleared debris on the beach area.

- Non-native tree of heaven and Russian olive was found near the proposed lower landing of the tram within the subject property (**Photo 7**). Ecoscape recommends that the tree of heaven and Russian olive be removed by hand, and the disturbed area be replanted with native plantings such as big sagebrush (*Artemisia tridentata*) and hydroseeded with grass seed mix (see Section 6.8 below); and,

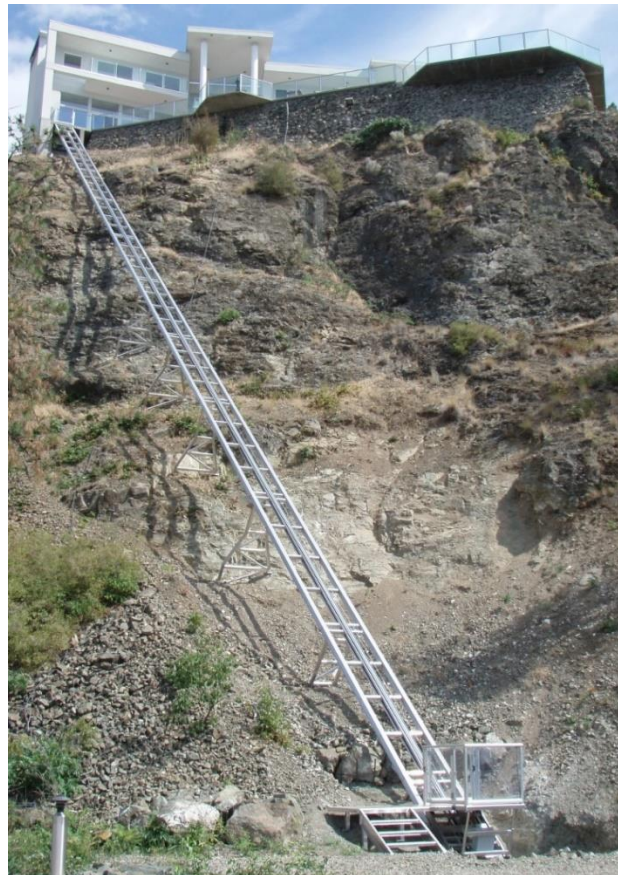
Photo 8. View of example tram to illustrate how it hovers over the landscape and the minimal permanent footprint associated with the helical screws.

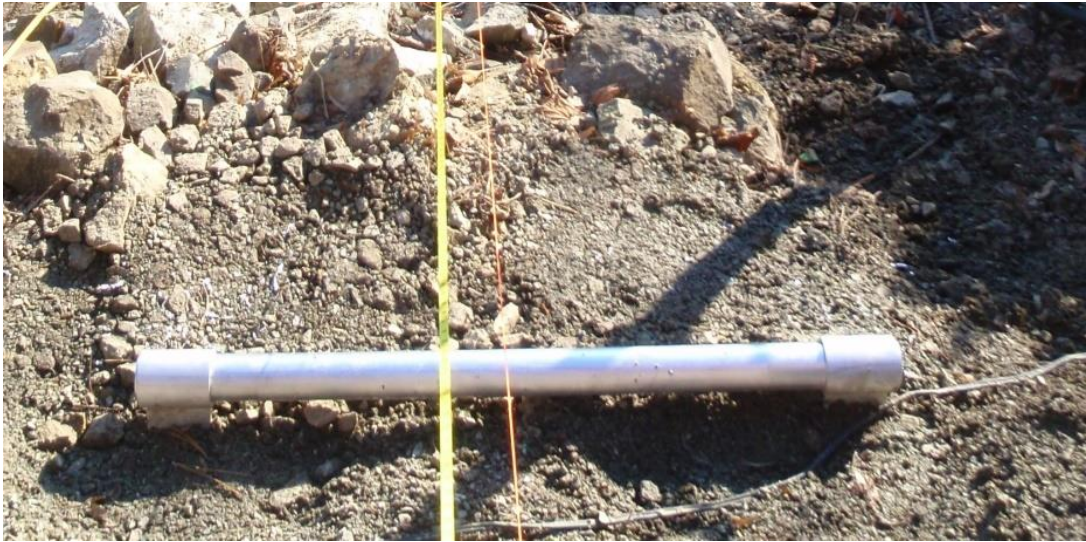
Photo 9. View of a helical screw pile.

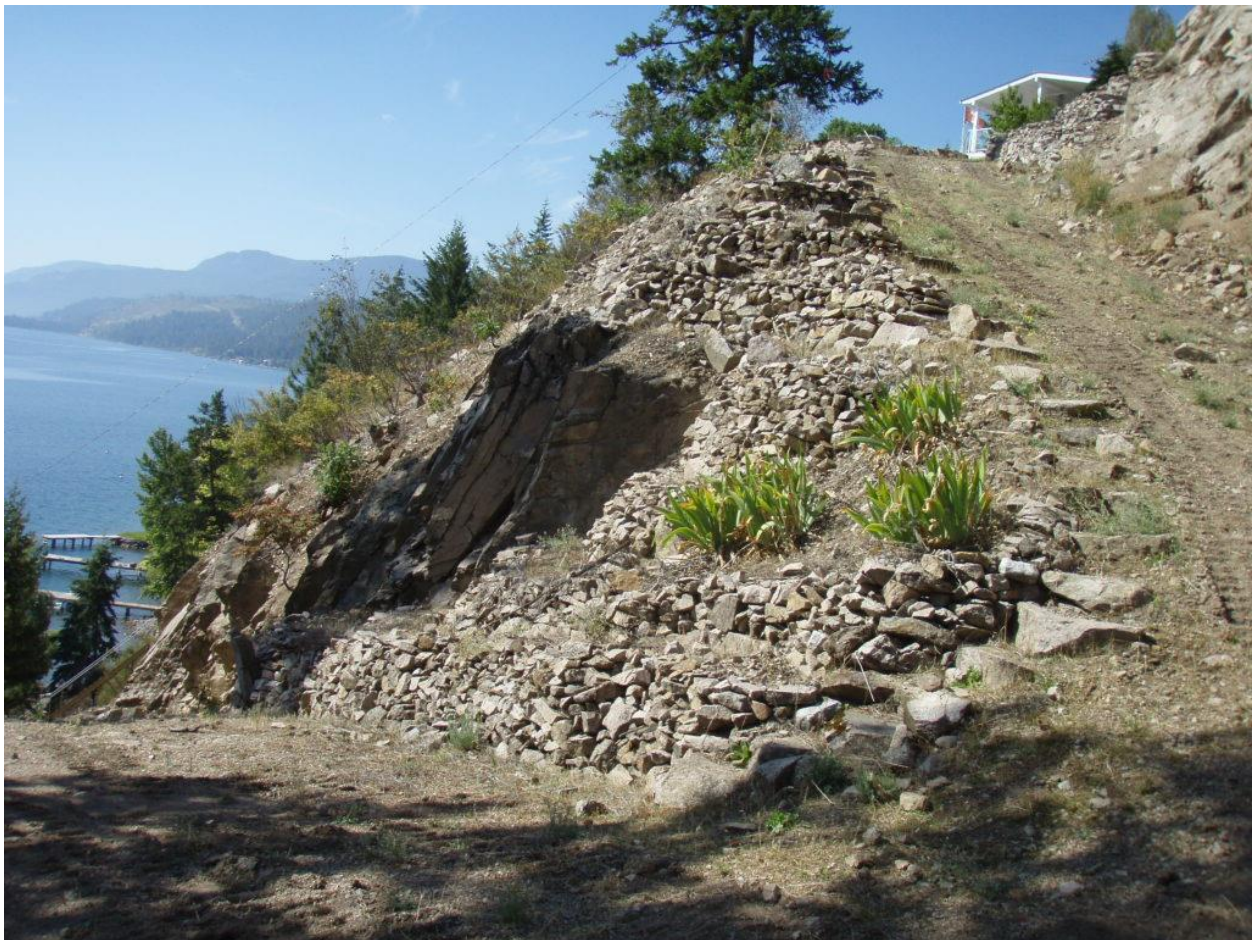
Photo 10. View of example trail/road to illustrate how extensive cuts and fills and switchback can severely alter the landscape in order to achieve the required grades.

constructing a tram down a steep slope. If an unstable slope were to fail into the lake from constructing a trail, it would almost certainly result in a HADD due to infilling of the lake.

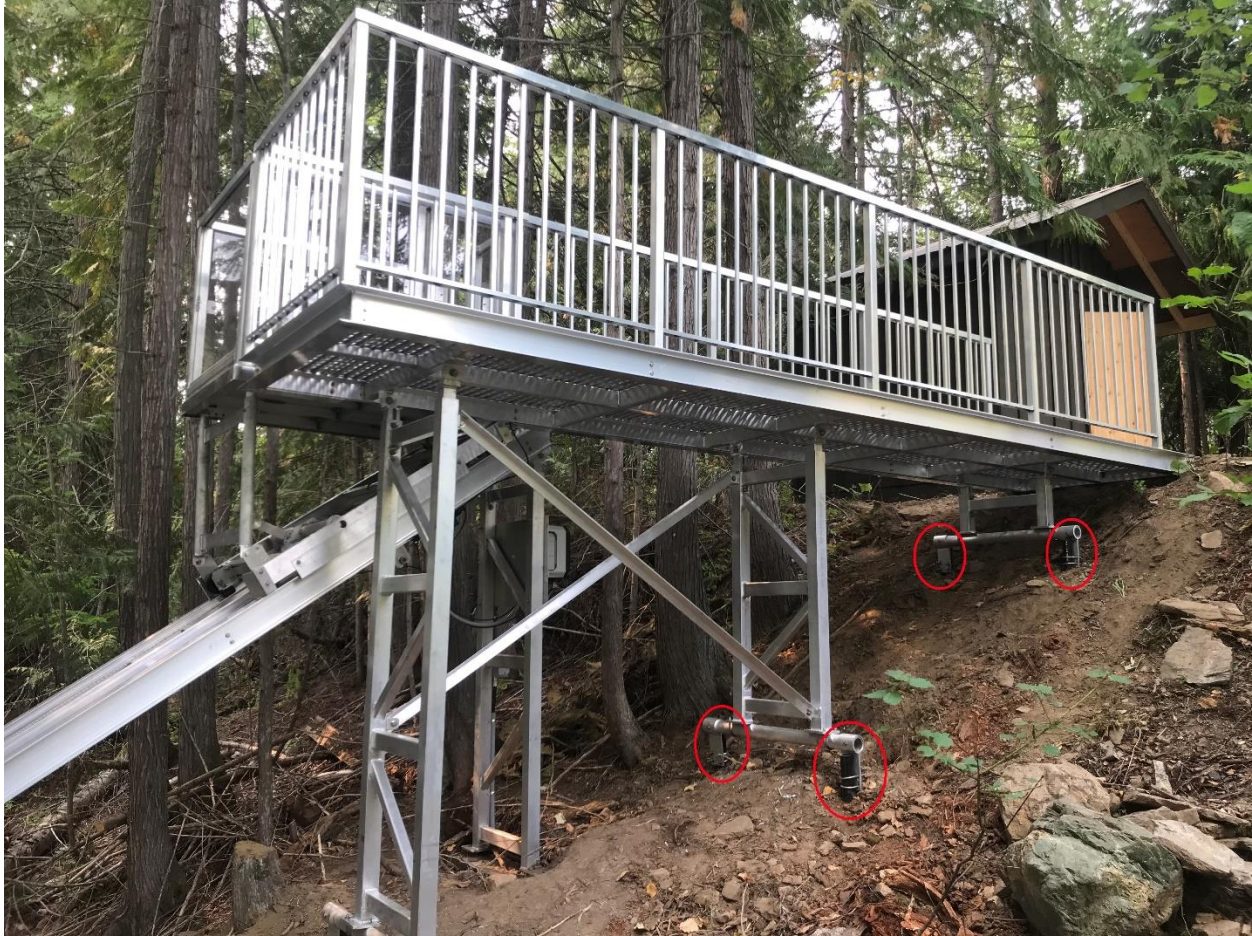
Photo 11. View of a tower bracket on two piles and their minimal permanent footprint.

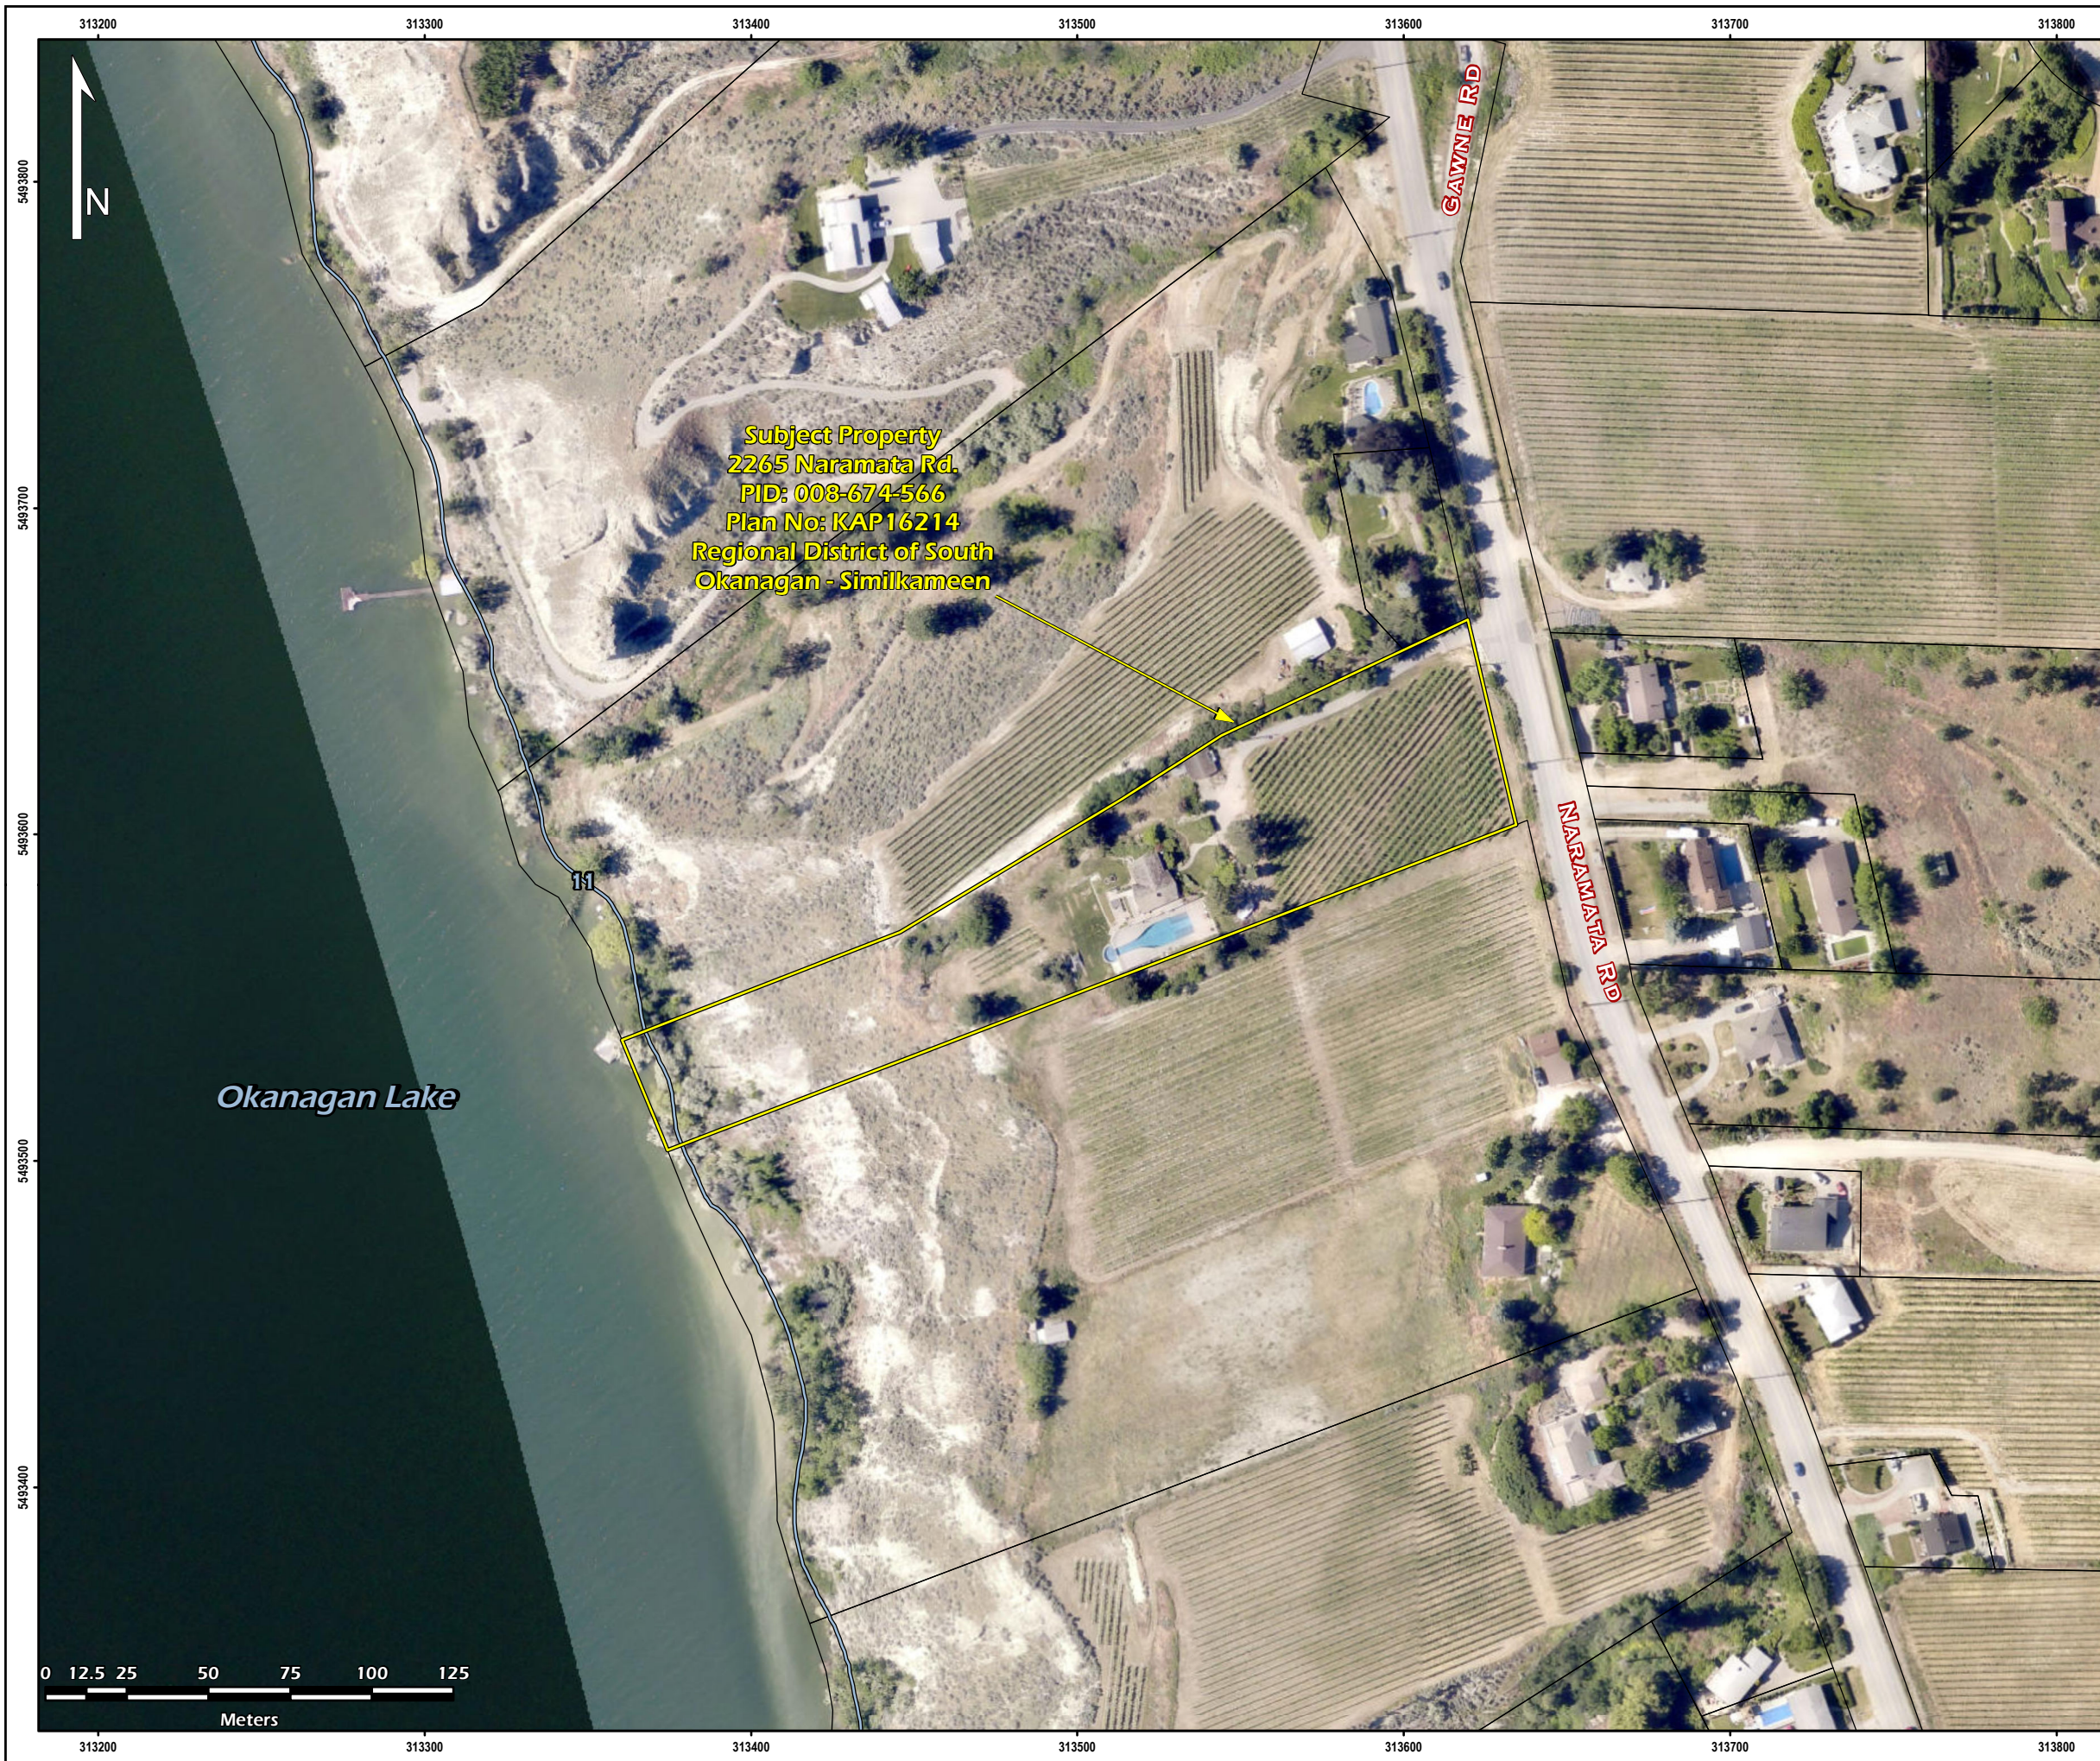
FIGURE 1
 Site Location and Fisheries Information

Subject Property
 2265 Naramata Rd.
 PID: 008-674-566
 Plan No: KAP16214
 Regional District of South
 Okanagan - Similkameen

The subject property occurs along Okanagan Lake Foreshore Inventory and Mapping (FIM) Segment 11 (**Figure 1**), which is described as rural with a medium level of impact (10-40%) and 11% of the shoreline disturbed (Schleppe, 2010). The shore type of the approximately 3,407 km segment is described as having a cliff/bluff shore type composed of 30% gravel, 25% bedrock, 20% cobble, 15% boulder, and 10% sand with a medium (25-75%) level of embeddedness.

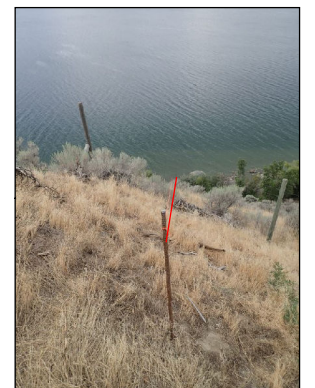
Photo 1: Start of Tram looking down towards Okanagan Lake

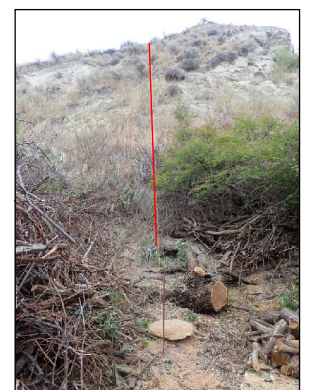
Photo 2: End of Tram Looking Up
