Project No: RGC-3832

February 6, 2025

**Subject: Preliminary Geotechnical Assessment for Proposed Residential House at  
2624 Forsyth Drive, West Bench, Penticton BC**

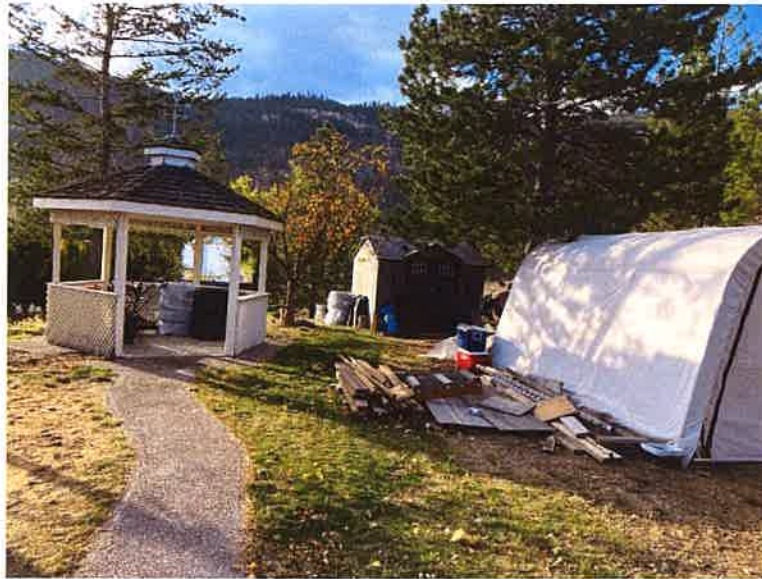
*Photo 1- Proposed Construction Area 1- Facing to the west, Photo taken Nov. 2024*

The proposed construction areas are shown on the enclosed test hole location plan, areas were traversed during our geotechnical investigation, the proposed areas are generally flat. See Photos 1 to 4. There is a benched slope on the north side of the proposed development area 1 with an access lane on a bench of the slope. The average gradient of the slope is 2 Horizontal to 1 Vertical or shallower, dipping towards the south.

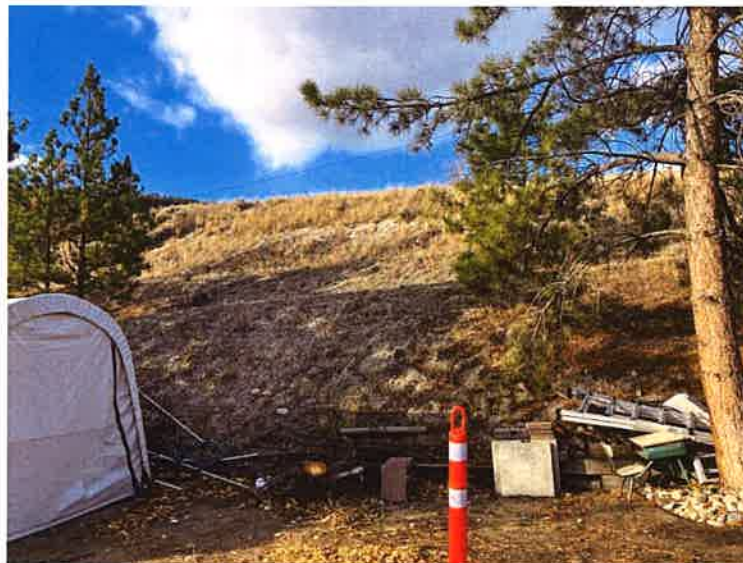
Generally, the slopes are lightly vegetated with some signs of surficial erosion on the body of the slope. No signs of slope instability were observed on the proposed construction areas.

*Photo 2- Benched Sloped to the north of  
the Proposed Construction Area 1, Photo taken Nov. 2024*

5. RGC visually assessed slope on the proposed construction areas 1 to 3 and did not note any indications of slope instability.
6. RGC concluded that there was no evidence of slope instability affecting the proposed construction areas 1 to 3.

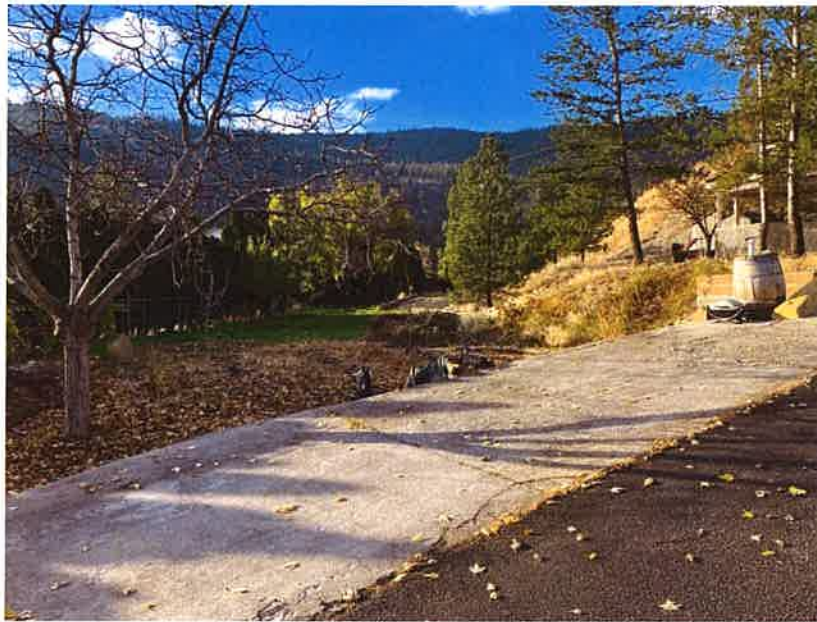
*Photo 3- Proposed Construction Area 2-  
Facing to the west-Photo taken Nov. 2024*

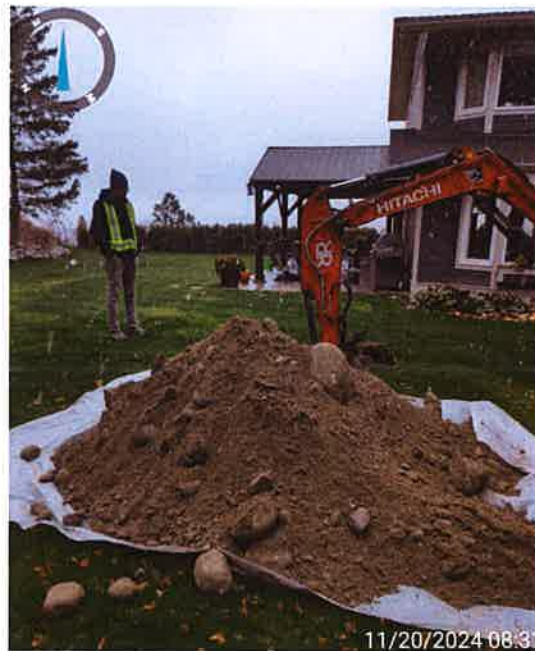
*Photo 4- Proposed Construction Area 3-  
Facing to the south-Photo taken Nov. 2024*

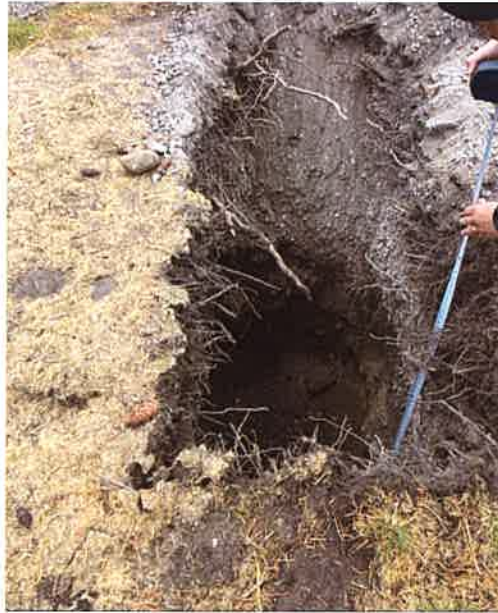
*Photo 5- Encountered Ground at TP1-  
within Proposed Construction Area 1-Photo taken Nov. 2024*

Depth	Soil Description	Sample	Test
0 - 0.4 m 0 - 1 ft.	Topsoil, roots	-	-
0.4 - 1.2 m 1 - 4 ft.	FILL, Gravel and sand, trace silt, compact, angular to very angular, dry	-	-
1.2 - 2.0 m 4 - 7 ft.	Sandy gravel, trace cobbles, trace silt, compact, dry		
2.0 - 2.0 m 7 - 7 ft.	Test pit ends at 7 ft.

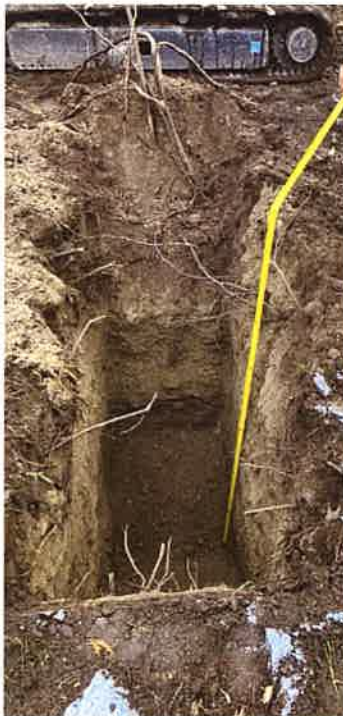
*Photo 6- Encountered Ground at TP2-  
within Proposed Construction Area 2-Photo taken Nov. 2024*

Depth	Soil Description	Sample	Test
0 - 0.2 m 0 - 1 ft.	Topsoil, roots	-	-
0.2 - 2.0 m 1 - 7 ft.	Sand, some gravel, trace cobbles, trace silt, compact, dry	-	-
3.1 - 3.1 m 10 - 10 ft.	Test pit ends at 7 ft.	-	-

Test pits were excavated in November 2024 as a part of this assessment. The soil strata encountered in test pits generally consist of topsoil underlain by sand with gravel, trace cobbles to a maximum depth of 7 ft. below the existing grade. At the location of Test Pit 2 (TP2), a layer of sand and gravel is interlayered between aforementioned strata. The test pit location plan and test pit logs are attached. No groundwater was observed at time of excavation, groundwater levels may fluctuate seasonally.

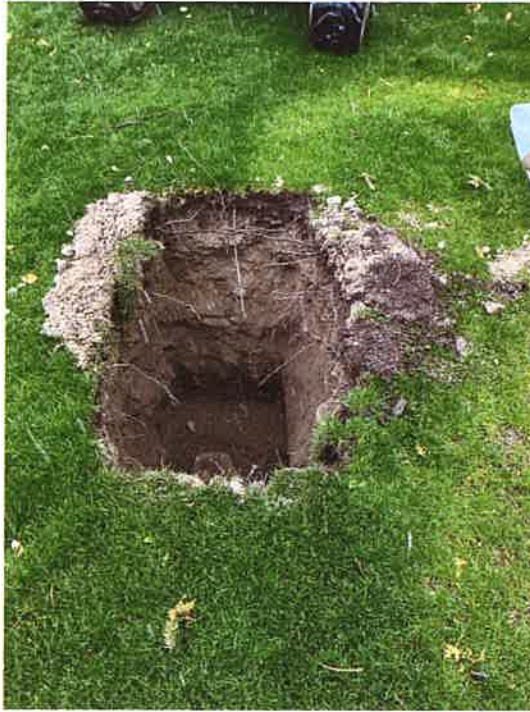
*Photo 7 Encountered Ground at TP3-  
within Proposed Construction Area 3-Photo taken Nov. 2024*

Depth	Soil Description	Sample	Test
0 - 0.2 m 0 - 1 ft.	Topsoil, roots	-	-
0.2 - 1.8 m 1 - 6 ft.	Gravelly sand, trace cobbles to boulders, trace silt, compact, dry	-	-
2.7 - 2.7 m 9 - 9 ft.	Test pit ends at 6 ft.	-	-
