Ecora File No.: 230018-02

Regional District of Okanagan-Similkameen
101 Martin Street,
Penticton, BC
V2A 5J9

Reference: Emergency Geotechnical Assessment for 3169 10th Avenue, Keremeos, BC

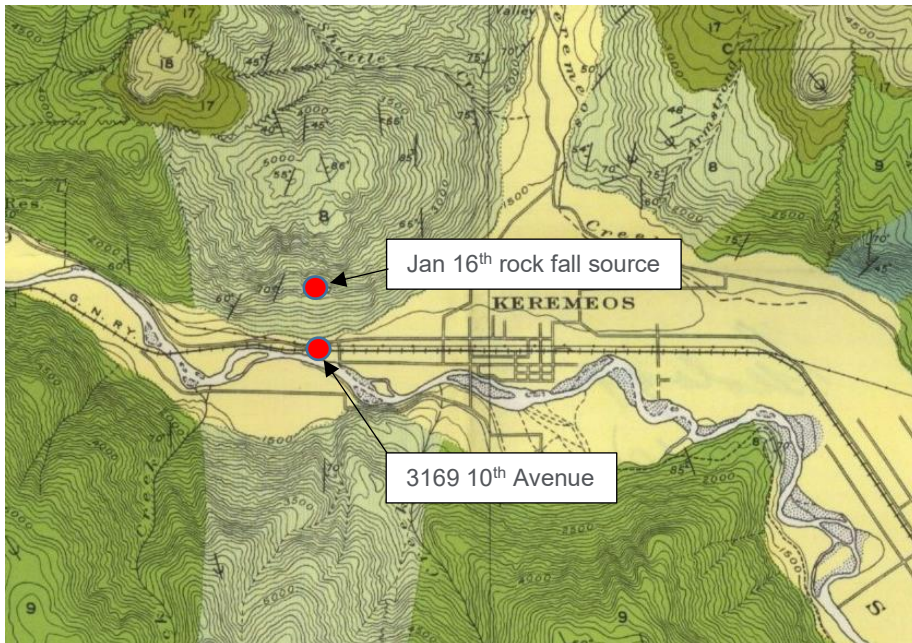
Figure 3.1: Bedrock geology of the Keremeos area.

Reference to iMapBC and the bedrock geology map “Keremeos, Similkameen District, British Columbia” indicates the bedrock geology above the site consists of chert, siliceous argillite, siliciclastic rocks, some tuff and greenstone of the Shoemaker Formation. Figure 2.1 below contains an excerpt of the referenced map with the location of the site impacted by the January 16th rock fall event and the source zone.

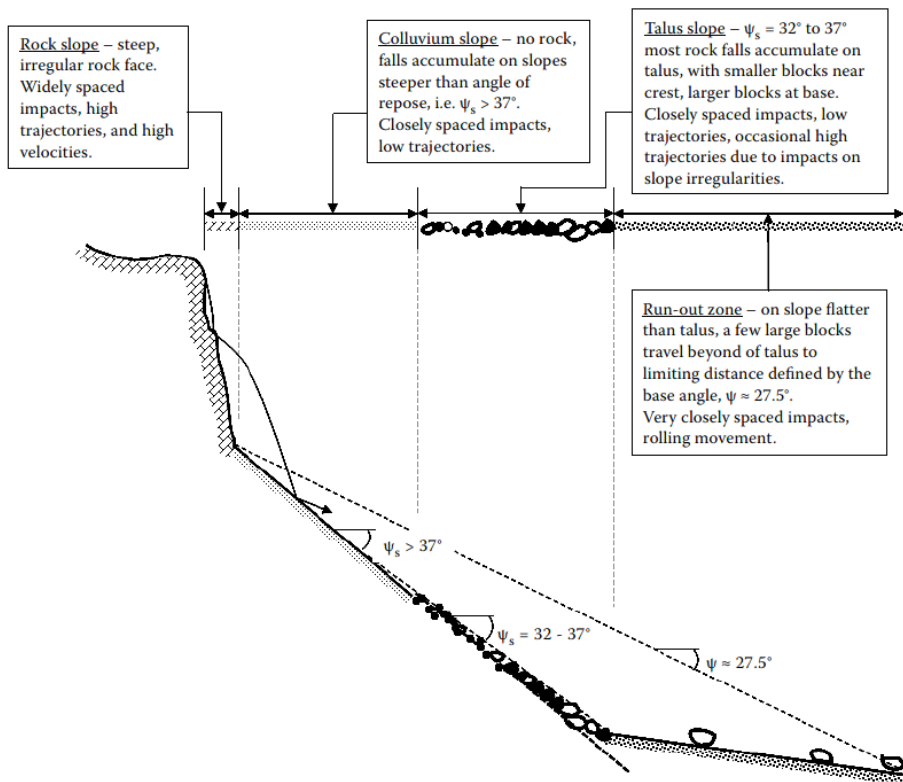
Figure 4.1 Typical rock fall slope configuration (from “Rock Fall Engineering” by Duncan C. Wyllie, 2015).

Figure 4.1 below illustrates a typical rockfall slope and run-out zone.

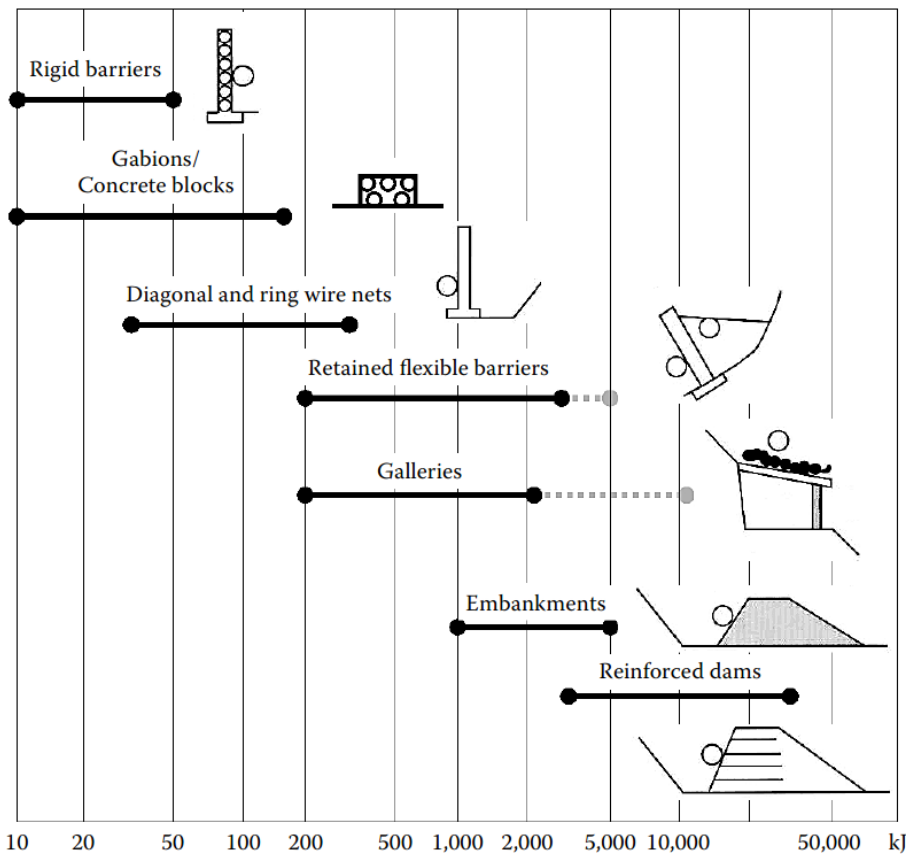
Figure 7.1: Examples of rock fall protection measures based on impact energy (from “Rock Fall Engineering” by Duncan C. Wyllie, 2015).

The likelihood of future rock fall events impacting the subject property is elevated during periods of seasonal freeze-thaw, however, the probability of recurrence exceeds current accepted criteria for exposure to geohazards and therefore permanent long-term rock fall mitigation measures would be required if the property is to be safely occupied.

These rock-fall mitigation measures could include such works as ditch and berm configuration or steel mesh barrier. The type of mitigation measure should be determined with a detailed geohazard assessment and designed by a Qualified Professional Engineer. Considering the size of the observed rock fall debris from the January 16th event, a mitigation measure will likely be substantial in size and cost. Figure 7.1 below illustrates potential mitigation measures based on their energy impact capacity.
