Elinor Lake North Dam 2020 Dam Safety Review Report

For Regional District of Okanagan-Similkameen

February 25, 2021

H362819-00000-228-230-0003

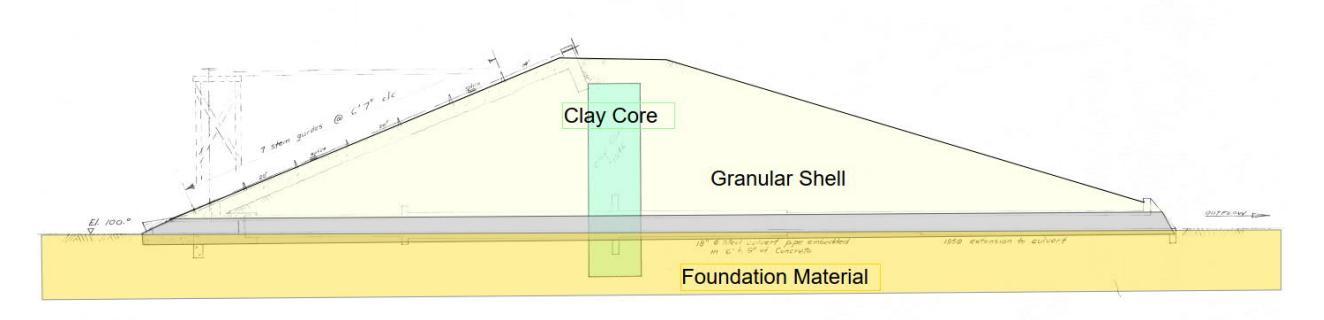
Figure 7-1: Typical Cross Section of the Elinor South Embankment Dam used for North Dam Assessment

The available construction drawings for Elinor Lake South Dam indicate that the central core of the dam is constructed with clay core materials with vertical side slopes as is illustrated in Figure 7-1. This geometry is considered non-conventional which could be due to the lack of considerable quantity of clay materials at the site. Embankment dam cores are generally constructed with inclined slopes to ensure that no core/shell separation and sliding take place and the core materials experience vertical positive stress from the shell materials.

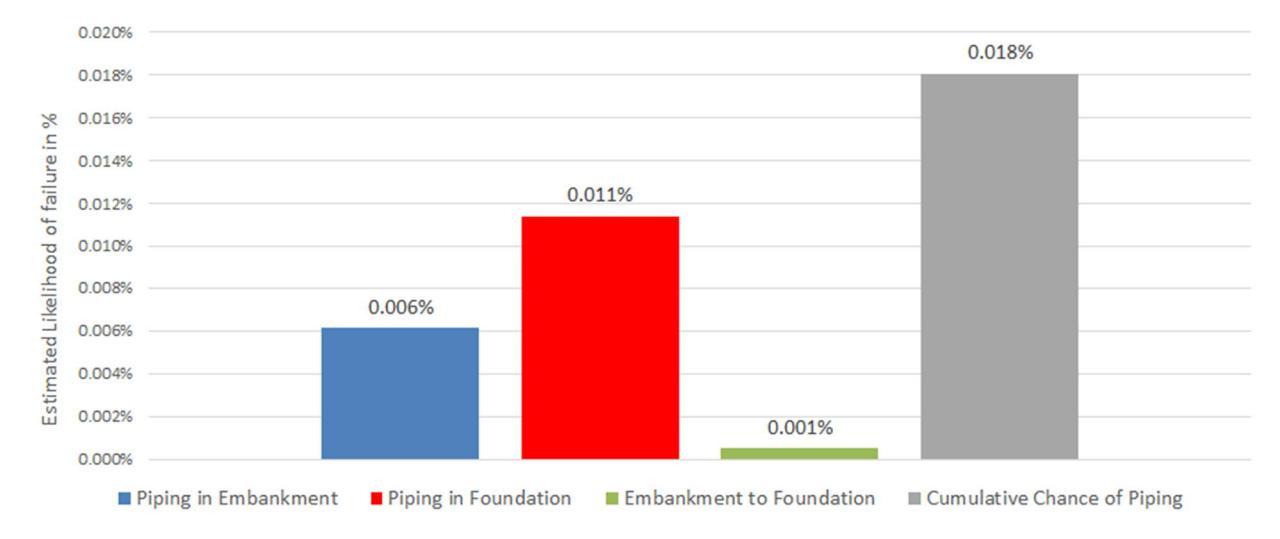
Figure 7-7: Estimated Annual Probability of Failure of the Elinor Lake North Dam Using Foster and Fell [2000]

Considering the level of information related to design and construction, despite the fact that the two (North and South) dams are different in height, the assessment performed for the North and South Elinor Lake Dams was the same. Furthermore, the piping risk of both dams should be addressed together due to similarities (and differences, e.g., no culvert in the North Dam) in their current consequence classifications, design concept, and construction scheme. The various assumptions utilized in the Foster and Fell [2000] analysis at the dams for the three (3) discussed failure types are presented in Table 7-16 through Table 7-18. References for the weighting factors are provided in Figure 7-4 to Figure 7-6. Annual failure probabilities applicable to both dams are presented in Figure 7-7.

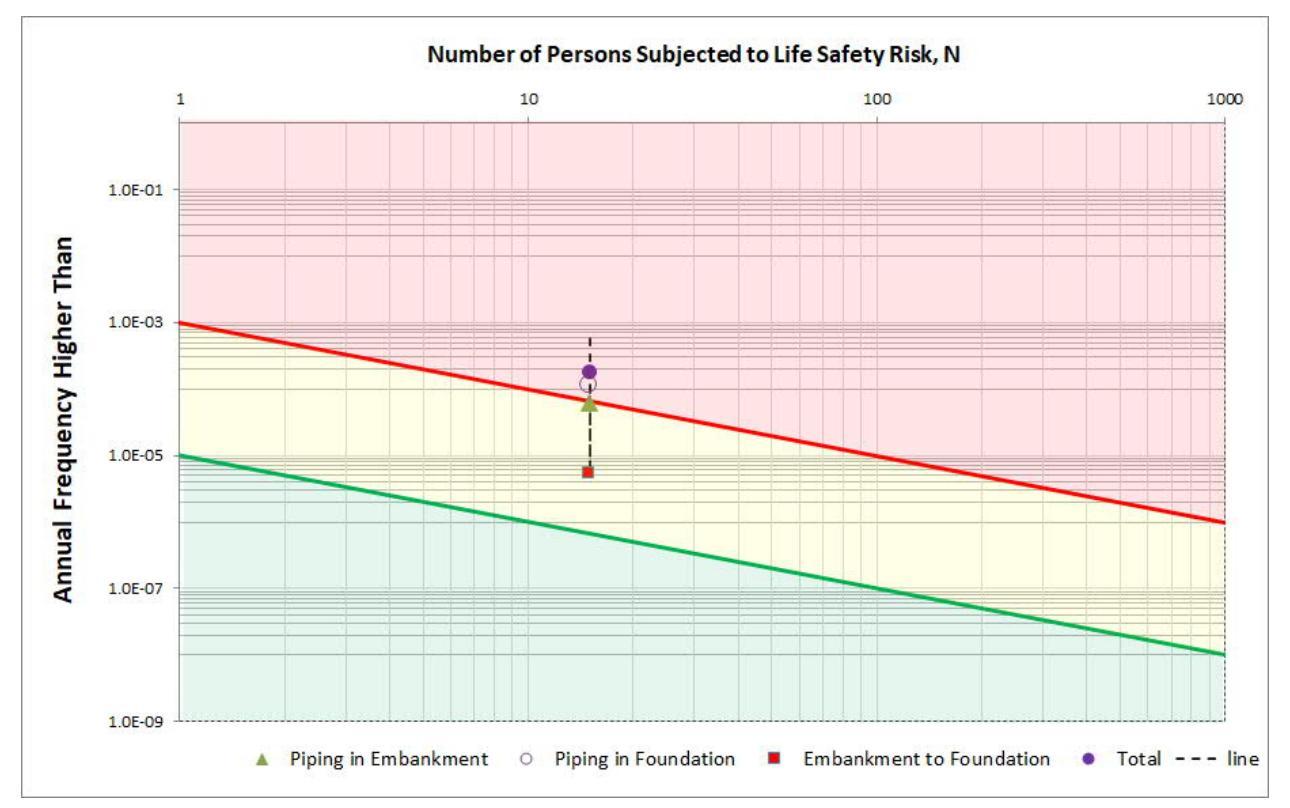
Figure 7-8: Existing Risk Acceptability for Elinor North Earthfill Dam Considering DFCC of 15

In its existing condition, the total probability of piping failure at the Elinor Lake North Earthfill Dam appears to be close to unacceptable ranges. However, this potential can be reduced in a number of ways. First, as can be observed in Figure 7-8 the broadly acceptable band is highly influenced by the potential number of people.

- Structural mitigation in terms of installing piping control measures such as a reverse filter blanket at the toe of dam is an alternative measure which might be considered for the Elinor North Dam. (see Issue EN-5 in Table 13-1).
- Conduct geotechnical investigation and assessments to further assess the internal zoning, internal stability, and filter criteria.
- Install additional instrument at dams to measure internal pore water pressure and total seepage quantity, by the installation of piezometers and weirs, respectively.

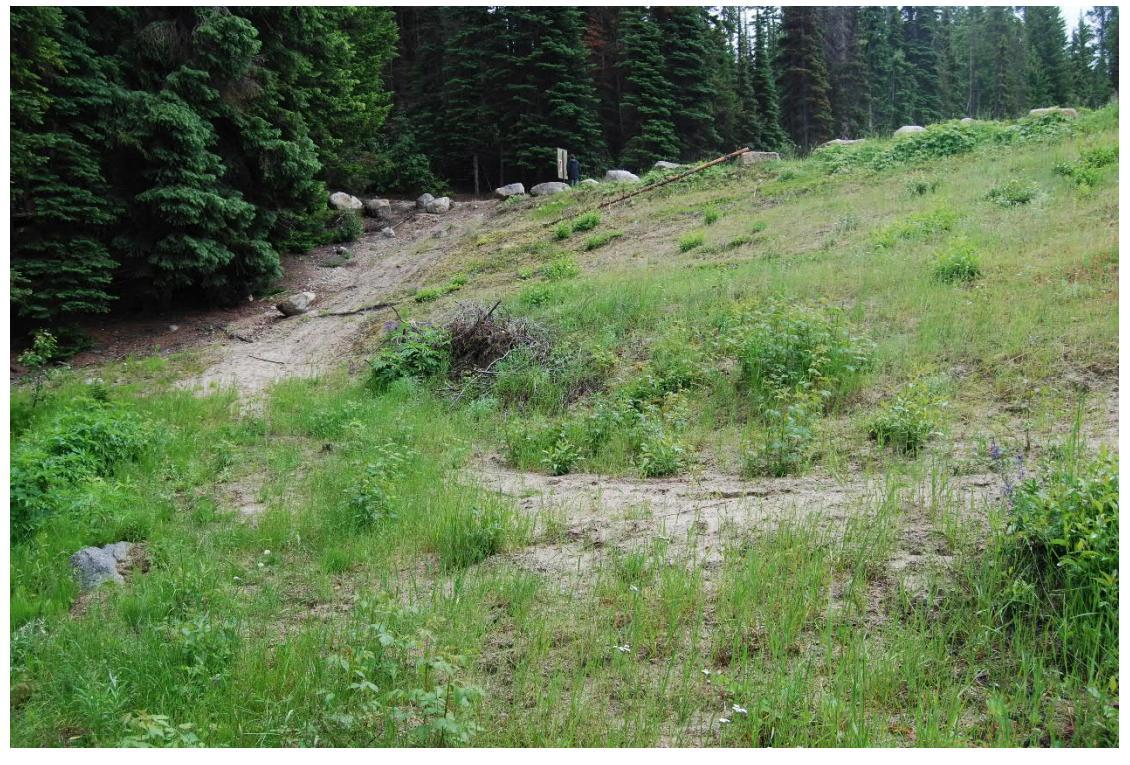
Photo A5: Elinor Lake North Dam, Downstream Slope, looking at Right Abutment

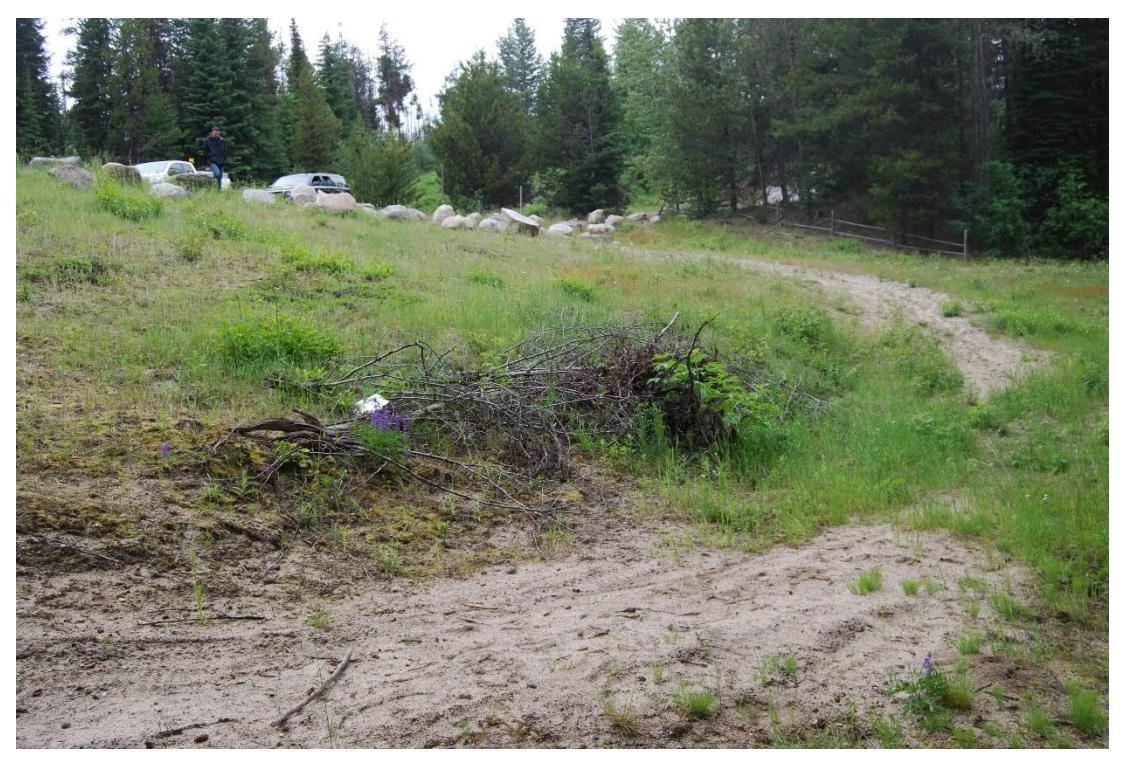
Photo A6: Elinor Lake North Dam, Downstream Slope, Looking at Left Abutment

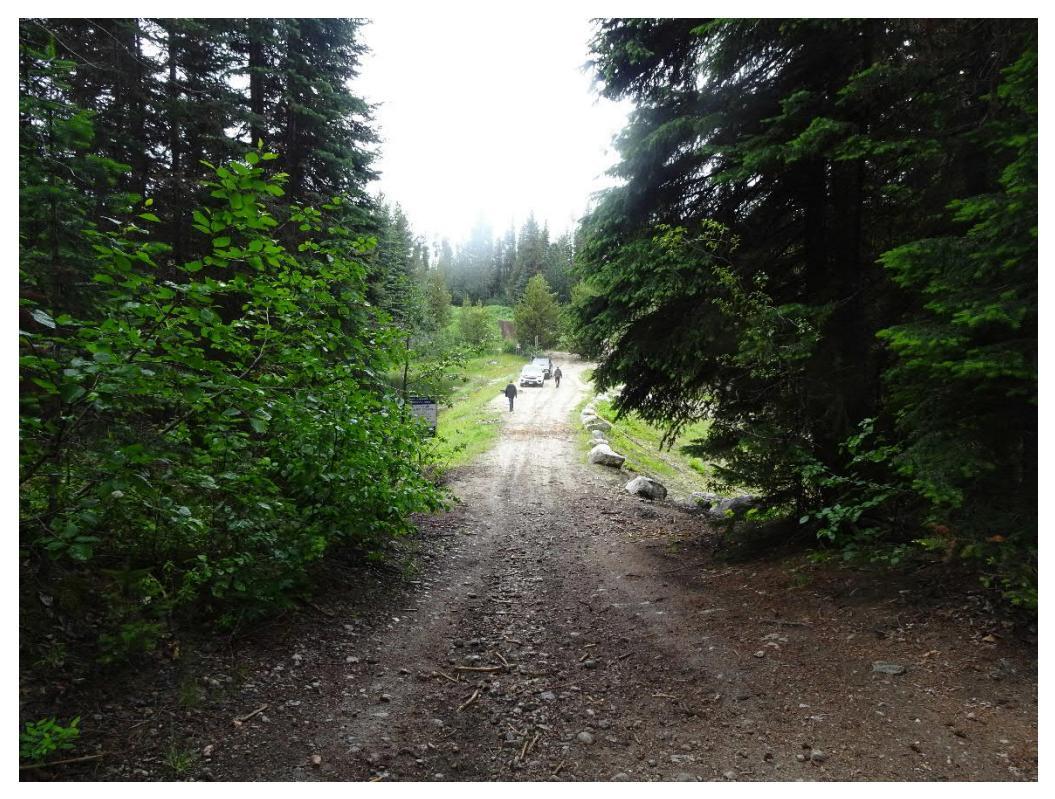
Photo A11: Elinor Lake North Dam, Crest and Right Abutment Area
