Final Report for
Naramata Dam
2020 Dam Safety Review Report
For Regional District of Okanagan-Similkameen

February 25, 2021

Naramata Dam - 2020 Dam Safety Review Report

H362819-00000-228-230-0005

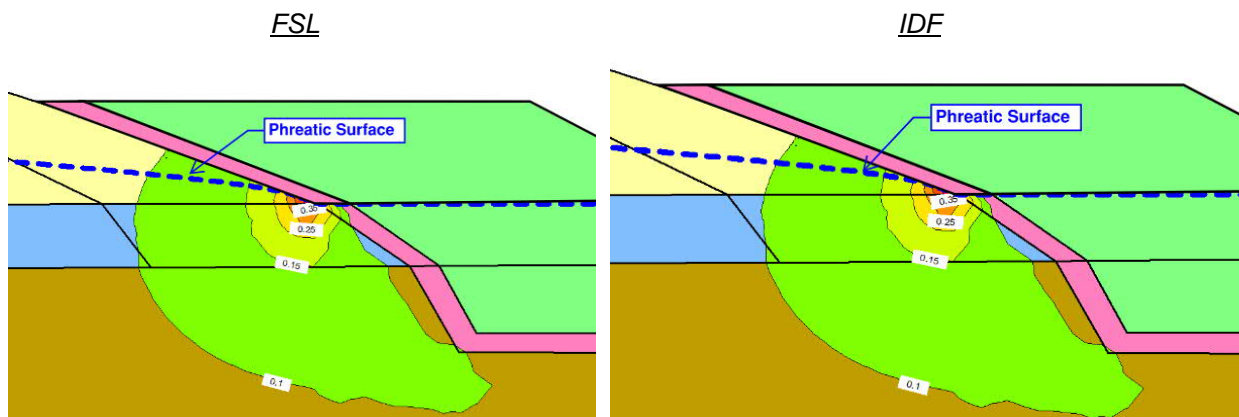
Figure 7-8: Distribution of Exit Seepage Gradients with Relief Drain

The results of the seepage analysis indicate that the provision of a relief drain which intercepts seepage below grade is likely to be an effective mitigative measure against boil and piping initiation at the downstream dam toe. The relief drain significantly reduces exit gradients beyond the dam toe and large exit gradients are driven to a deeper depth. The

The seepage analysis was repeated with the addition of a pressure relief drain at the downstream dam toe which extends to a depth of 2 m below grade. The drain includes an approximately 1.5 m tall overlying riprap berm which applies vertical surcharge pressure and provides resistance against boiling and heave. The objective of the relief drain is to intercept seepage and hydraulic gradients below grade to mitigate the initiation of boiling and piping at the surface. High exit gradients may still exist below the drain, however, their disruptive effects will be balanced by the overburden pressure of the relief drain.

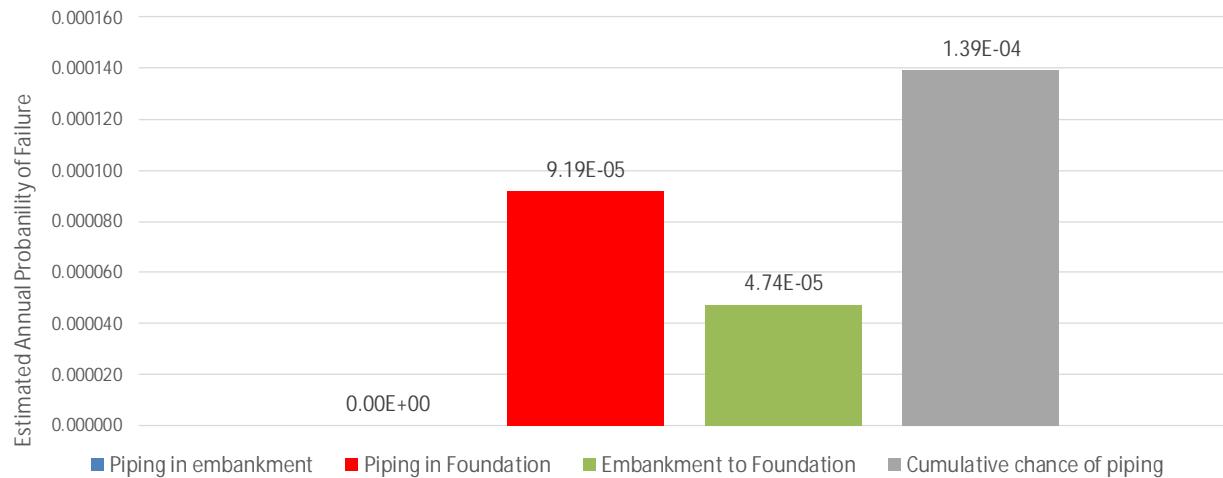
Figure 7-12: Estimated Annual Probability of Failure of the Naramata Lake Earthfill Dams Using Foster and Fell [2000]

The piping risk assessment for the East and West Dams was performed using identical input parameters. Although the East and West dams are constructed with different elevations, the dams share similar consequence classifications, design concepts, construction schemes, and overall configurations. The various assumptions utilized in the Foster and Fell (2000) analysis at the dams for the three discussed failure types are presented in Table 7-15 through Table 7-17. References for the selected weighting factors are provided in Figure 7-9 through Figure 7-11. Annual failure probabilities applicable to both dams are presented in Figure 7-12 and Figure 7-13.

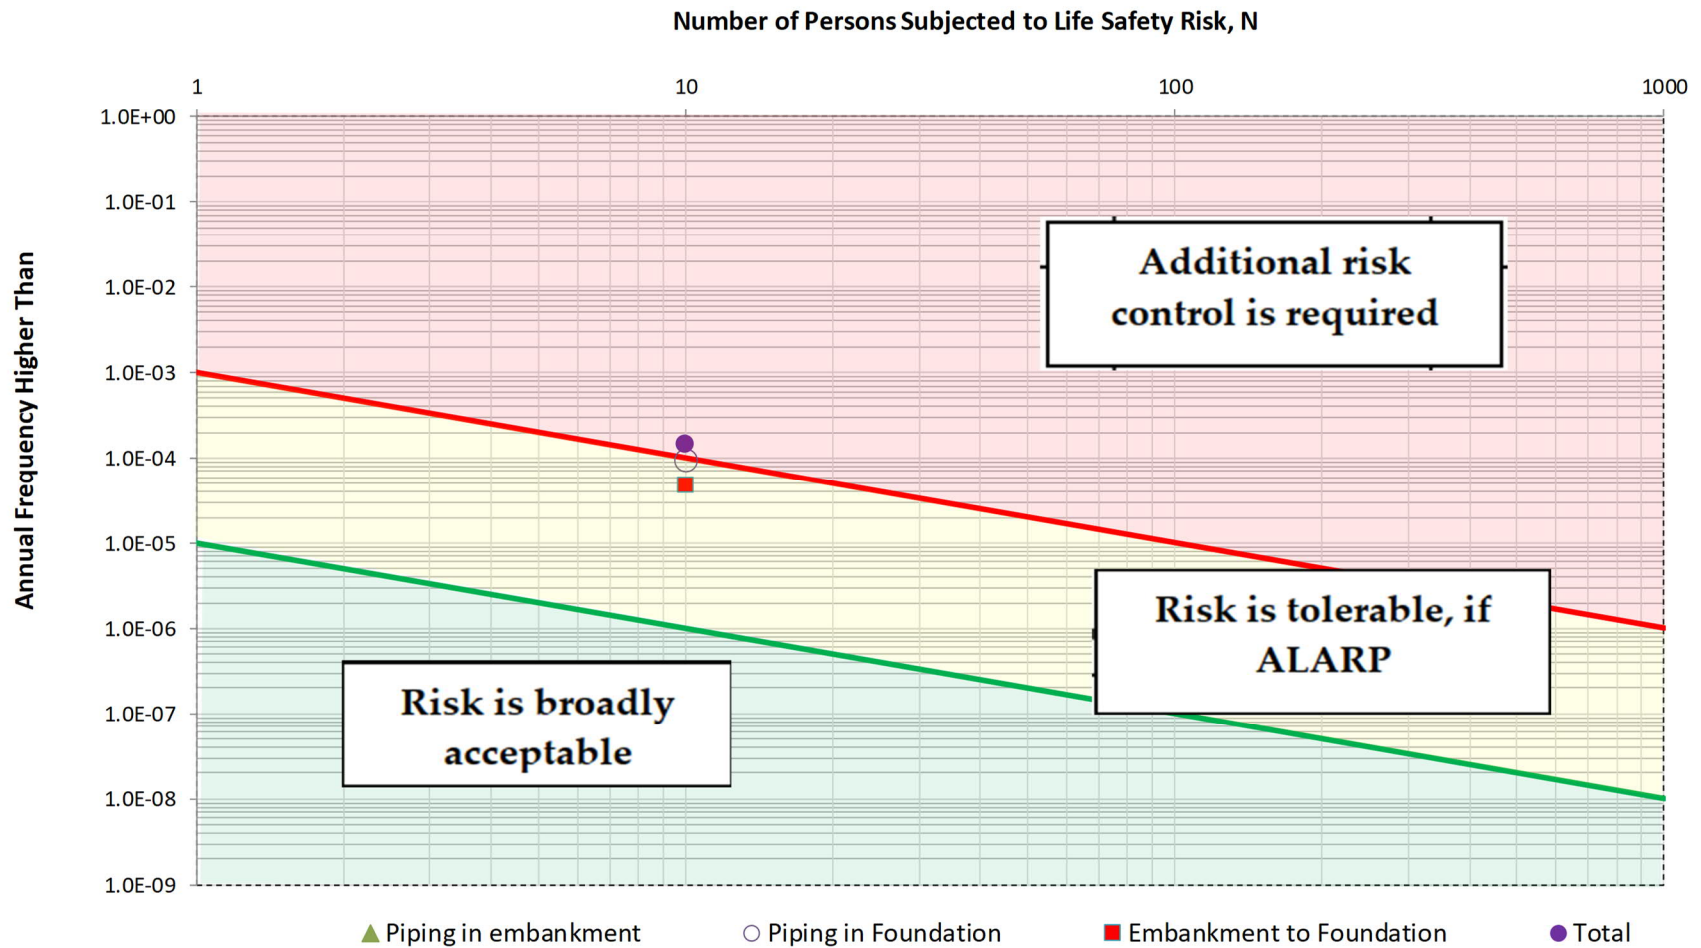
Figure 7-13: Existing Risk Acceptability for the Naramata Dam Considering VERY HIGH DFCC

According to CDA Guidelines (CDA, 2013a), the life safety risk should be consistent with accepted practice in other high hazard industries and with the understanding that risks should be made as low as reasonably practicable (ALARP). Using this approach, a better understanding of the piping risks can be obtained by plotting the annual exceedance probability against the expected number of persons subjected to a Life Safety Risk. Figure 7-13 outlines the piping risk with regards to life safety risk using the DFCC of “Very High” and assuming a potential for Loss of Life.

Several measures may be considered to reduce the piping risk. The risk acceptance is highly sensitive to the number of persons subjected to a life safety risk. Therefore, undertaking the suggested improvements to the dam and developing a more comprehensive public warning and evacuation plan may provide a more favorable risk rating which categorizes the risk as tolerable (if ALARP). Additional measures may include supplementary training and instructions to Dam Operators to properly identify, sample, and respond to seepage turbidity. Seasonal turbidity laboratory tests may then be conducted on any water samples taken (see Issue No.12 and All-5 and in Table 13-1).

Structural mitigation may include the construction of piping control measures such as a reverse filter blanket at the toe of the dam(s).

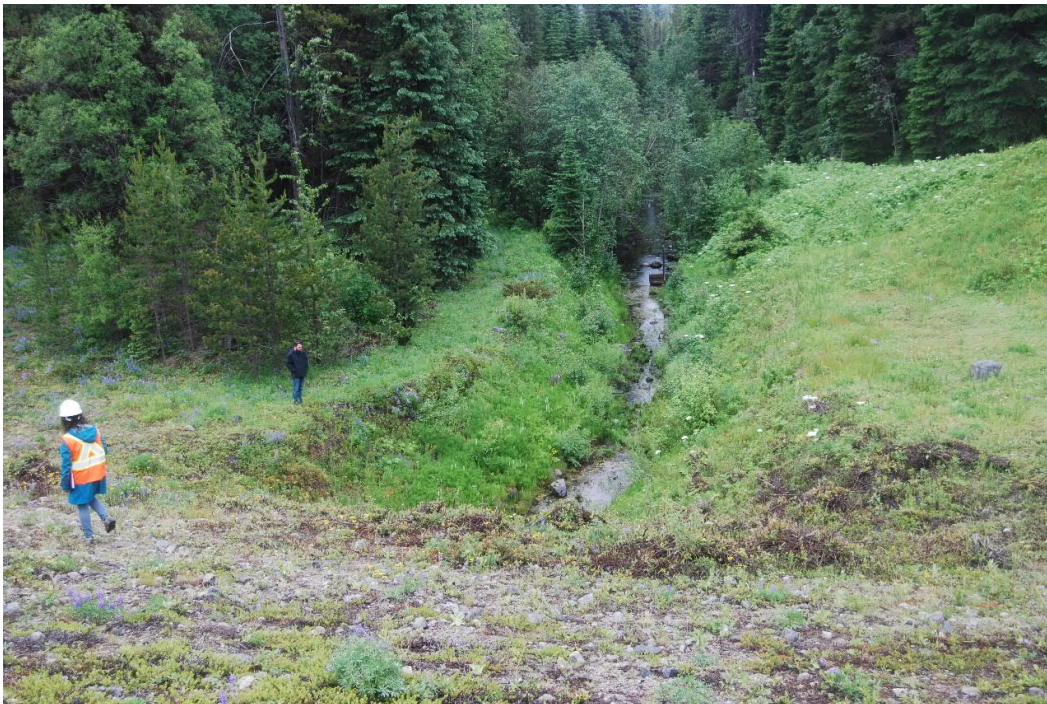
NL-15	Vegetation control along the tailrace channels	2020 DSR	NCs	New	Increase frequency of vegetation clearing along the tailrace trenches for future seepage/piping monitoring.	High
NL-16	Currently no rip-rap or erosion protection layer on the dam crest or upstream slope.	2020 DSR	NCm	New	Provide appropriately sized armour protection along the upstream face of the dam from the crest to 1 m below the low water level.	
NL-17	LLO structure is unprotected from vandalism and accidental damage from ATVs or other traffic at dam crest.	2020 DSR	NCm	New	Provide protection to the screw stem by adding bollards or a steel cover to prevent damage from ATV traffic.	Low
NL-18	Recommendations recently provided to increase public safety and reduce risk to RDOS.	2019 Risk Survey, 2020 DSR	NCp	Outstanding	Review security protocols and implement appropriate restrictions including those set out in the 2019 Risk Control Survey (Precise Services, 2019) to prevent damage or vandalism.	High

Photo A6: Naramata Dam downstream tailrace channel

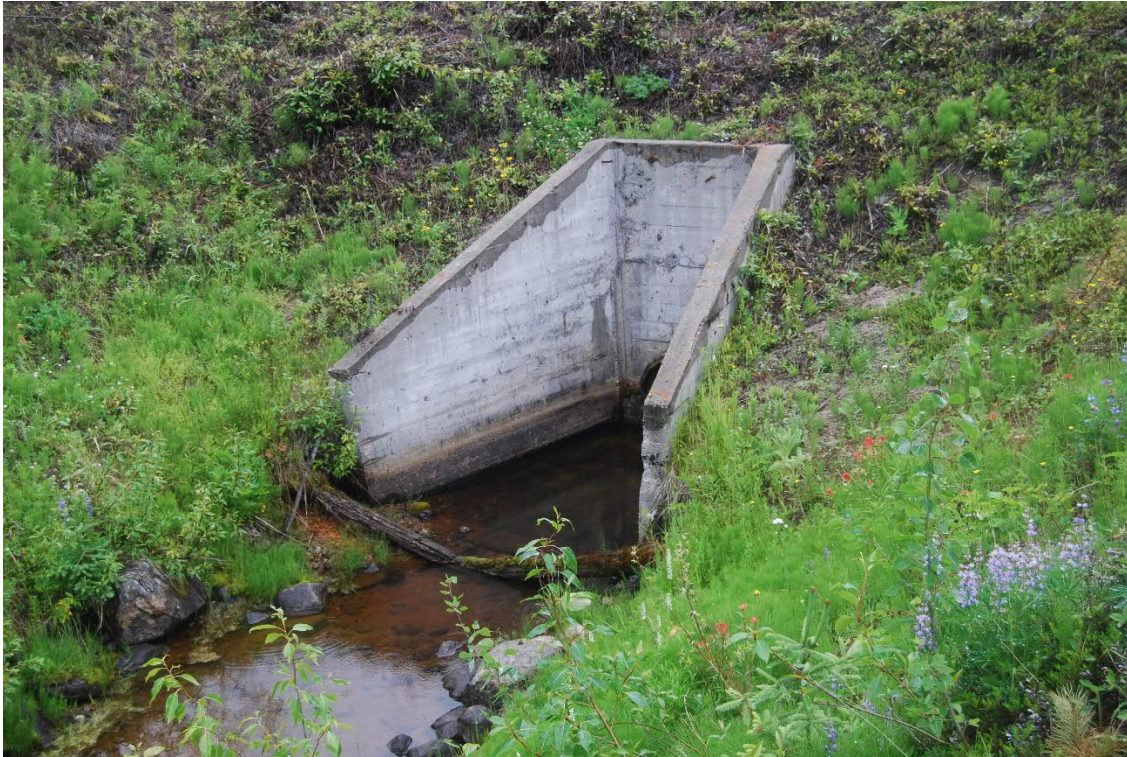
NL-19	Minor concrete cracking in localized area around outlet pipe in LLO structure	2020 DSR	NCm	New	Repair the cracked area of concrete after chipping off the loose and cracked concrete section	Low
All-1	OMS could be improved by including supporting confirmation that highlighted maintenance activities are being completed.	2020 DSR	NCs	New	Regular verification of the completion of maintenance items recorded in the weekly site surveillance form would further support that maintenance items are being completed.	Low
All-2	OMS does not have a table with positions and associated names describing roles and responsibilities.	2020 DSR	NCo	New	Update table in OMS to include positions and associated names describing roles and responsibilities.	Medium
All-3	Routine Dam Inspection Report format does not contain all aspect of BC Dam Safety Office's Site Surveillance Form for weekly inspections.	2020 DSR	NCp	New	Routine Dam Inspection Report format should be improved to more closely follow the BC Dam Safety Site Surveillance Form for weekly inspections.	Low

Photo A7: Naramata Dam Low Level Outlet structure, exit location and stilling basin

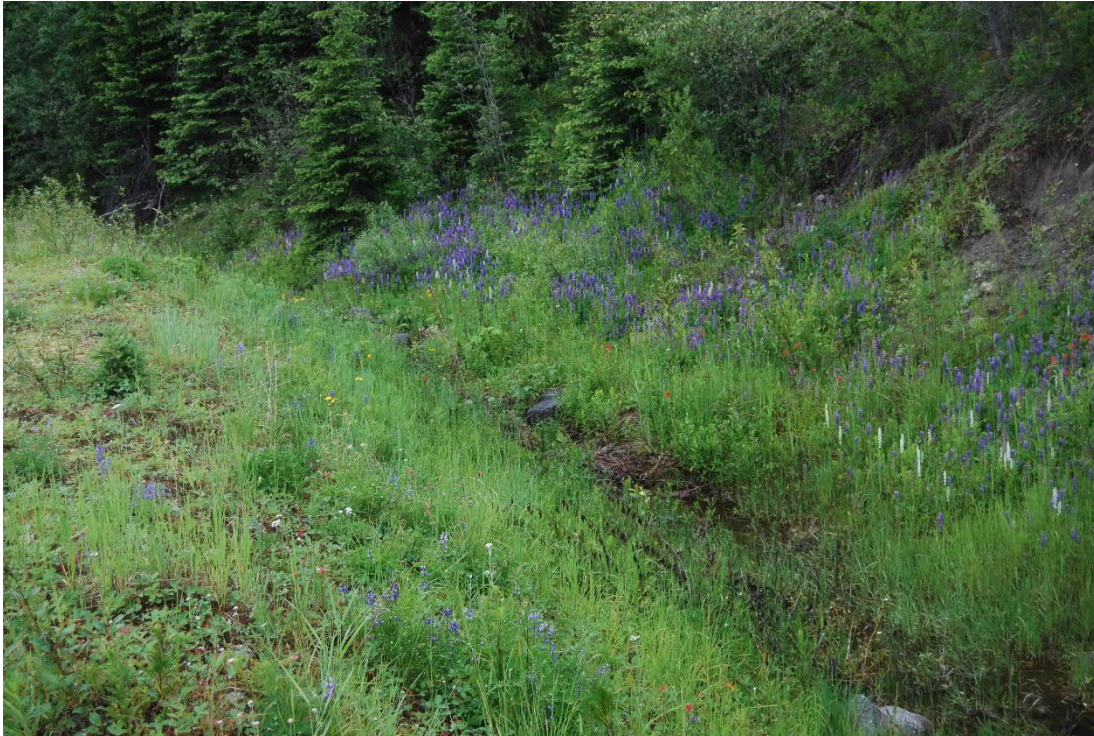
The spillway intake and outlet includes an excavated, grass-lined channel with some rock placement downstream of the spillway crest. The road to access the main dam crosses the upstream portion of the spillway (i.e. prior to flow passing over the crest). During the IDF, 4.6 m³/s with 0.7 m of head and approximately 1.4 m/s will pass over the spillway. This velocity may damage an unprotected grass lined channel over time, however, it is unlikely to

Photo A11: Naramata Dam spillway downstream channel

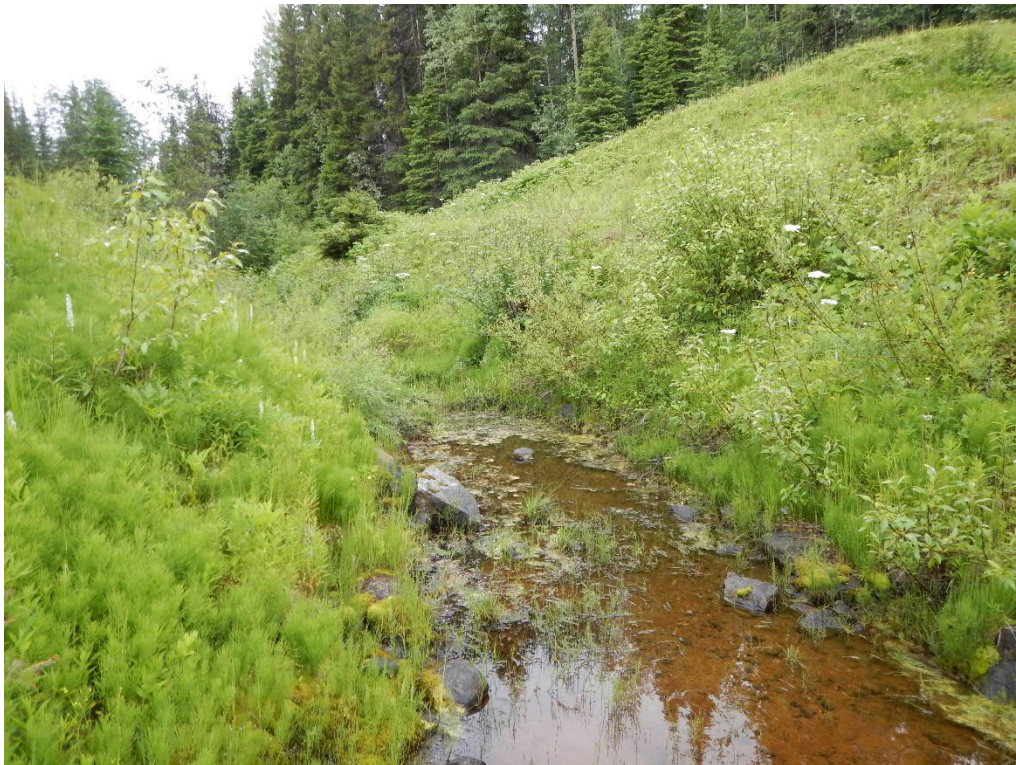
Photo A12: Naramata Dam spillway downstream channel
