Regional District of Okanagan-Similkameen

**DAM SAFETY REVIEWS FOR
ELINOR LAKE NORTH (SADDLE) DAM AND
ELINOR LAKE SOUTH DAM**

K13101459.001

December 17, 2010

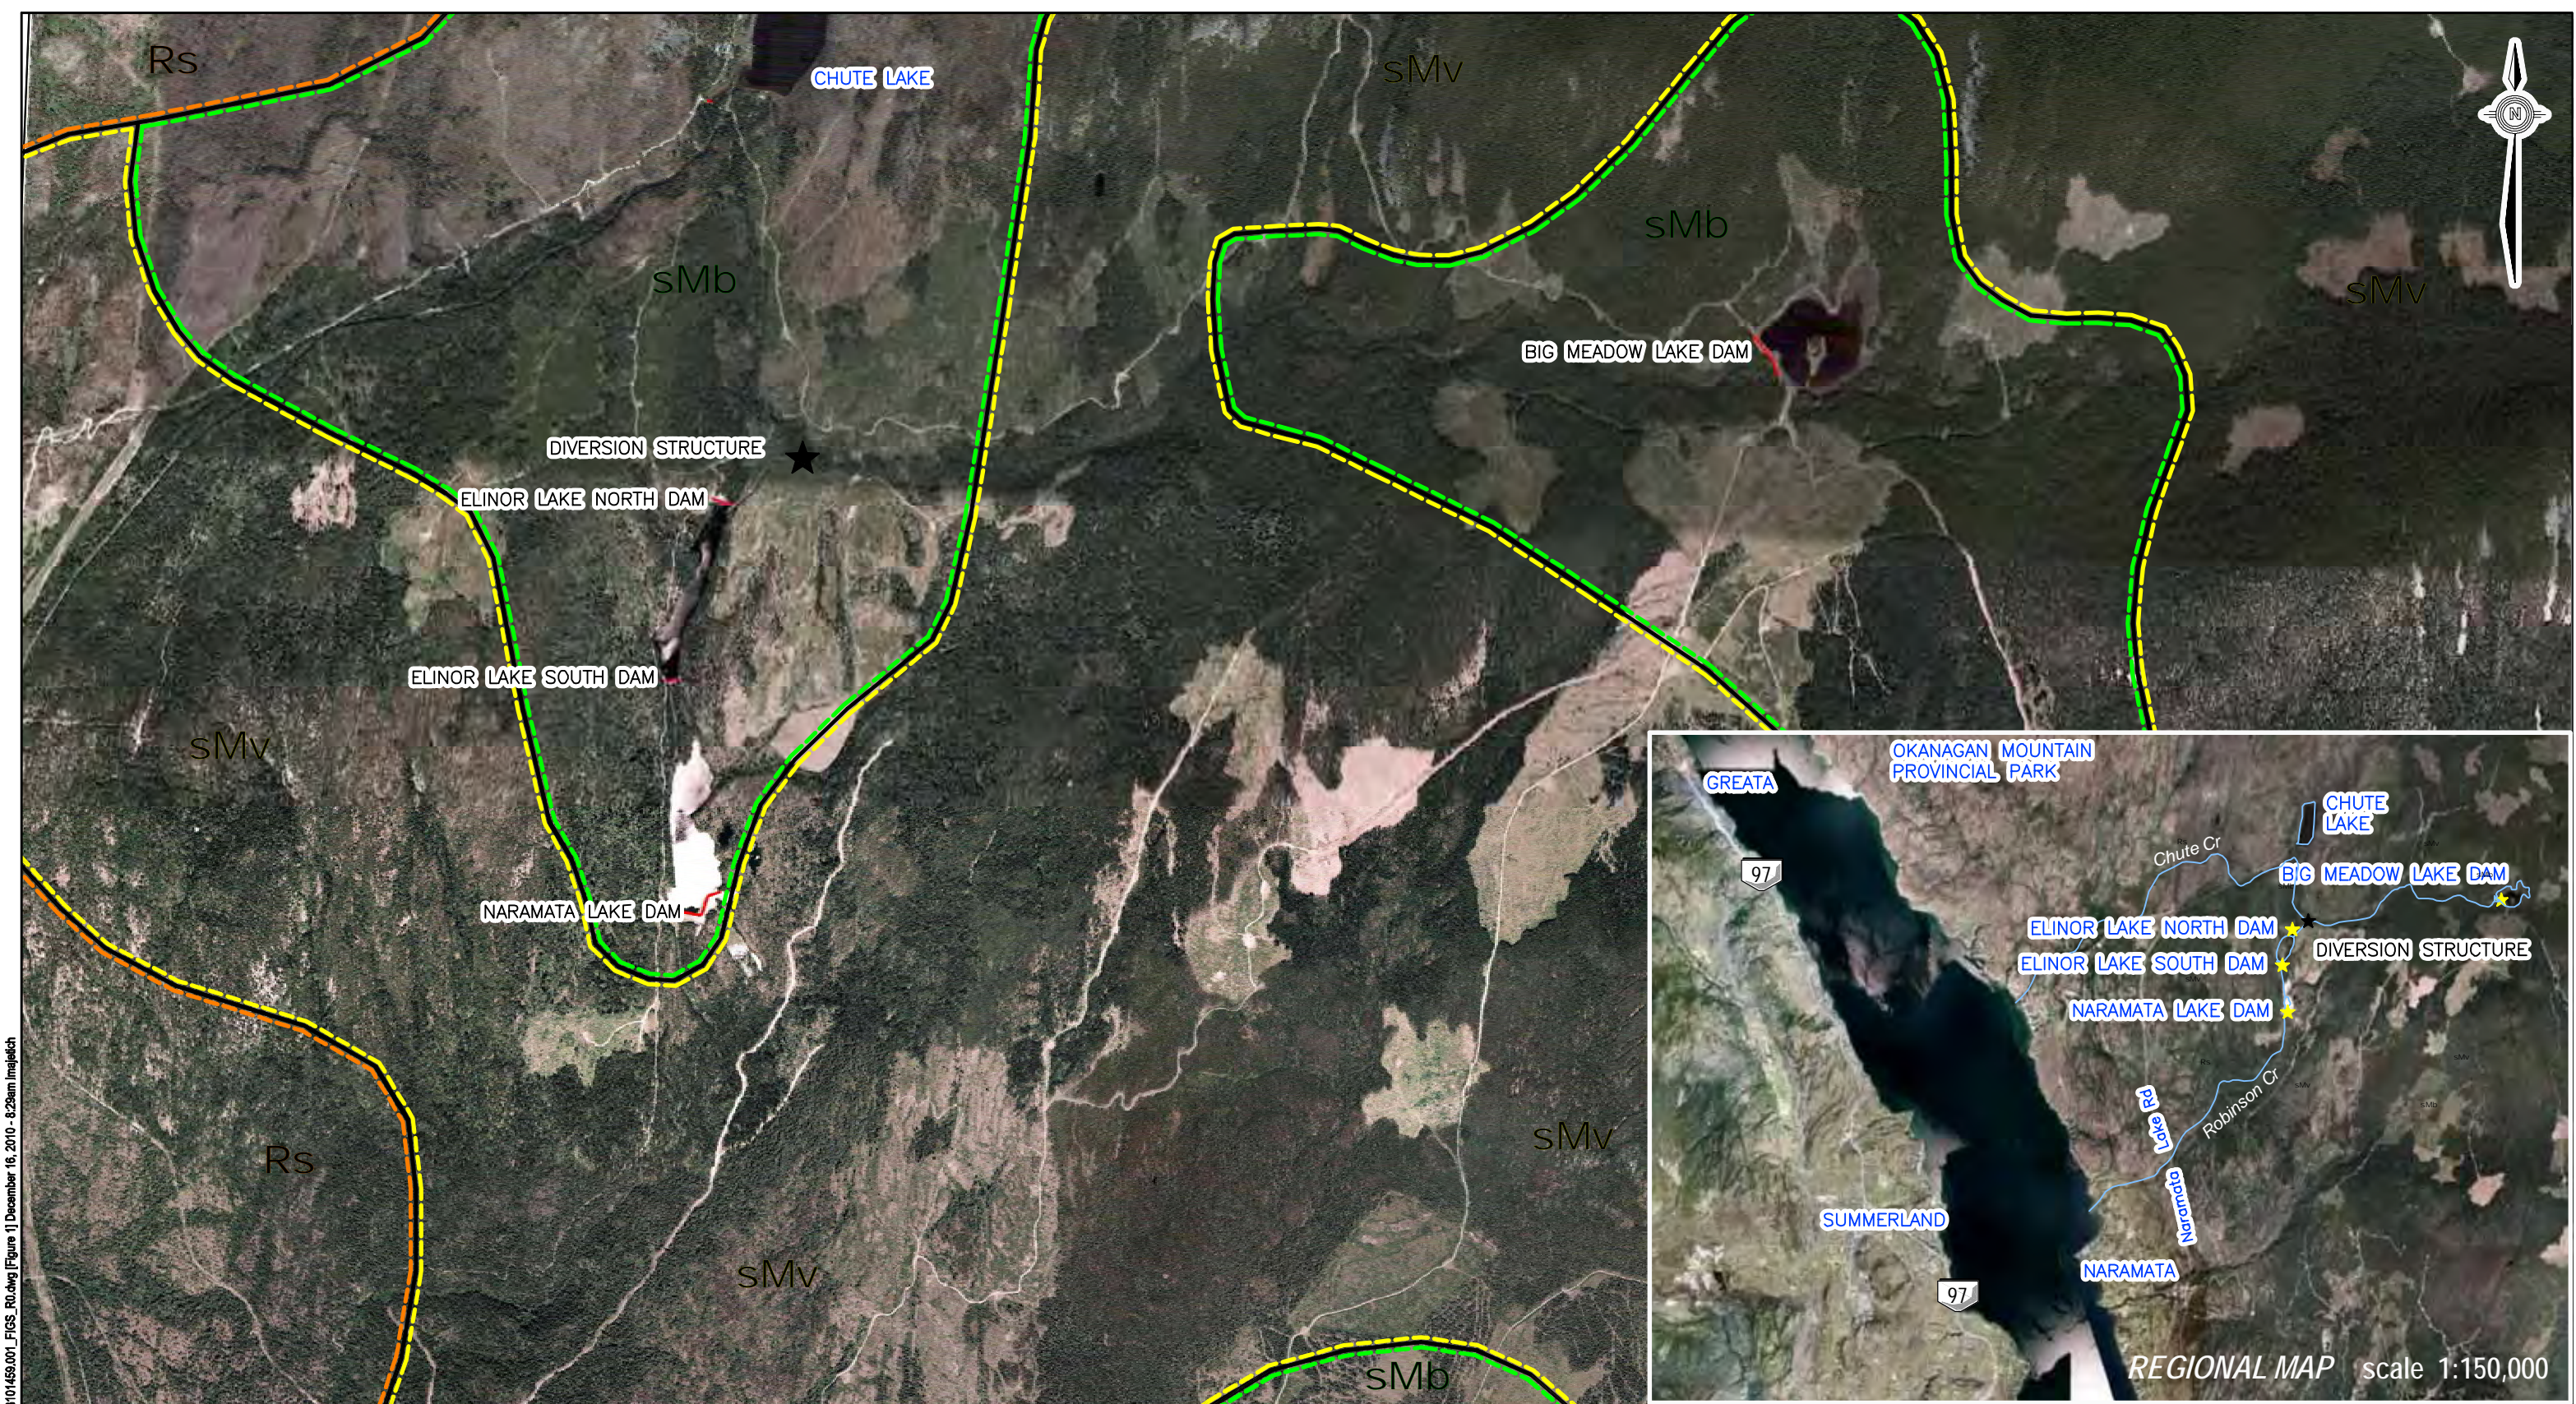
Q:\kelowna\Drafting\K13101459\001\Elinor K13101459\001_FIGS_R0.dwg [Figure 1] December 16, 2010 - 8:28am ImageJetch

The surficial geology of the Naramata dams' area is shown on the attached Figure 1.

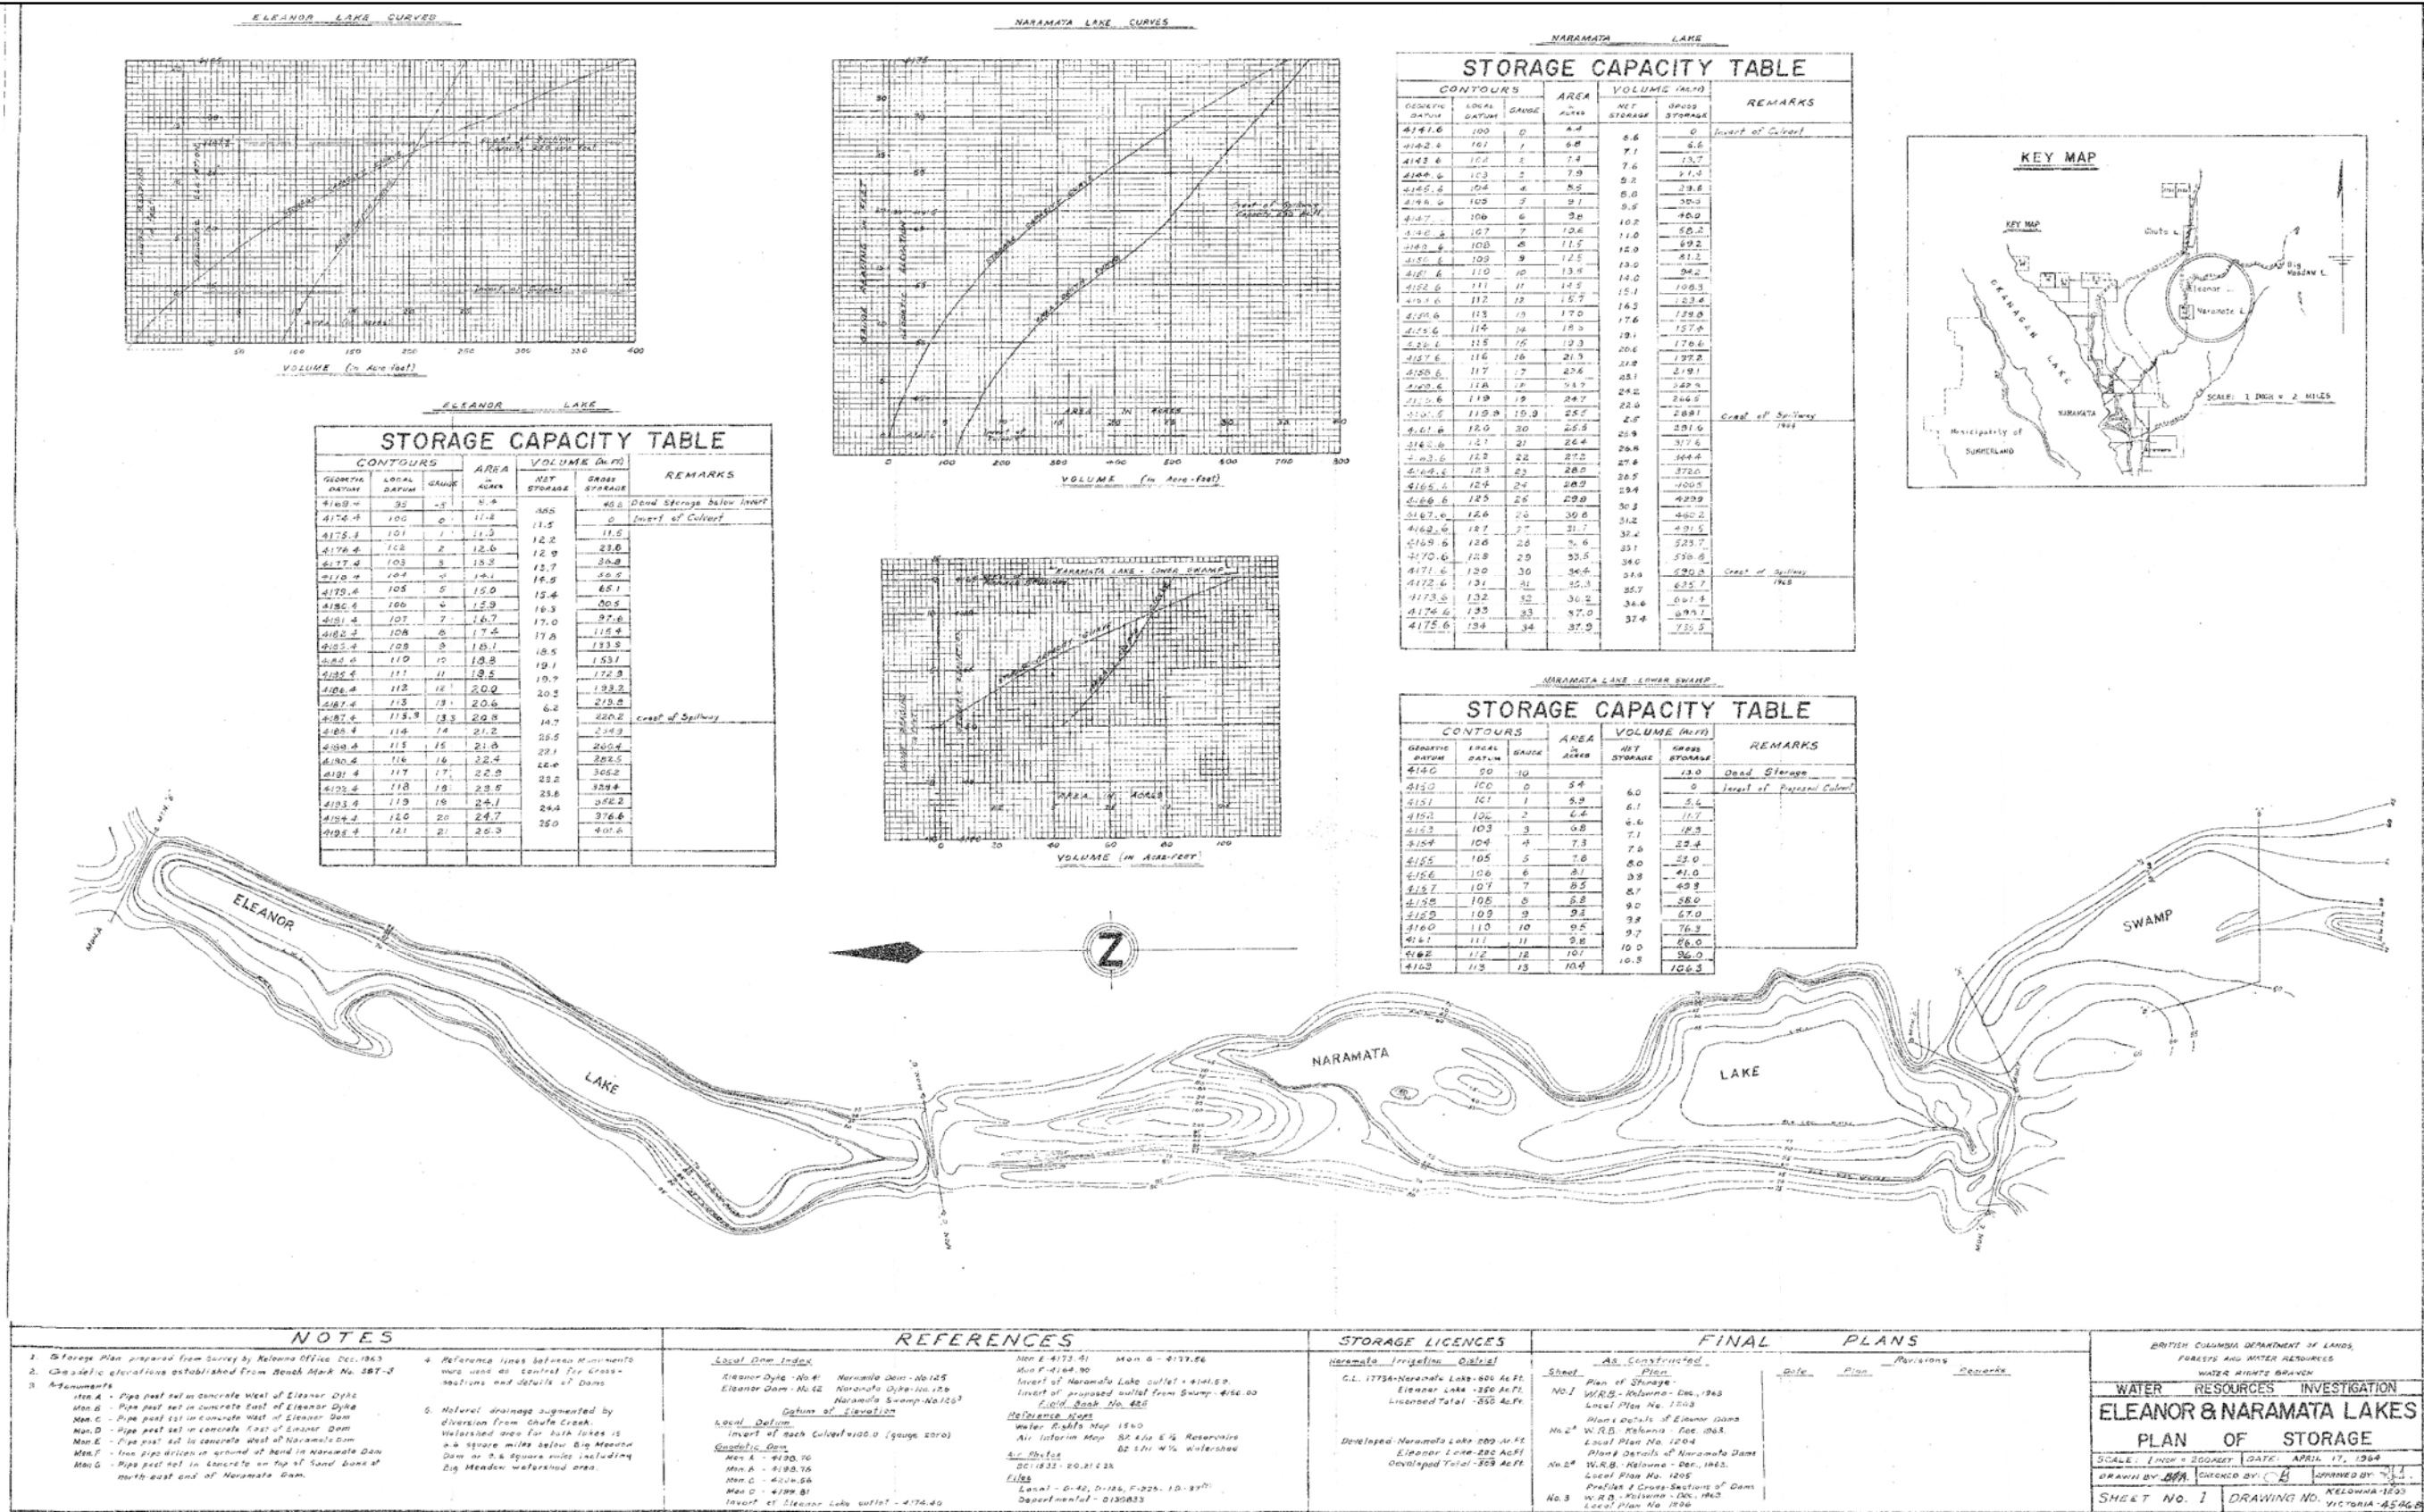
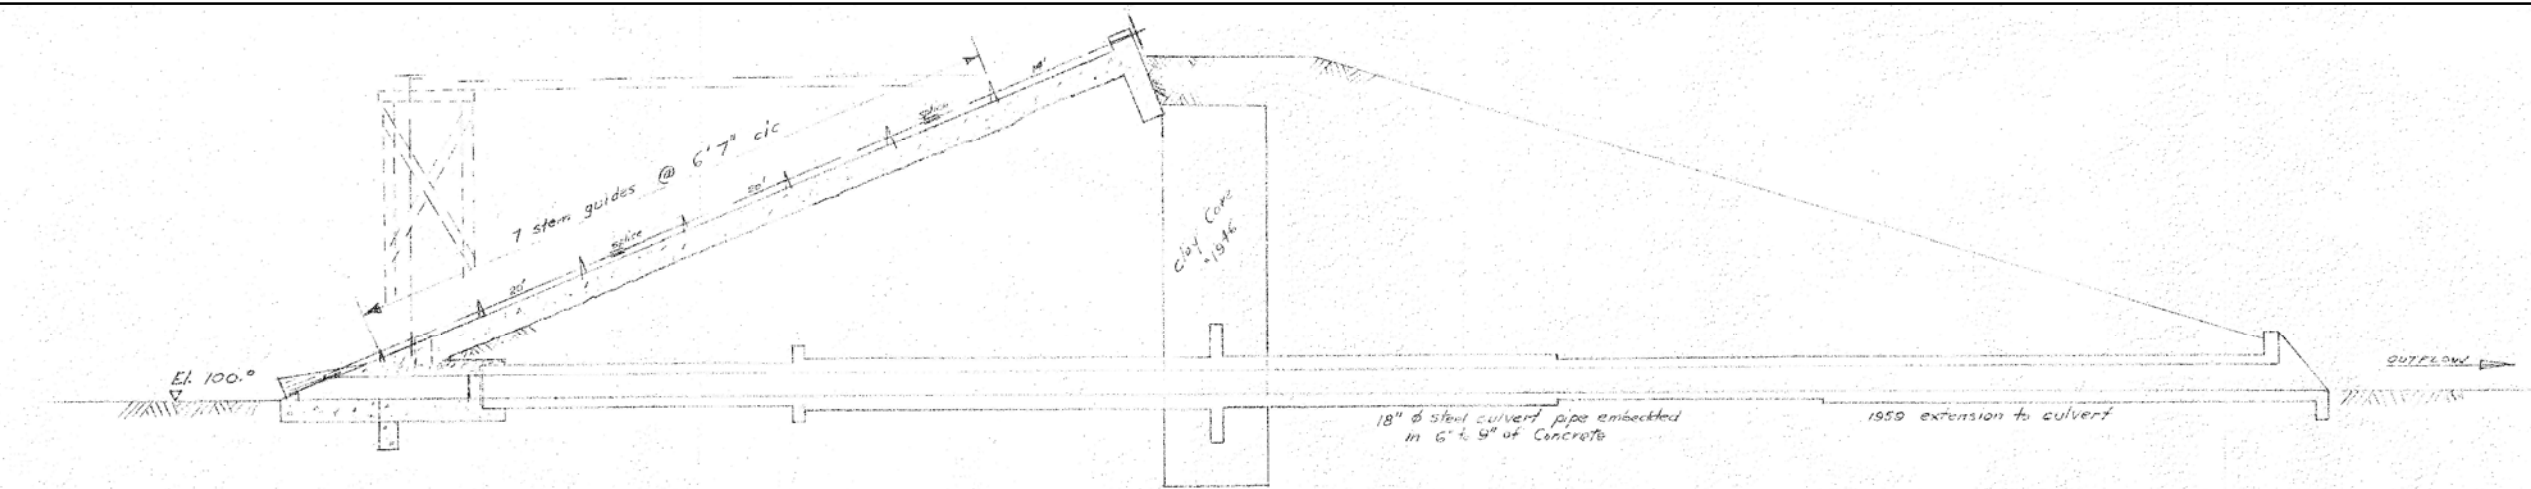
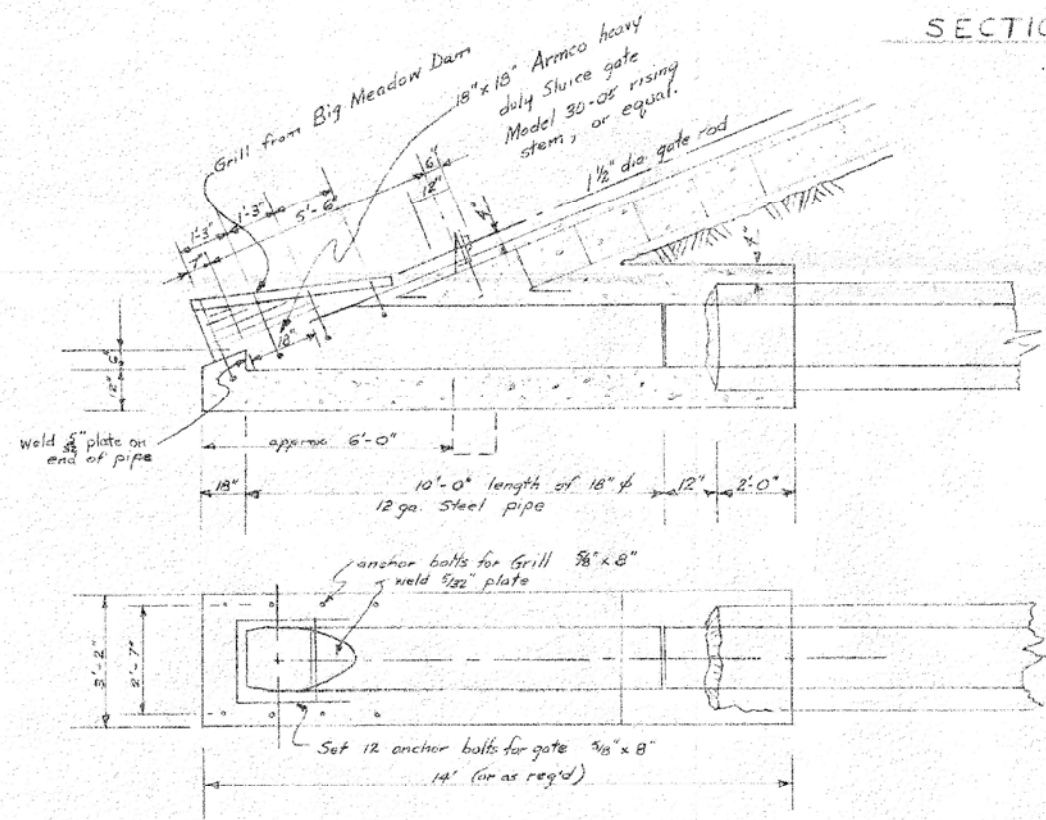
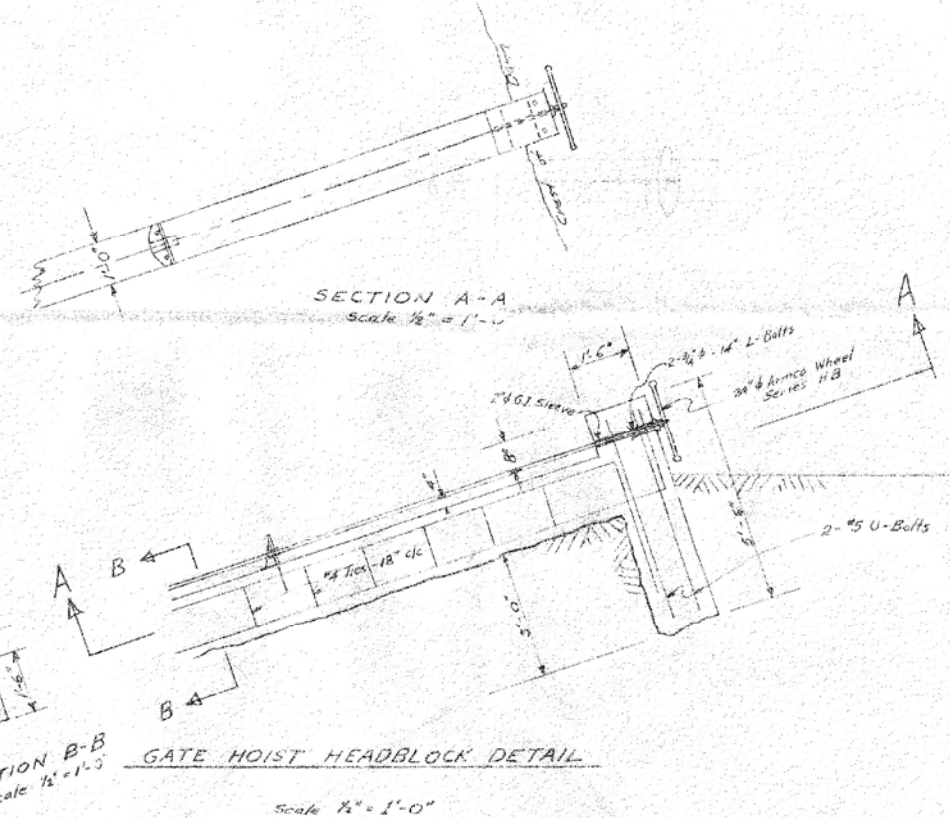
PROJECT NO. K13101459.001	DWN LM	CKD MJL	REV 0
OFFICE EBA-KELOWNA		DATE December 15, 2010	Figure 4

A plan of the Elinor Lake Reservoir and a section of the South Dam embankment at its maximum height are shown on the attached Figures 3 and 4.

CLIENT		ELINOR LAKE DAMS SAFETY REVIEW			
  REGIONAL DISTRICT RDOS OKANAGAN-SIMILKAMEEN		Elinor Lake South Dam Embankment Section, Details of Culvert Gate Repairs			
EBA Engineering Consultants Ltd.

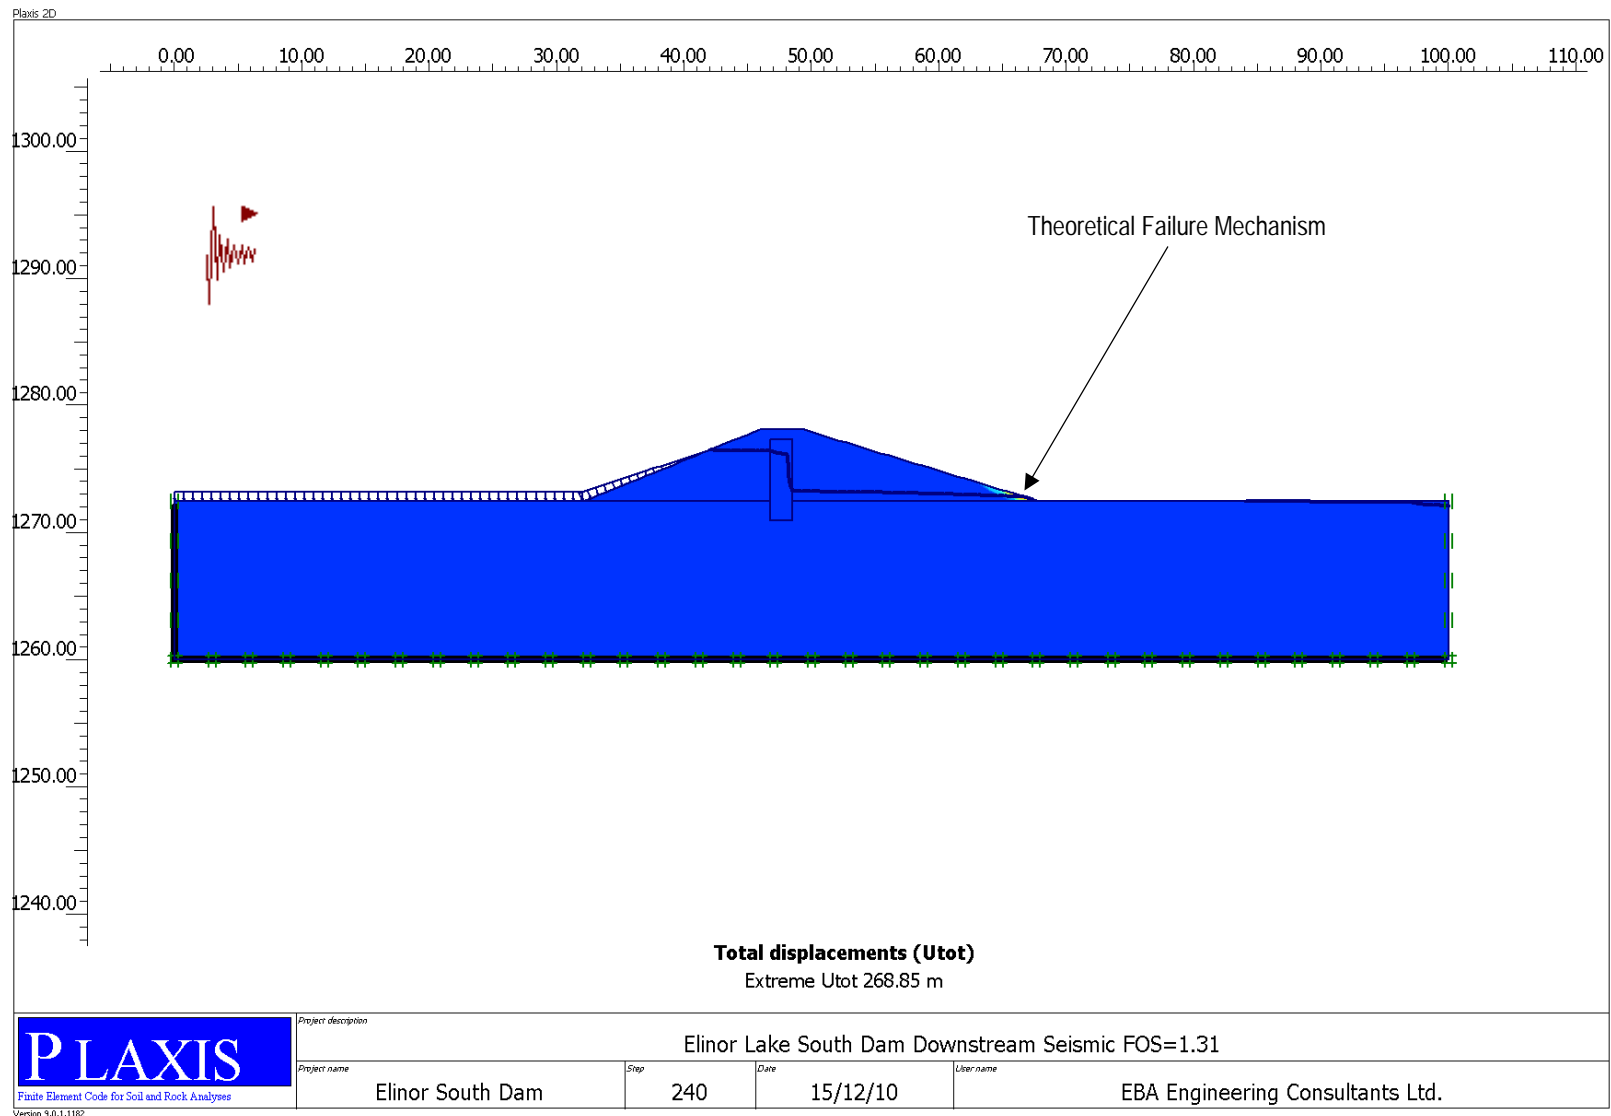
Figure 7

The stability review of the Elinor Lake South Dam was considered at its maximum height with the geometry and soil profile of the model based on the embankment cross section shown attached Figure 3. The results of the analysis indicate that the dam meets or exceeds the CDA minimum factors of safety criteria for both static and seismic loading. The results of the analysis is summarized are in Table 10 below and presented on the attached Figures 6 to 9 inclusive.

The phi-c reduction procedure in PLAXIS® generates additional, large, non-physical displacements with the shape of the deformed mesh and pattern of the displacements giving an indication of the shape of the theoretical failure mechanism.

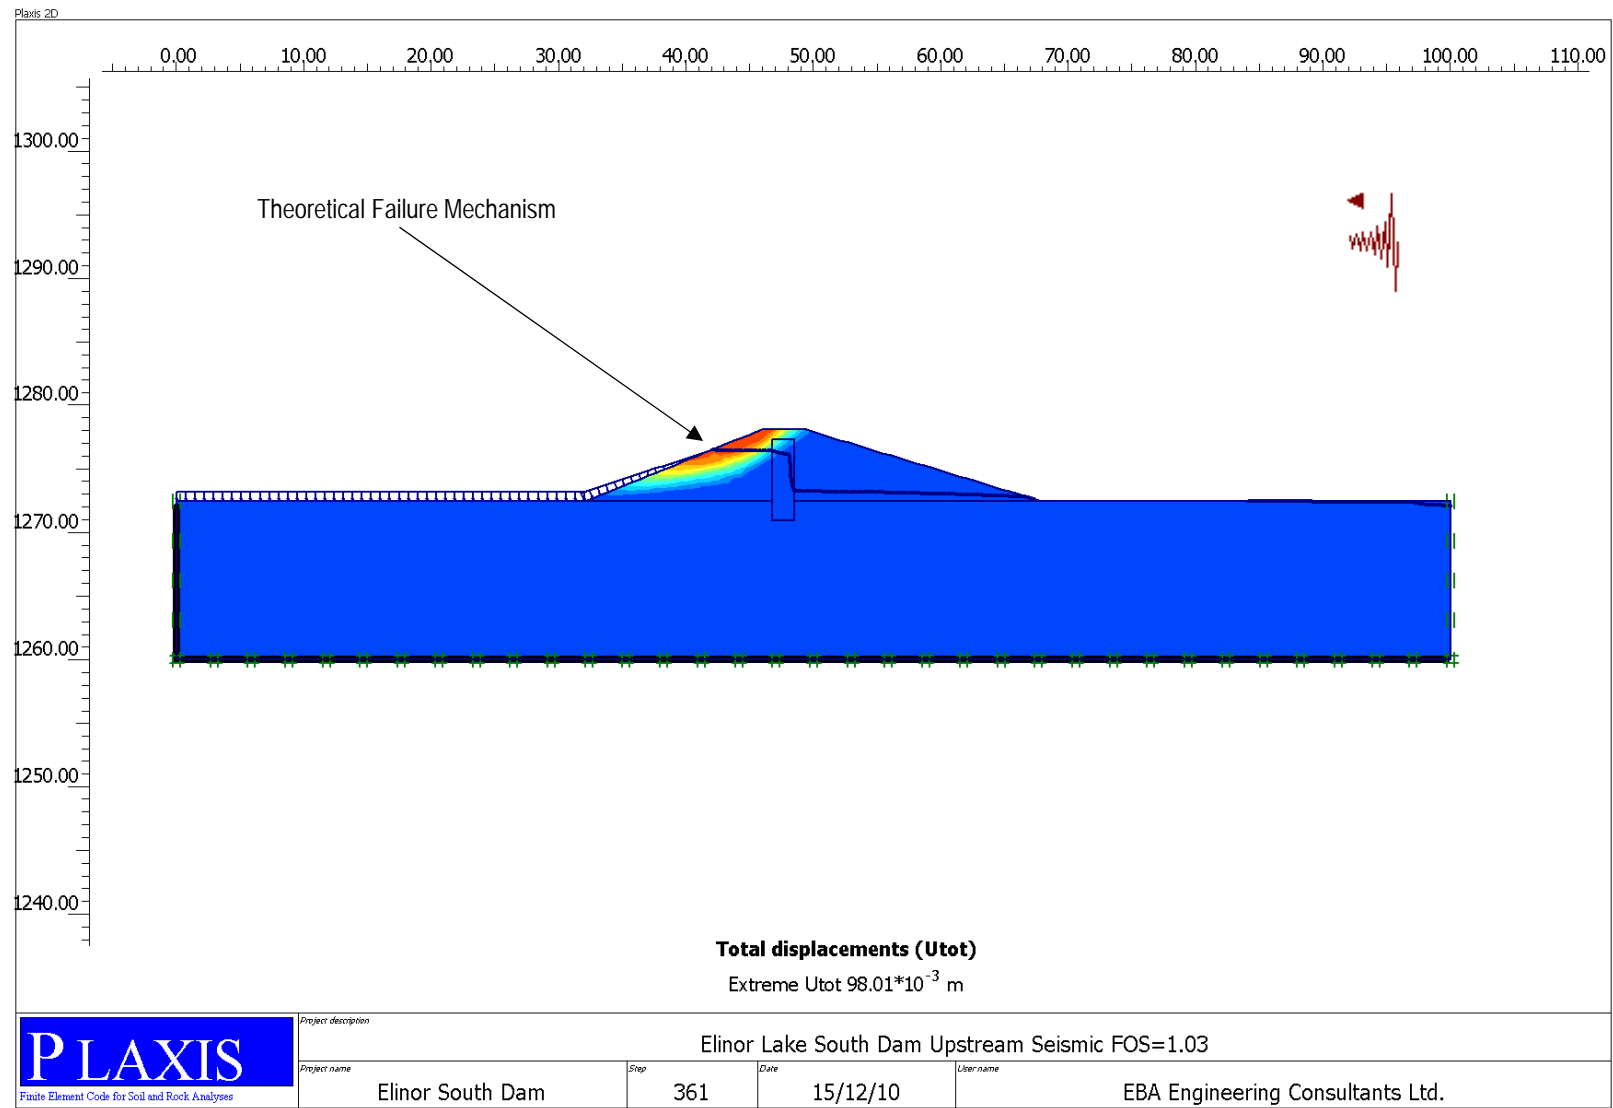
Figure 8

The phi-c reduction procedure in PLAXIS® generates additional, large, non-physical displacements with the shape of the deformed mesh and pattern of the displacements giving an indication of the shape of the theoretical failure mechanism.

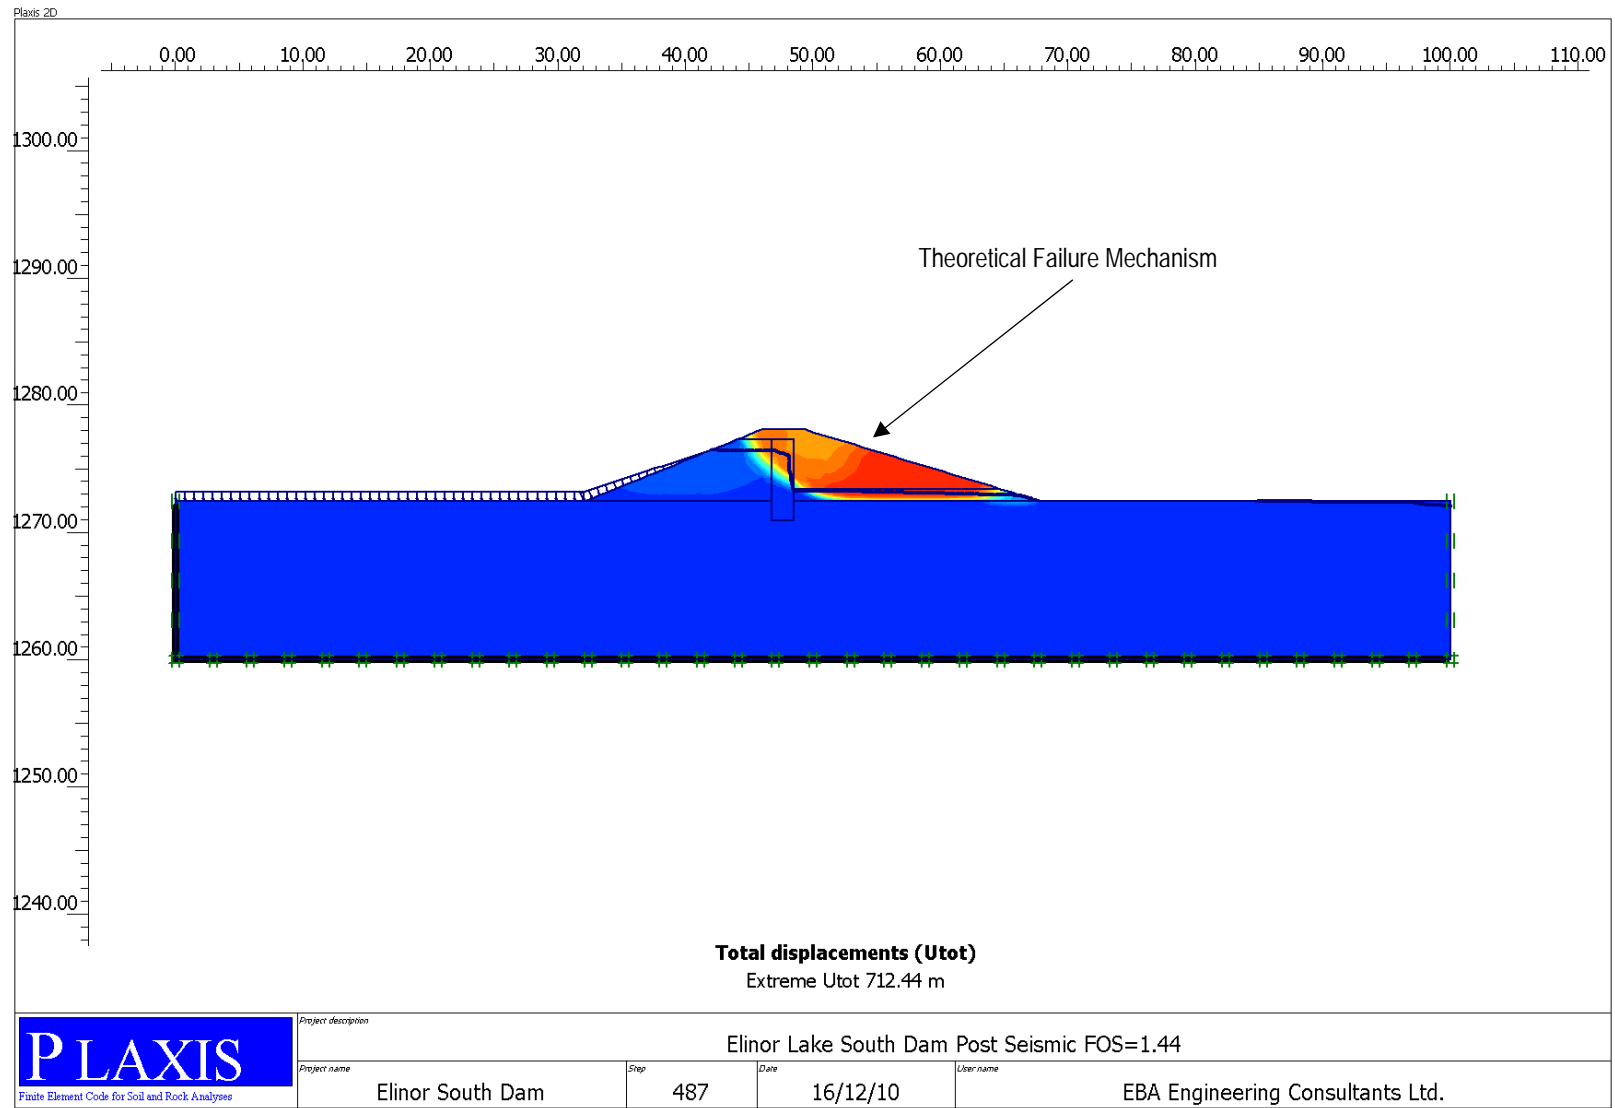
Figure 9

1. The phi-c reduction procedure in PLAXIS® generates additional, large, non-physical displacements with the shape of the deformed mesh and pattern of the displacements giving an indication of the shape of the theoretical failure mechanism.
2. Undrained residual shear strength of soil, S_r estimated for an equivalent clean sand SPT corrected blow count of 10 from Figure 88 of Idriss & Boulanger (2008).

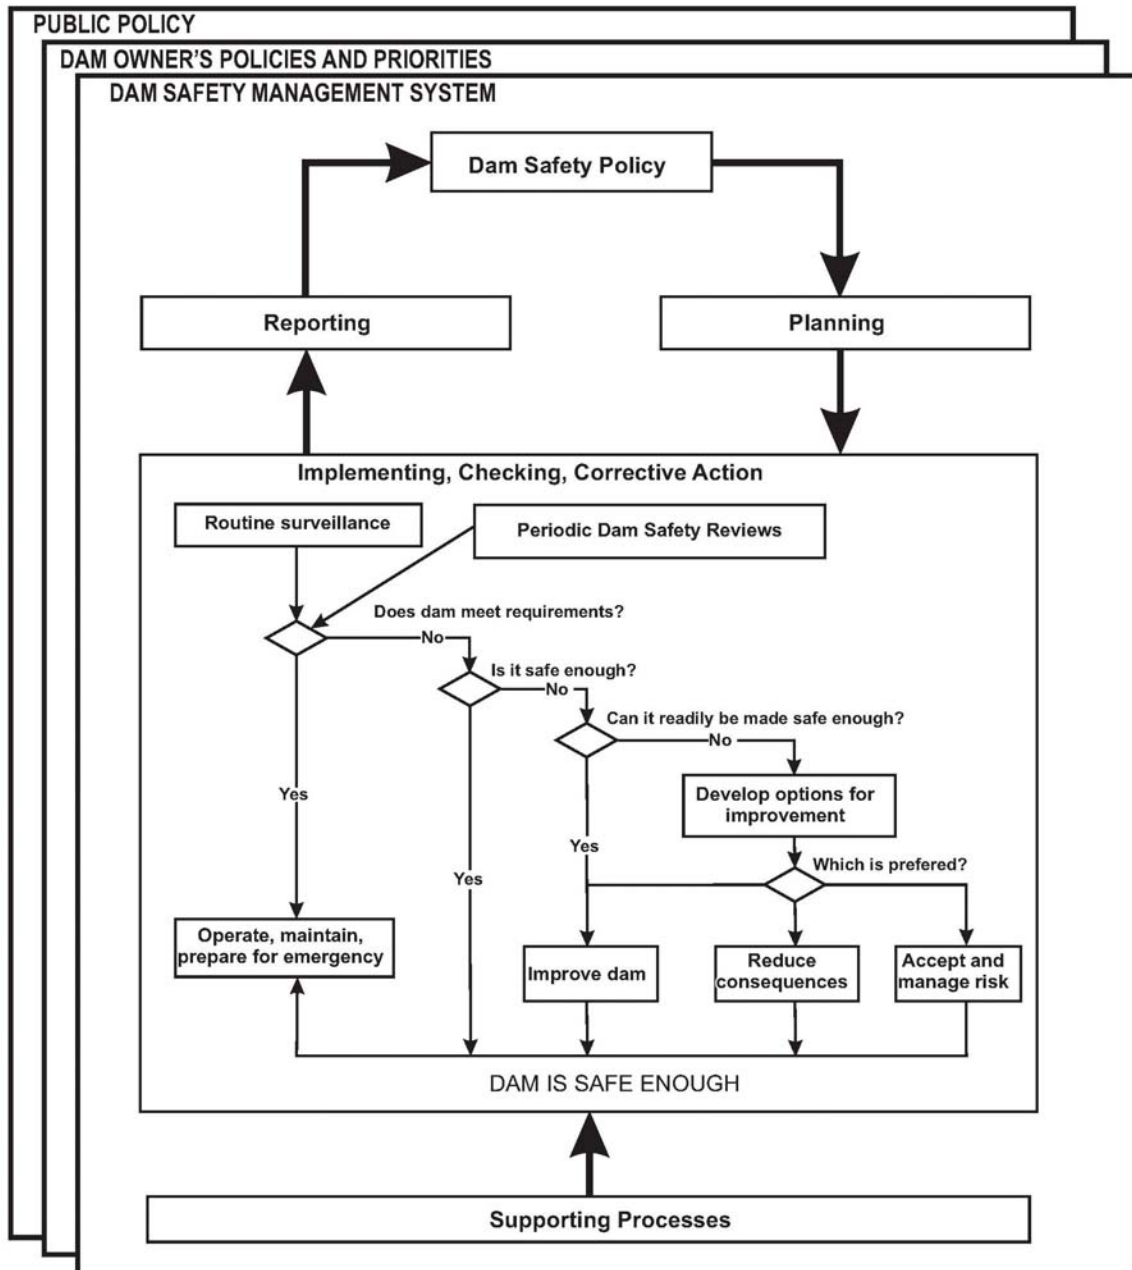
Figure 10

A general schematic of a dam safety management system is presented in Figure 10. EBA has assessed the dam safety management system in place for the Elinor Lake Dams and the results of that assessment are presented in this section.
