Vintage Views Wastewater System Assessment Report

Dated: February 2024

Ecora File No.: 230122

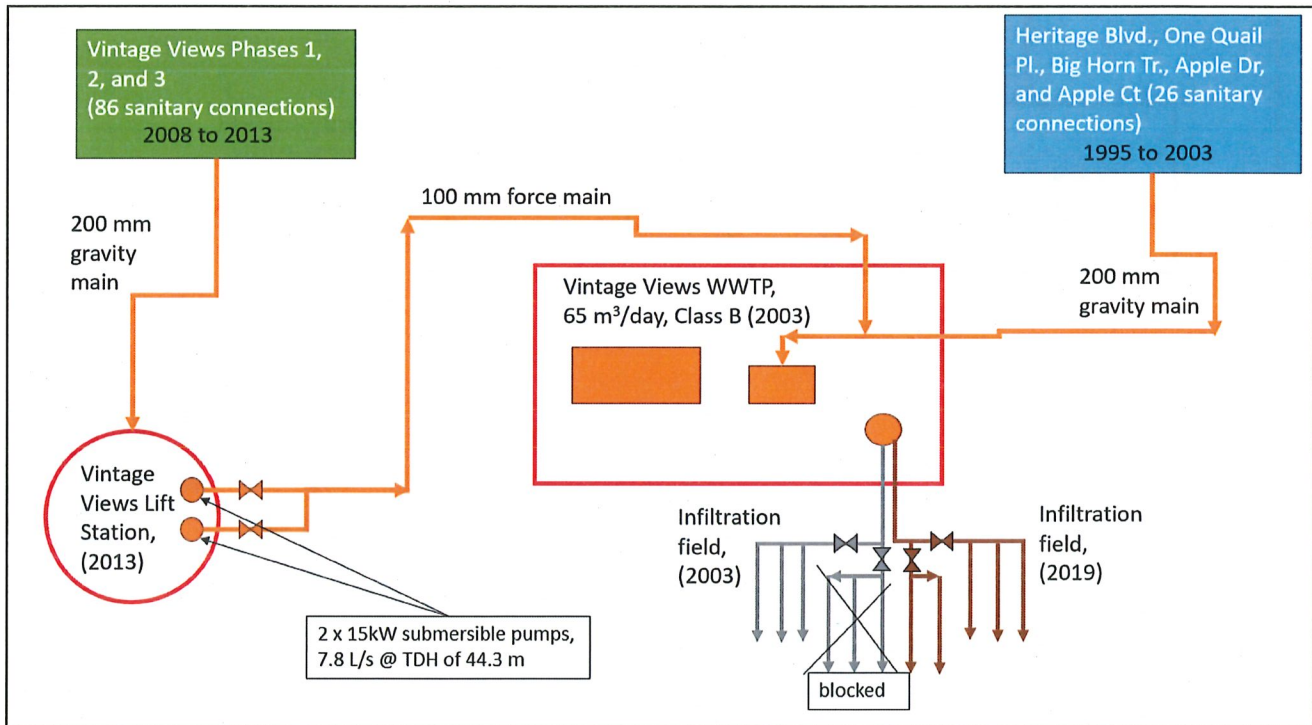
Figure 2: Schematic layout of the Vintage Views Sanitary System

- All wastewater from the three phases of the Vintage Views development flows via gravity through a pipe network consisting mainly of 200 mm diameter pipes to a sanitary lift station located downhill and to the west of the development. Wastewater is then pumped from the lift station through a 100 mm diameter force main with a length of approximately 487 m to the Vintage Views WWTP. All of the vacant lots are in the Vintage Views area. There are therefore two (2) inlets to the WWTP that combine in a manhole on the WWTP site.

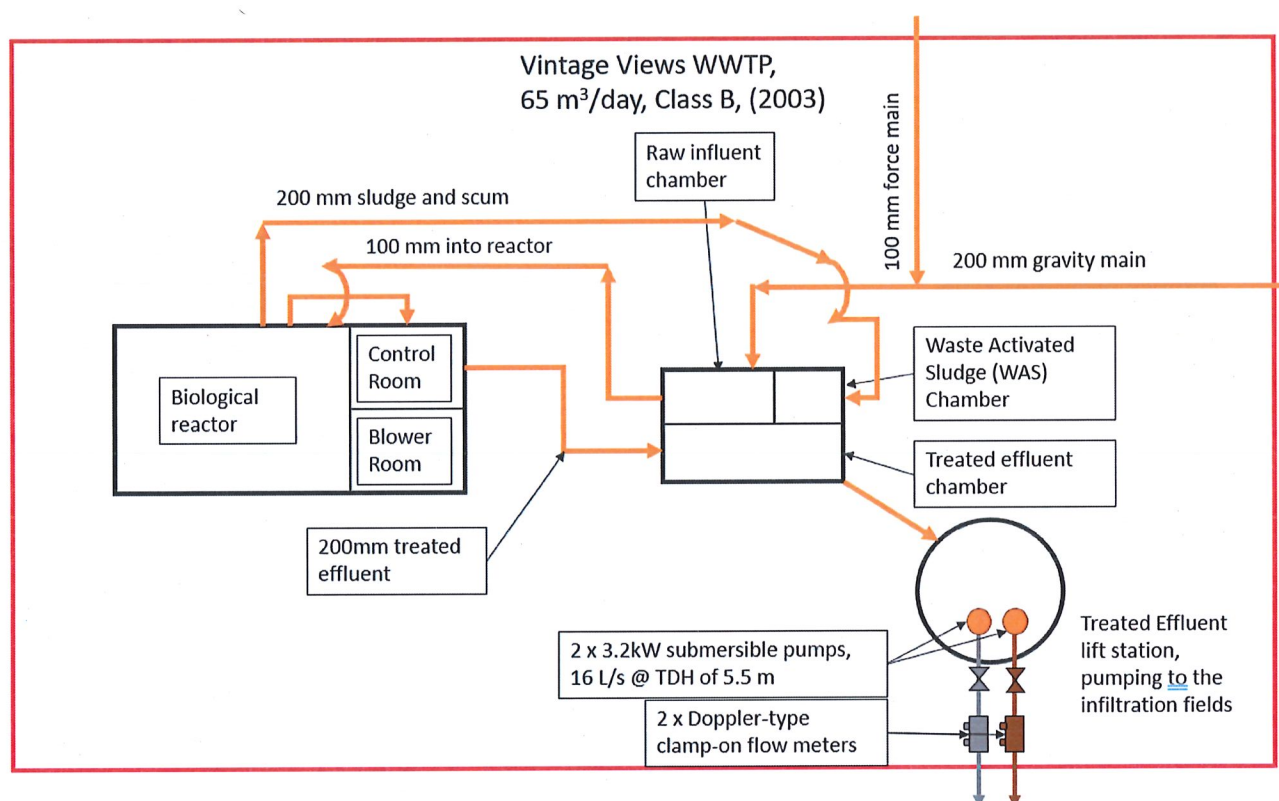
Figure 3: Schematic layout of the Vintage Views WWTP

- The WWTP was originally constructed by a different private developer (not Vintage Views Developments), called Mountain Landco Ltd. in the year 2003. Vintage Views Developments Ltd. subsequently purchased the WWTP from Mountain Landco Ltd in 2009. The original intention during construction in 2003 was that the WWTP would have an initial capacity of 65 m³/day and that it could be upgraded to a capacity of 195 m³/day in the future. (However, the WWTP currently fails to treat flows lower than 65 m³/day to the permitted standards.) The biological reactor consists of 3 compartments of which only the first is currently in use. The two (2) unused compartments are currently filled with rainwater, but they can be repurposed in the future. (For example, equipment such as media filters may be installed in them. A few modifications and additions will be required for lighting, heating, access, and ventilation.) A schematic of the wastewater treatment plant is presented as Figure 3 below:

- The infiltration field that was constructed in 2003 has an area of 0.33 ha. We understand that half of this infiltration field is completely blocked, damaged, or otherwise unusable. A new infiltration field that was constructed in 2019 has a surface area of 0.27 ha.

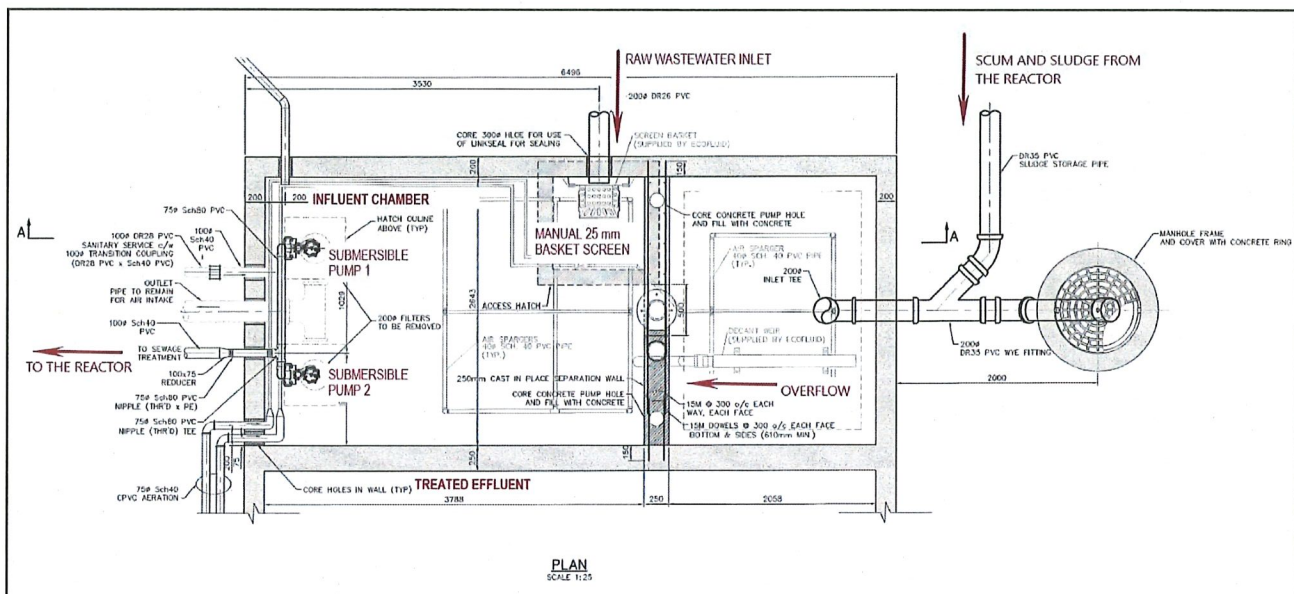
Figure 4: Inlet chamber, sludge chamber, and treated effluent chamber.

- The WWTP drawings are available should the RDOS need to scrutinize them. The WWTP consists of the following components:
 - An inlet chamber with a live storage volume of 15 m³. There is a relatively coarse manual screen (25 mm openings) that separates rags and other larger items from the inflow. There are two submersible pumps installed inside the chamber. These are Meyers WHR5-03 pumps with 0.3

kW motors. The pumps automatically alternate. Their duty point is 3 L/s at 5.5 m total dynamic head (TDH). These submersible pumps transfer the wastewater into the first compartment of the biological reactor. A layout drawing of the inlet chamber, the sludge chamber, and the outlet chamber is presented as Figure 4 below:

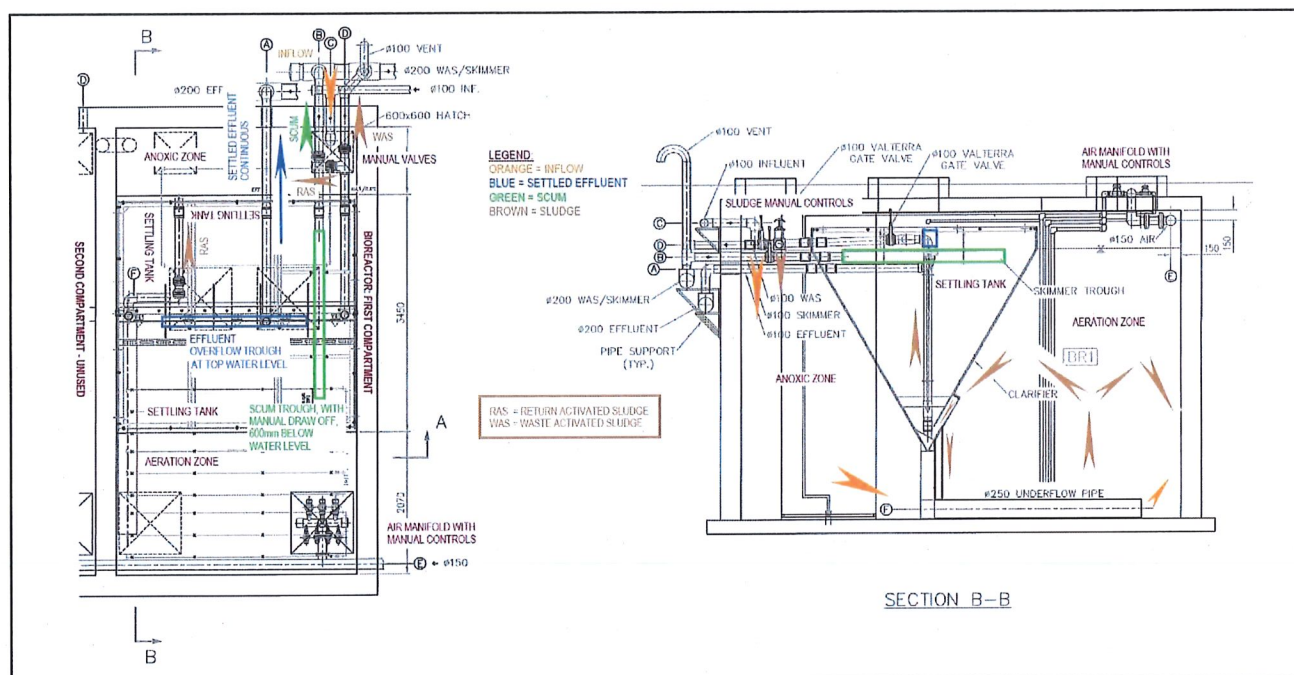
Figure 5: Bioreactor layout and section of the first compartment showing flow paths.

- Each of the three compartments in the biological reactor has dimensions of 3.65 m by 6.59 m and a water depth of 3.5 m, giving a volume of 84 m³. The total reactor size is 252 m³. Only the first compartment of the biological reactor is currently in use. A bubble aeration system in this compartment aerates the wastewater. There is also a settling tank/clarifier installed below the water level inside this compartment. This clarifier could not be inspected (because it is not visible below the water level). The overflow from this clarifier flows to the mechanical microfilter screen in the control room. Sludge is removed from the clarifier by an airlift pump. An airlift pump in wastewater treatment is a mechanism that utilizes compressed air to lift or transport liquids, such as sewage or wastewater, from a lower to a higher elevation. This pump operates by injecting air into a pipe submerged in the liquid, causing a mixture of air and liquid to become less dense, thereby creating buoyancy and facilitating the upward movement of the fluid. A layout and section of the first compartment of the biological reactor is presented in Figure 5 below:
