# Okanagan Falls Landfill

## 2023 Annual Report

### Operational Certificate: 15279

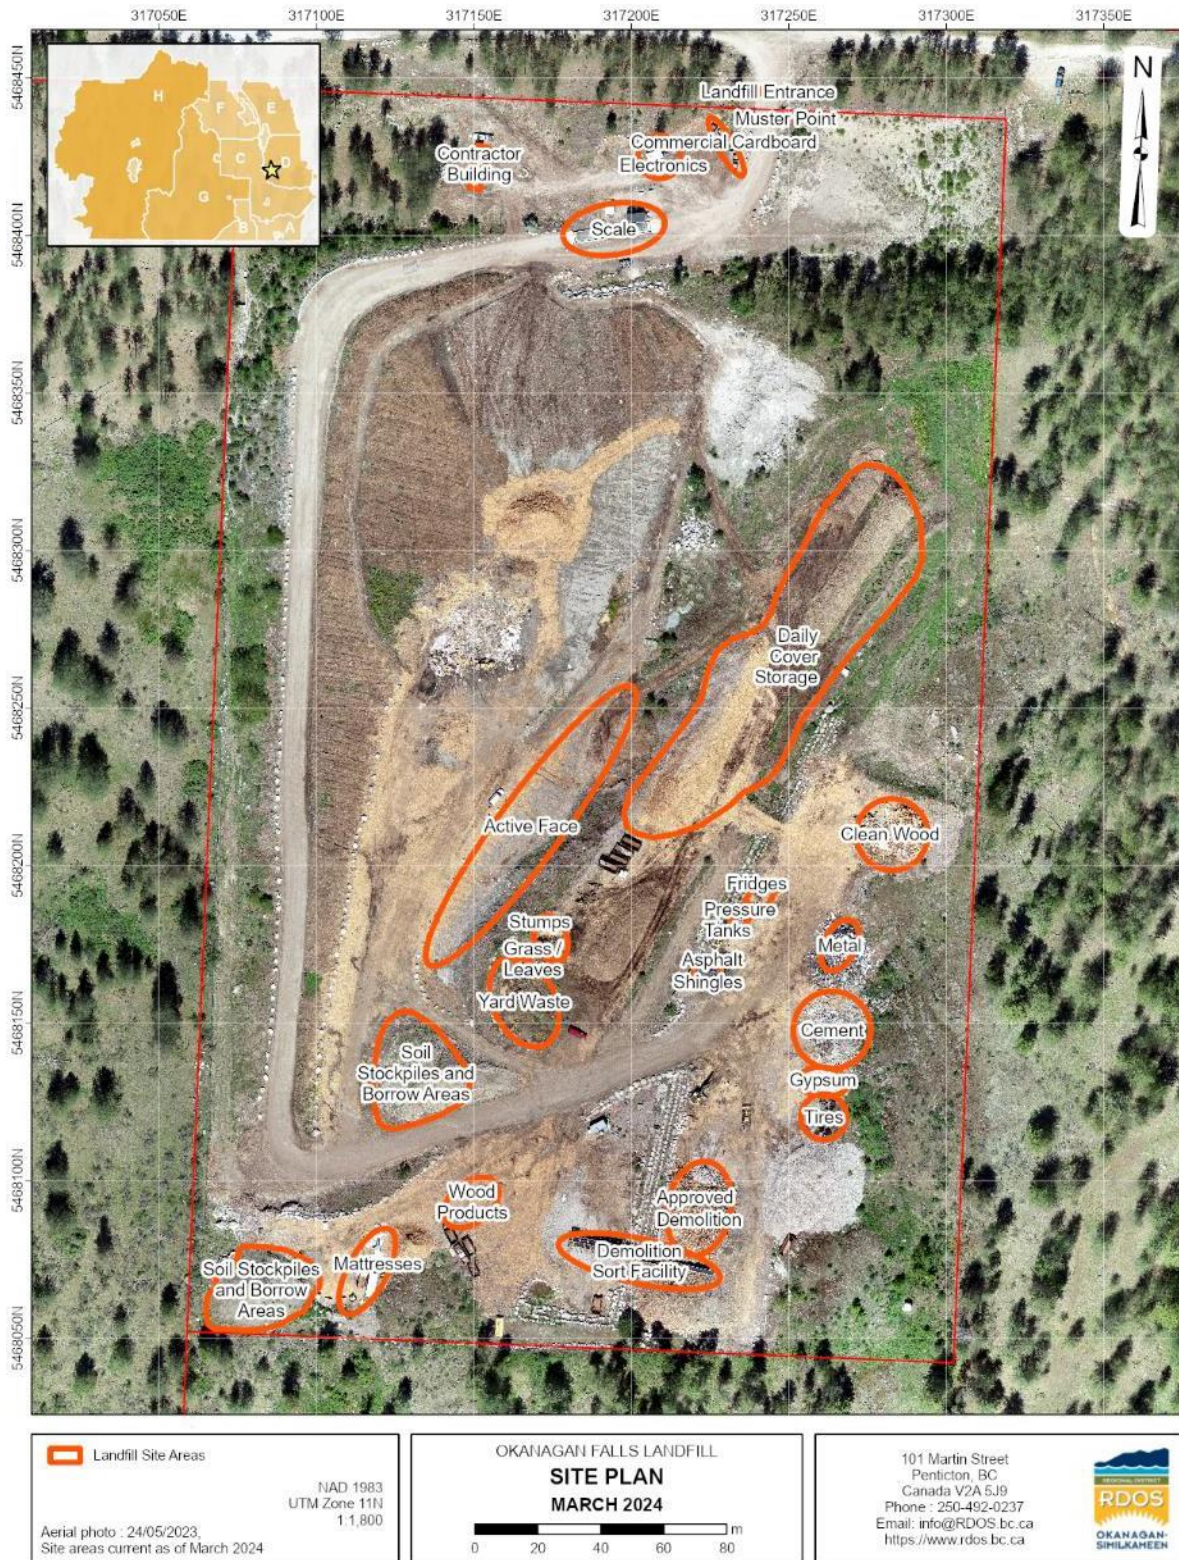
Figure 1a: March 2023 Okanagan Falls Landfill Site Layout

The entrance to the OFLF is located near the north-east corner of the site off Allendale Lake Road. An access gate controls entrance and/or exit. A page wire fence contains the east, west and south perimeter of the landfill, with a chain-link fence along the north boundary. The entrance gate is locked when the site is closed to prevent unauthorized vehicle entry and uncontrolled waste disposal.

The Scale and Scale House Facility as well as the landfill operator's trailer are located near the entrance at the north end of the Site.

Demolition sorting is done in the south east corner of the site.
